Artikel: Ship collisions against bridge piers
Autor: Ostenfeld, Chr.
DOI: <https://doi.org/10.5169/seals-20356>

Ship Collisions Against Bridge Piers

CHR. OSTENFELD

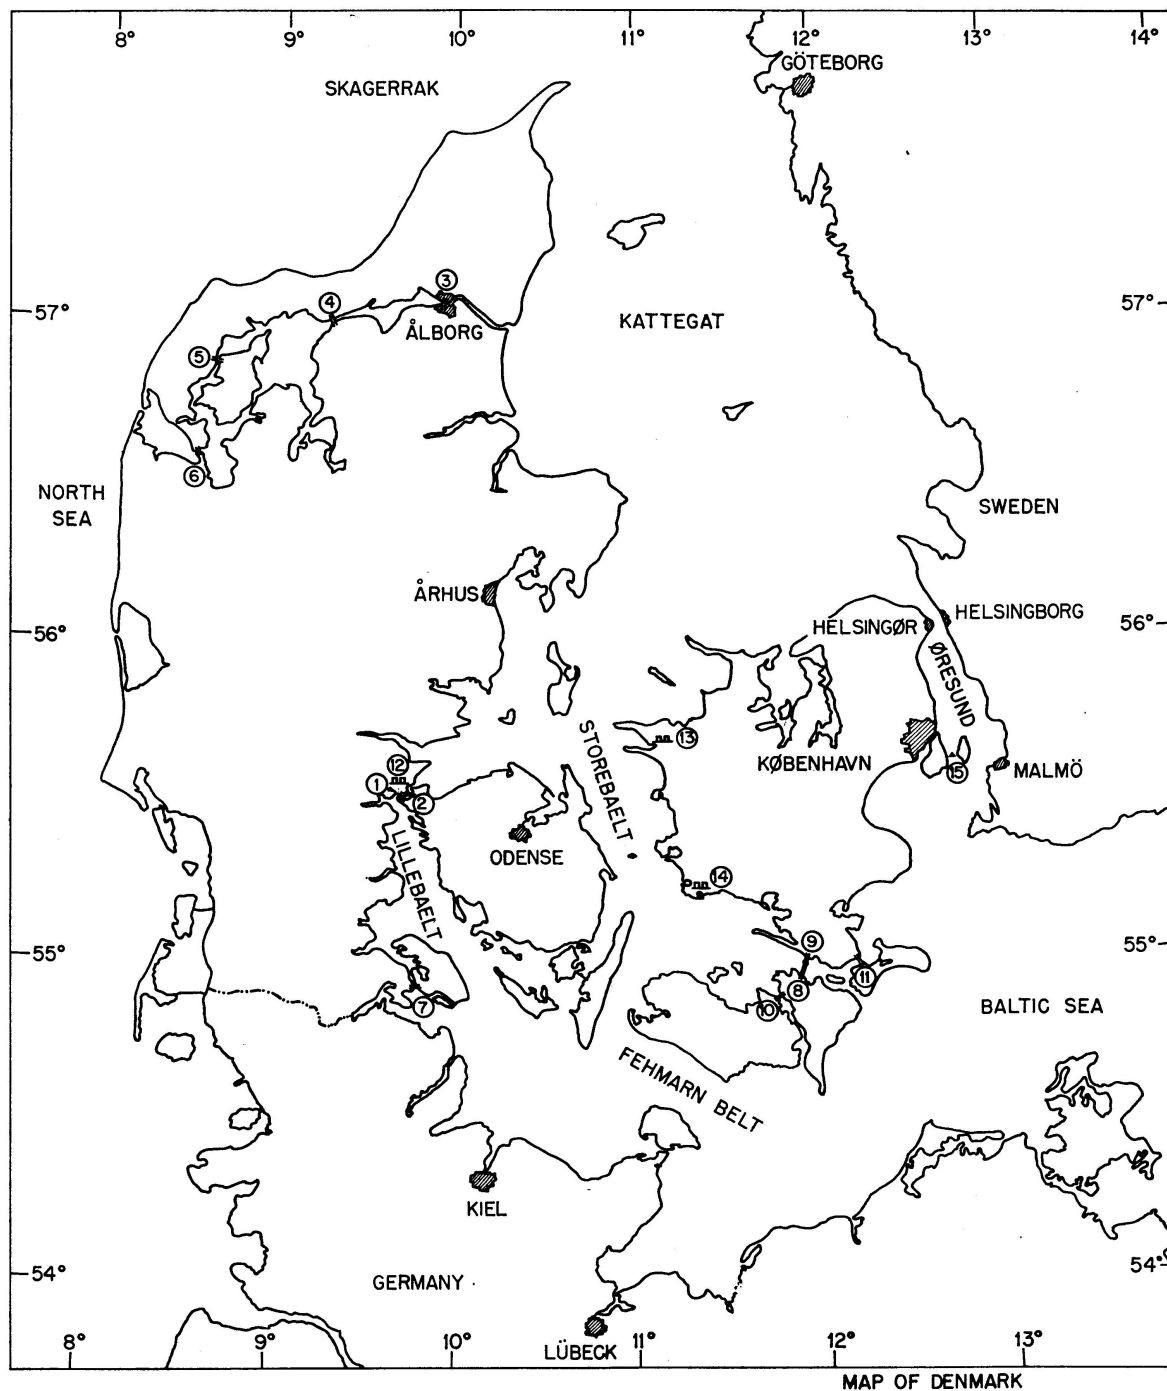
Bridges

1. Lillebælt, existing bridge
2. Lillebælt, new motorway bridge
3. Ålborg
4. Aggersund
5. Vilsund
6. Oddesund

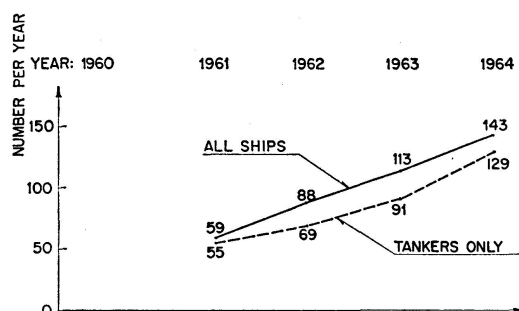
Number of ships launched over 25,000 gross tons ~40,000 T.D.W.

Information obtained from Lloyd's register of shipping.

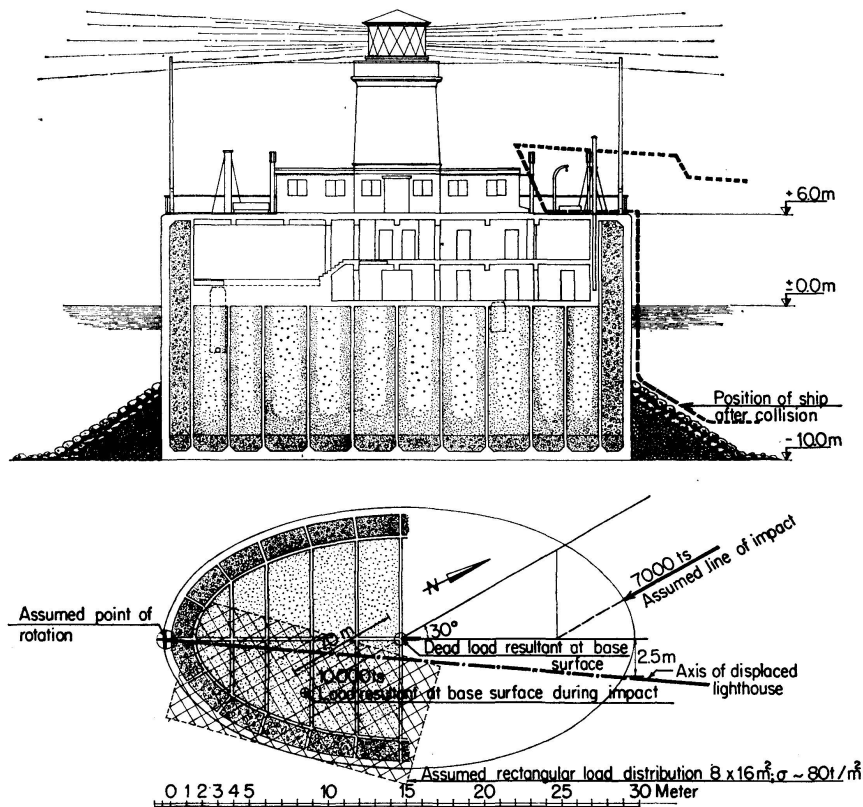
Speed, etc.: about 16 knots (8.25 m/sec.); the ship struck the lighthouse-structure at an angle of about 30° with the major axis (refer fig. 1).

Fig. 1. Drogden Lighthouse, in Øresund, SE of Copenhagen. The plan indicates the ship's line of approach, the displacement of the foundation and the assumed distribution of pressure in the underlying soil at the time of collision.

Northern end of lighthouse (the end involved in the collision) displaced 2.5 m eastward (refer fig. 1). One metre below water level a hole in the concrete resulted, $2.1 \times 2.5 \times 0.7$ m deep, probably caused by a deck in the ship at this level.

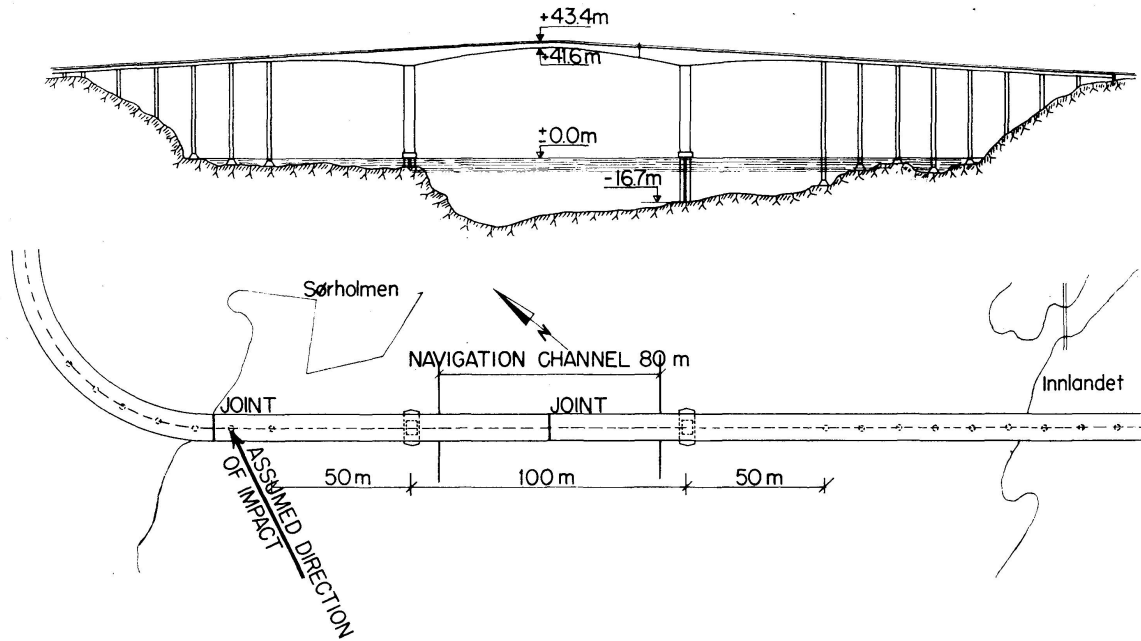
Fig. 2. Sørsund Bridge at Kristiansund, Norway. On the plan is indicated the supposed line of approach of the ship.

The column broke in two places: at the bottom and at the collision-point (the location is not exactly known). The deflection of the column at the collision-point was about 65 cm. The bridge deck was not damaged but was deflected upwards and warped. At a dilatation joint in the deck, located between the column involved and the next landward column, a deformation of 3 cm was observed on one side and 8 cm on the other.

When the column was pressed back into correct position the deck assumed its original shape. The concrete tongue in the joint was broken.

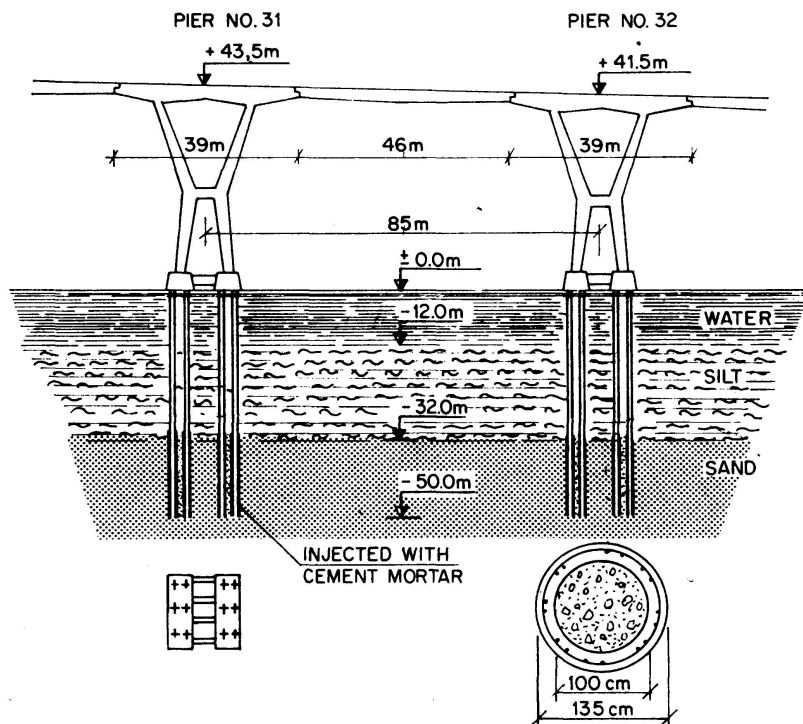
Fig. 3. Maracaibo Bridge, Venezuela. The figure shows the two piers, which were destroyed by the collision.

A pier consists of four reinforced concrete frames, designed as a combined H and V structure. The weight of the pier is about 10,000 t (see fig. 3).

Two piers (Nos. 31 and 32) and their cantilever structures were destroyed (the piles broke). Three suspended spans fell into the water, and several persons perished, driving in motor cars which happened to be on these spans, or during darkness running their cars into the gap. The damage is estimated at about 5 million dollars.

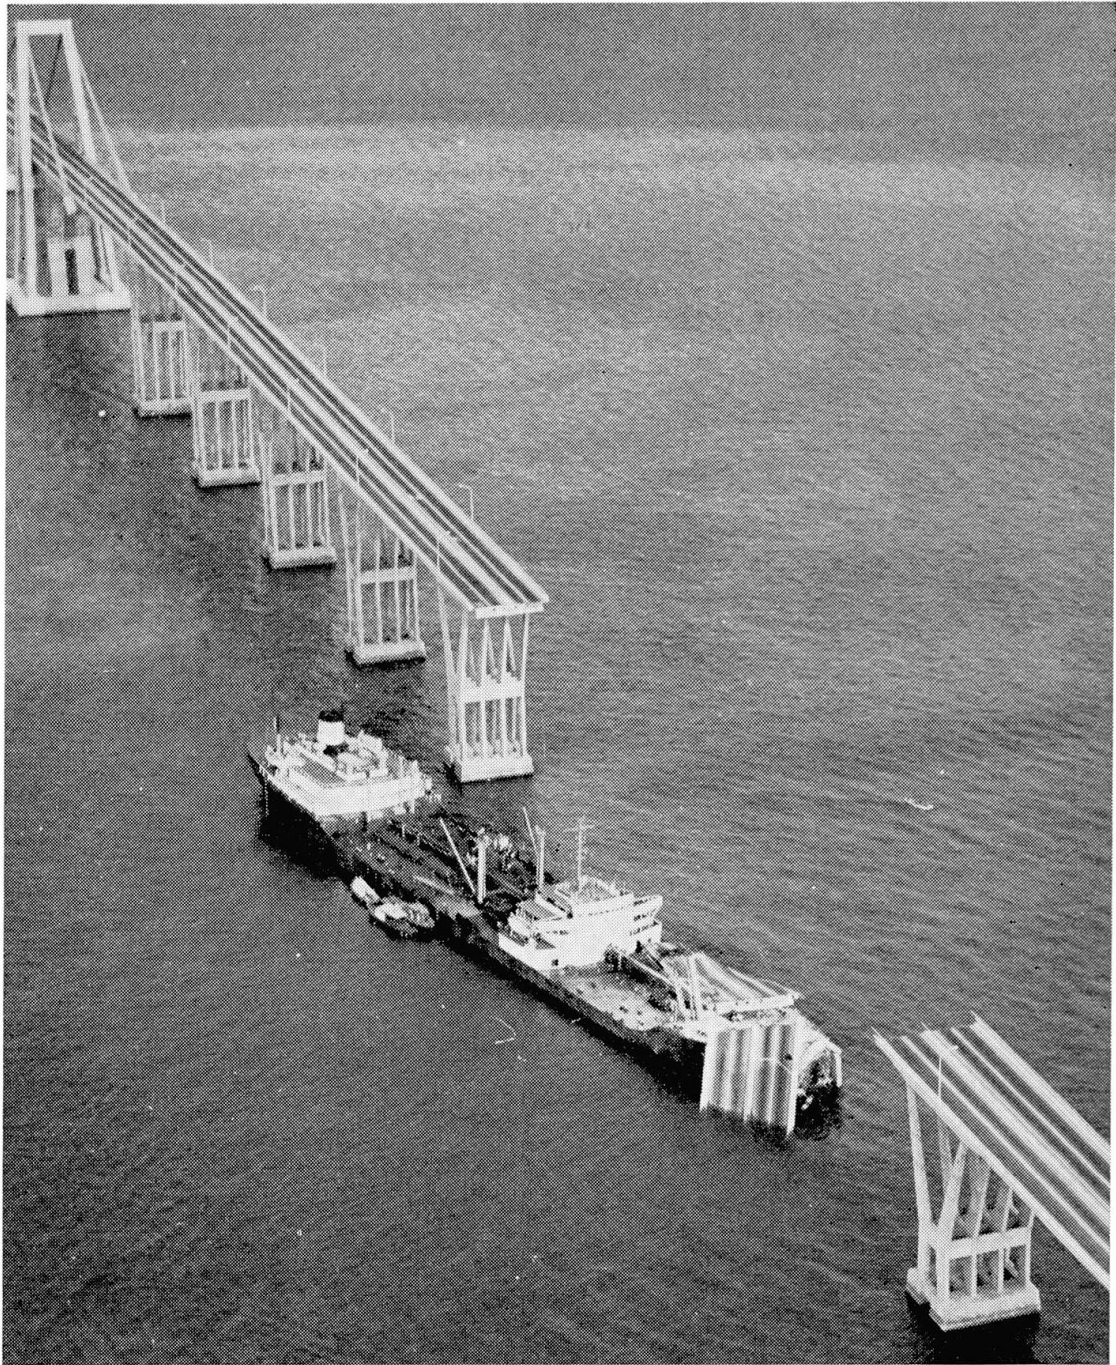
Photo 1.

Suspended spans fell down upon the bow of the ship and considerable damage resulted. The ship sprang a leak, it remained afloat, however (see photos 1 and 2).

Maracaibo bridge after the collision.

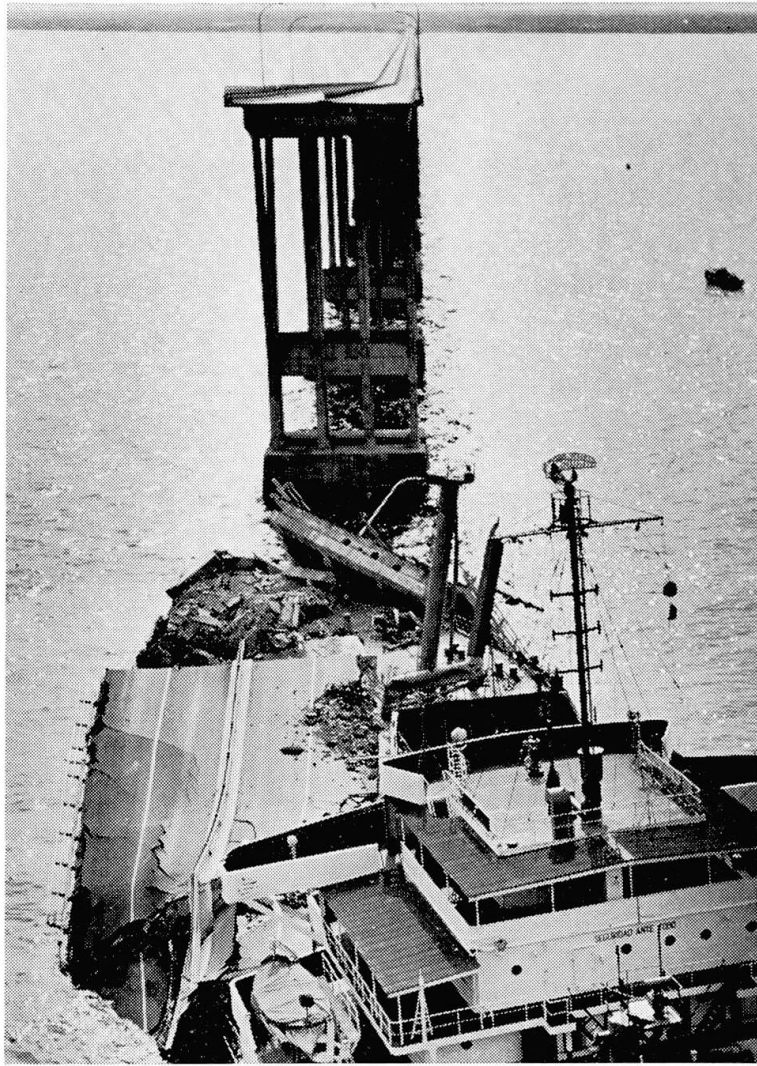
Photo 2.

Maracaibo bridge after the collision.

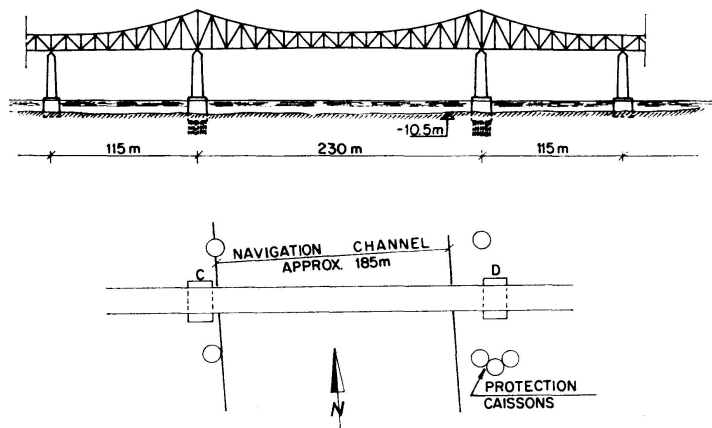
Fig. 4. Outerbridge Crossing, New York. The plan shows the location of the protection caissons in relation to navigation channel and piers.

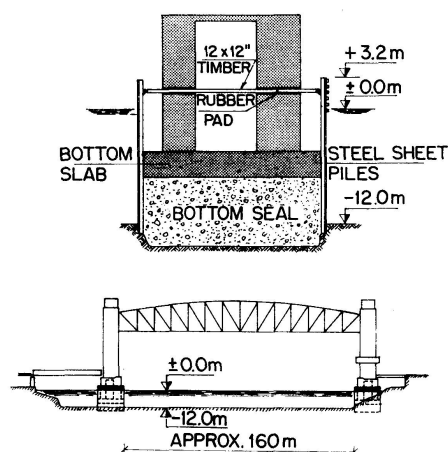
Fig. 6. Lift bridge across Arthur Kill, New York.

channel stand in about 12 m of water. The piers were built within cofferdams of steel sheet piles, which were left in place, constituting permanent protections; they reach about 3 m above water level. Bracing of the sheet piling against the piers is established by timber, and 3" rubber padding is used. On the outside of the sheet piling normal timber fendering is furnished.

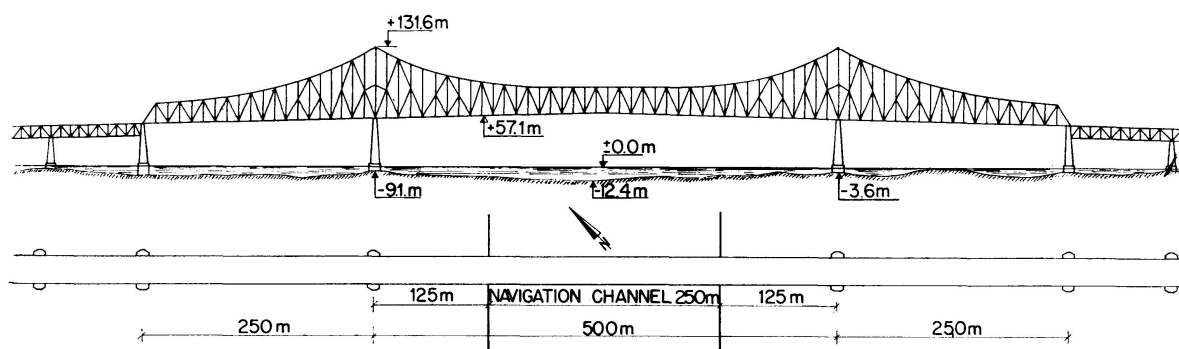
A new bridge across the Delaware River: the Chester-Bridgeport Bridge has now been planned, the spans being 250—500—250 m (see fig. 7).

Fig. 7. Chester-Bridgeport Bridge, Philadelphia.

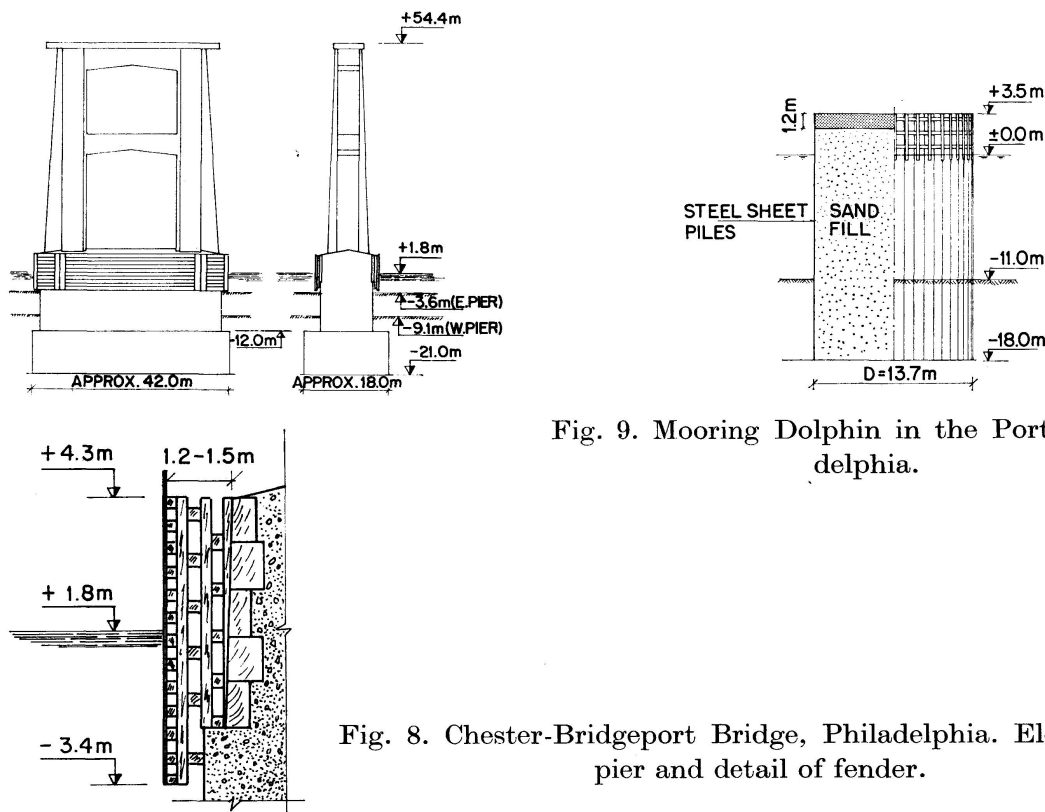
Fig. 9. Mooring Dolphin in the Port of Philadelphia.

Fig. 8. Chester-Bridgeport Bridge, Philadelphia. Elevation of pier and detail of fender.

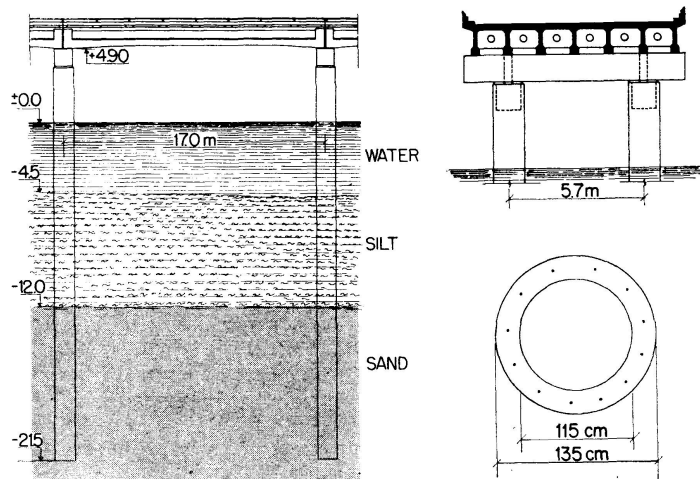
Fig. 10. Pontchartrain Bridge at New Orleans.

3 trestles were hit by the collision, 4 bridge deck elements fell into the water. Two of the trestles were renewed (new piles driven), the third was repaired. Four new bridge deck elements were erected. Total cost of repair about 150,000 dollars.

Due to the frequent collisions (five up to now) the repair service of this bridge is exceptionally well organized. Piles and deck elements are ready in stock. A floating derrick-crane drives the piles and erects the elements. In this particular case the bridge was ready for use within five days.

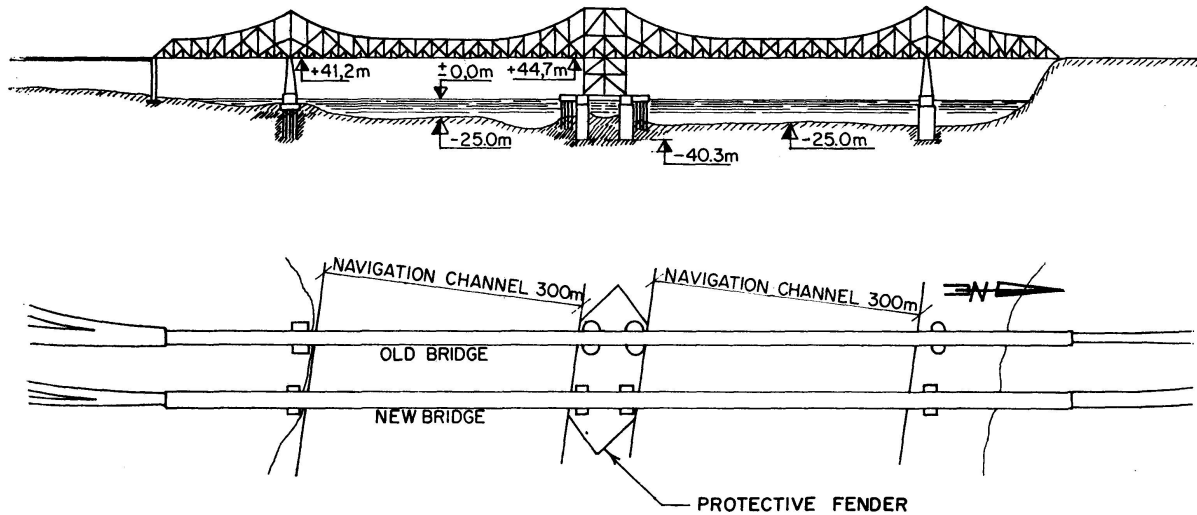
Fig. 11. Carquinez Strait Bridge, California.

The existing bridge connection, leading across a sound with an intense traffic, comprise two parallel bridges, one of them built in 1927, the other in 1958. The superstructures of the two bridges are practically identical, a steel cantilever structure with a central pier and two navigation spans, each having a width of about 335 m (refer fig. 11).

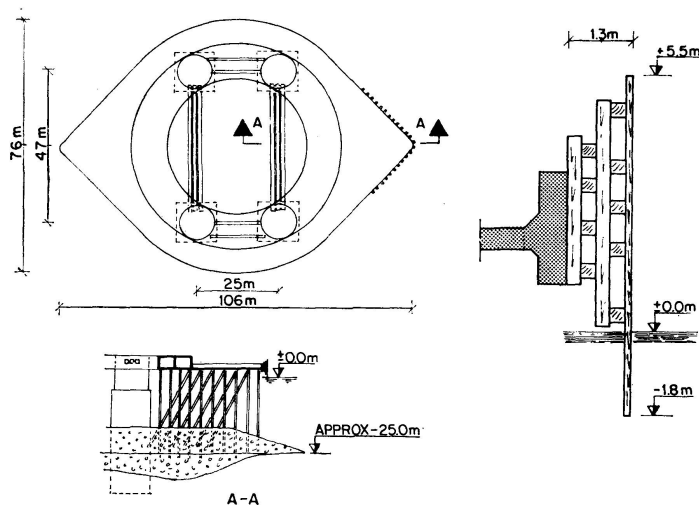
This permanent protection, refer fig. 12, consists of a heavily reinforced horizontal concrete slab, supported on vertical piles and rakers, brought down

Fig. 12. Carquinez Strait Bridge, California. Pier protection, plan and section, and detail of fender.

into a thick layer of rock debris. The concrete slab is interconnected with the four reinforced concrete caissons, so that the construction in its entirety functions as one unit with a view to absorption of impact. The outer edge of the concrete slab is relatively thin, it is assumed that this part of the slab will be crushed and, partly, be forced into the ship; in this way adequate provision is found to have been made for absorption of the greater part of the kinetic energy. Moreover, the concrete slab is provided with a fender, consisting of vertical and horizontal timber with a total depth of about 1.3 m. When the new bridge was built, in 1958, the steel tower of the central pier was founded

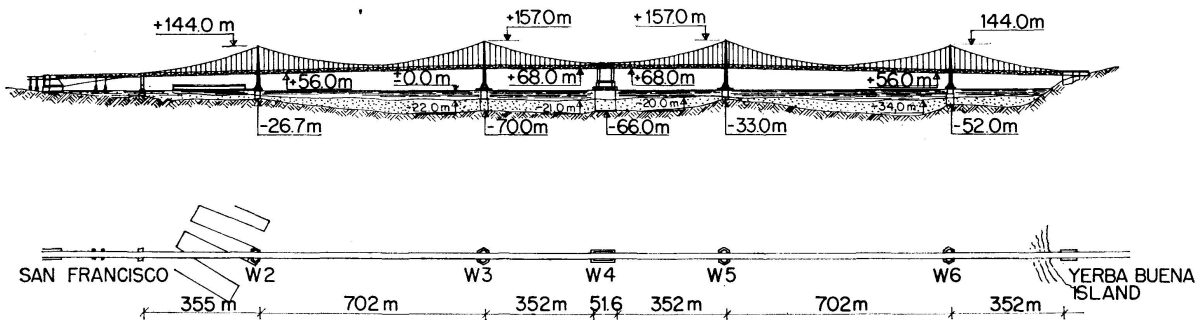
This bridge, crossing the bay between San Francisco and Oakland, has a total length of about 6.5 km and consists of two suspended bridge sections, each having a main span of about 700 m, cantilever spans of maximum about 425 m, and a number of girder spans (refer fig. 13). In the suspended bridge

Fig. 13. San Francisco-Oakland Bay Bridge, California.

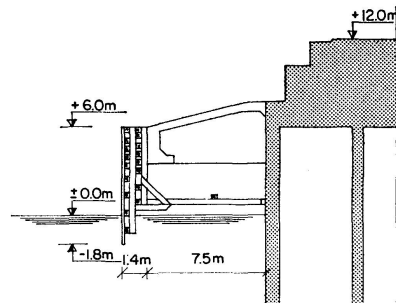
Fig. 14. San Francisco-Oakland Bay Bridge, California.
Detail of pier protection.

The protecting structure (refer fig. 14) is a ribbed concrete slab cantilevered 7.5 m from the ends of the pier and 3.6 m from the sides. To the concrete slab is attached, moreover, a timber fender structure, consisting of several layers of vertical and horizontal timber with a total depth of about 1.4 m, reaching from about 6 m above to about 2 m below water level. Hence, the total distance the ship has to pass before reaching the pier proper will be about 9 and 5 m respectively, whereby a considerable amount of kinetic energy can be absorbed.

In the past, ships have collided with piers W 3 and W 5 in a number of cases. On W 3 part of the fenders has been destroyed on two occasions through impact from an unknown ship. W 5 has been involved in collisions three times, hit at the same place, whereby some damage to the fenders resulted: in 1949 an oiltanker collided with the pier, in 1957 a maintenance ship belonging to the navy, displacement 1700 t, ran into the pier in a dense fog, and in 1963 it was hit by an unknown ship. None of these collisions resulted in damage to the protecting concrete slab.

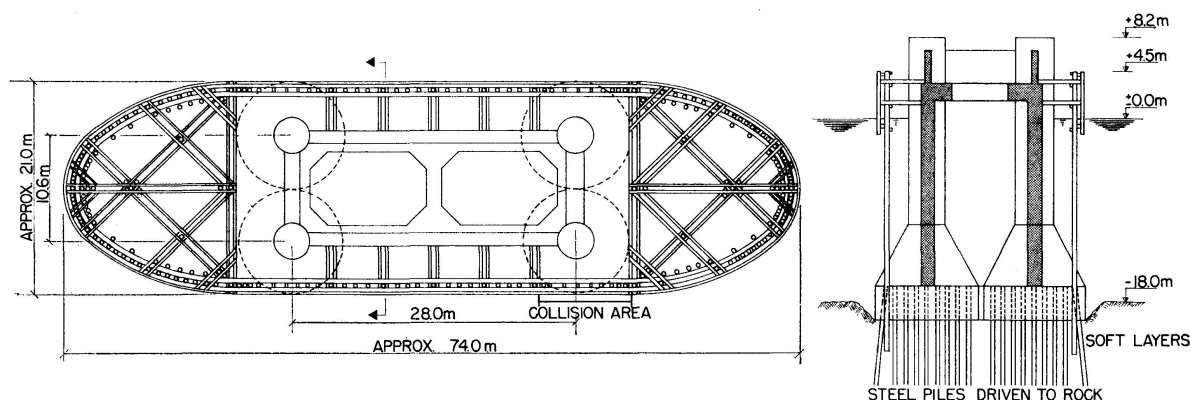
Fig. 15. Richmond-San Rafael Bridge, California. Pier protection, plan and section. Note particularly the extent of the protection in comparison to the four slender bridge piers.

embracing the entire circumference of the pier, refer fig. 15. In principle the protecting structure is detached from the shafts of the columns and consists of horizontal and vertical timber reaching from about 4.5 m above to 1.5 m below water level and attached to vertical piles driven down into the seabottom. Upstream and downstream of the pier, where the risk of collision is greater, the protecting structure reaches about 20 m beyond the columns.

The part of the protecting structure that was hit (opposite to a pier shaft) was completely destroyed. The damage amounted to about 23,000 dollars. The pier suffered no damage.

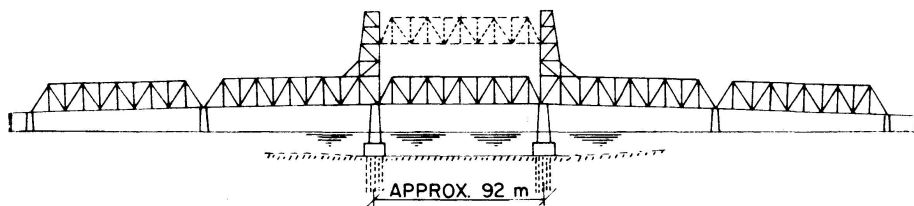
The bridge has five main spans, the central span, bridging the 80 m wide navigation channel, being a lift span. The piers flanking the navigation channel have a base area of about 18×8 m. They stand in about 13 m of water and are supported on piles. The weight of a pier, including shaft, is about 5000 t.

Fig. 16. San Mateo-Hayward Bridge, California (old bridge).

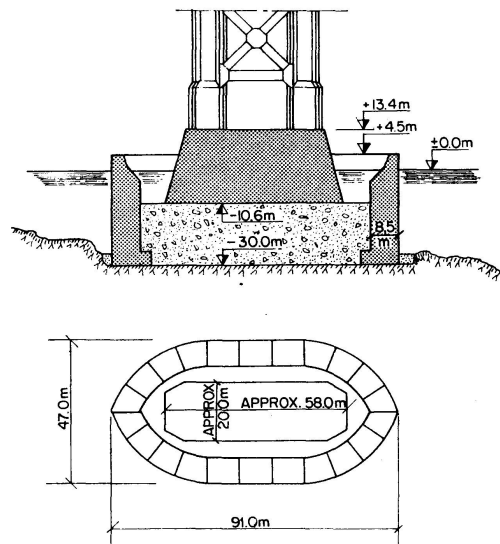
The pier construction, refer fig. 18, includes an external concrete cofferdam, with an about 8.5 m thick wall, a sealing layer about 20 m deep, and the pier proper, reaching from level about -10.6 to $+13.4$ m.

Fig. 18. Golden Gate Bridge, California. Plan of South Tower with concrete wall which was acting as cofferdam during the construction period and which is now acting as permanent protection.

The cofferdam is of approximately elliptic shape, the outer dimensions being about 91×47 m. The concrete was placed under water, in a movable steel shuttering, and carried up to level $+4.5$. Thereafter, the 20 m sealing layer was placed as under-water concrete. The water inside the concrete wall was pumped out, and the pier proper was concreted in the dry. The cofferdam remains in place and constitutes a very effective protecting structure for the pier proper. The weight of the cofferdam is about 135,000 t, whereas the weight of sealing layer + pier amounts to about 115,000 t.

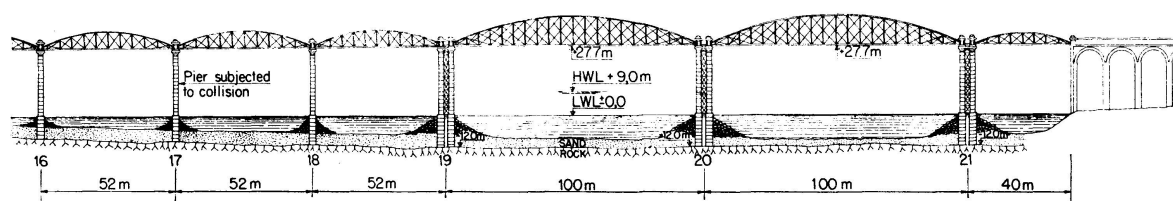
The bridge is a little more than 1 km long, having a series of spans of about 40—50 m, and two large navigation spans — far away from the place of collision.

Fig. 19. Severn Railway Bridge, England.

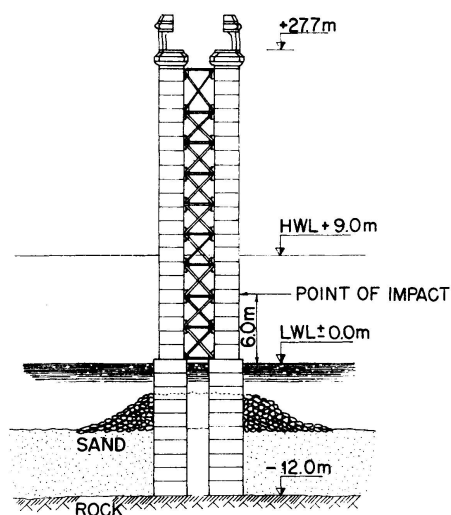
Fig. 20. Severn Railway Bridge, England. Pier 17.

The bridge was built in 1875—1879. The superstructure is of old-fashioned design: Parabolic steel trusses. Clear height under the bridge about 20 m, above high water level (tidal changes amount to about 10 m). Most of the piers, including the pier involved in the collision, consist of two cast iron cylinders, of diameter 2.1 m, filled with “Roman Cement” (see fig. 20). These cylinders stand on two similar cylinders of 2.7 m diameter, carried down to

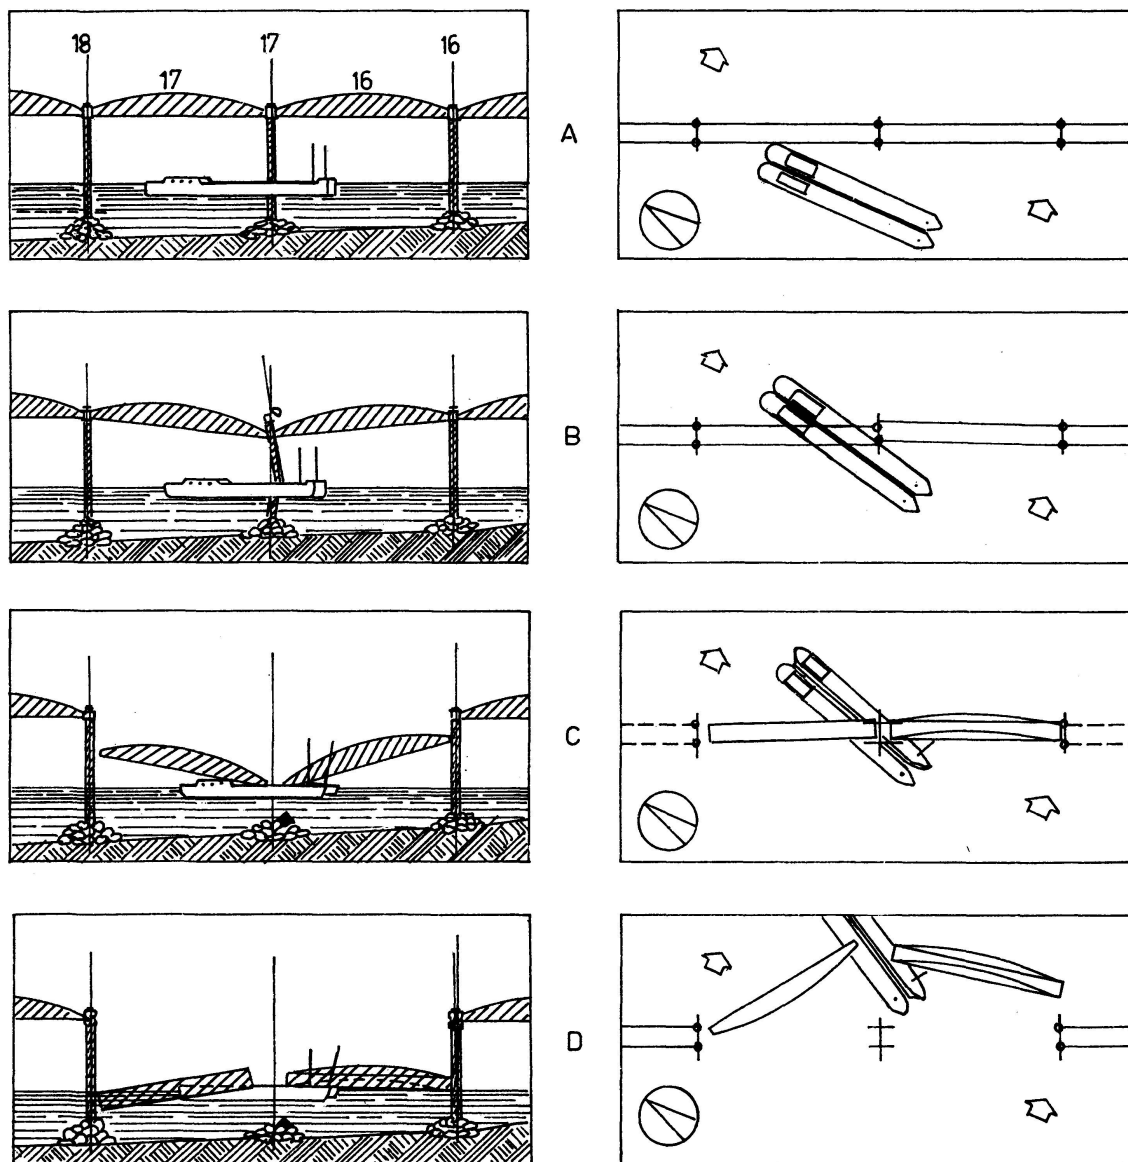
Fig. 21. Severn Railway Bridge, England. Reconstruction of events.

Fig. 21 illustrates the results of a thorough investigation undertaken by Peter Mason, Consulting Engineer. As a matter of course, Peter Mason undertook, among other investigations, a calculative analysis of the impact, and found — quite naturally — that the pier could not take any impact of importance.

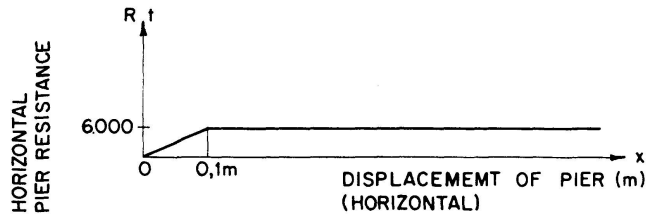
WORKING LINE DURING DISPLACEMENT:

Pier (the same in all cases investigated) weight excl. buoyancy about 50,000 t. Resistance from displacement to ultimate $R_{max} = 6000$ t.

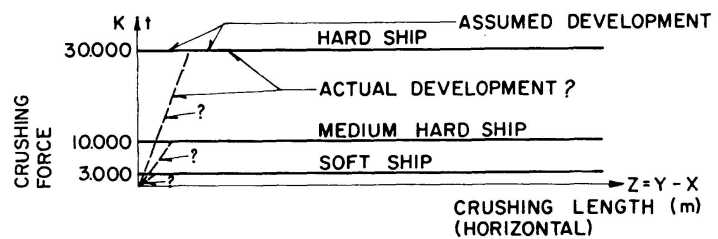
Ship: Displacement about 50,000 t (T.D.W. $\sim 37,000$ t) (the same in all cases). Crushing resistance (constant during impact):

$K = 3,000$ t soft ship

$K = 30,000$ t hard ship

WORKING LINE DURING IMPACT:

(Y IS MOVEMENT OF SHIP AFTER INITIATION OF IMPACT)
