**Artikel:** The construction of the Forth Road Bridge

# The Construction of the Forth Road Bridge

### H. SHIRLEY-SMITH

C.B.E., B. Sc., M.I.C.E., Engineer in charge of construction for the contractors, the A.C.D. Bridge Co.

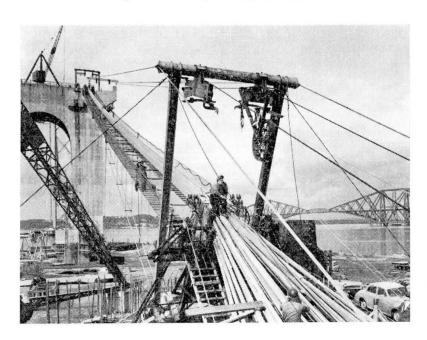
Fig. 5. Cable spinning nearly completed — the last spinning wheel leaving the South anchorage.

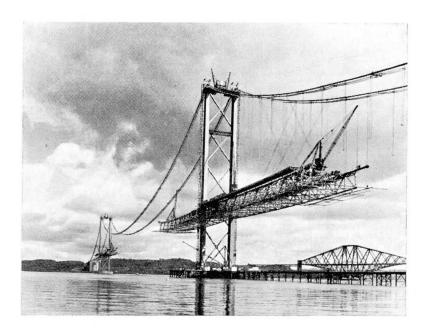
Fig. 8. A view during erection of suspended structure. Note temporary upward deflection of steelwork.

The first 90 ft. lengths of deck were cantilevered out from each side of each tower and the 15 ton travelling derricks assembled on them before the end of cable spinning, so that there would be no delay in starting deck erection. As soon as each panel of steelwork had been connected to the suspenders, the temporary crane tracks were extended and the derrick moved out to the end of the panel in order to erect the next one. The work in main and side spans was kept in balance until 18 panels had been erected on either side of each tower. Owing to the fact that the main cables, which were clamped in the saddles at the tower tops, had to stretch some 18 feet in their length of 7,000 feet between anchorages as the deck was erected and its dead load came onto them, the tops of the towers were at this stage deflected back a maximum of 30 ins. to the shore and the side spans were temporarily humped up. For this reason erection had then to be discontinued in the main span until the side span steelwork was completed. Concreting of the roadway panels in the side spans was then begun, the work being organized so as to spread the load as uniformly as possible along their length, whilst steel erection in the main span was completed. The gap at mid span before closure was  $8^{1}/8''$  in the top chord and  $8^{5}/8$ " in the lower chord which agreed within quarter inch of the calculated figures. Junction was then brought about by releasing the ends of the deck from the towers and so allowing the two halves to meet for connection at mid-span.

Before this occurred, the lower chord joints which had been opened began to close and were completed as soon as possible. Many connections in the middle of the side spans closed at much the same time and sometimes out of
