**Zeitschrift:** IABSE publications = Mémoires AIPC = IVBH Abhandlungen  
**Band:** 26 (1966)

## **The Construction of the Forth Road Bridge**

H. SHIRLEY-SMITH

C.B.E., B. Sc., M.I.C.E., Engineer in charge of construction for the contractors, the A.C.D. Bridge Co.

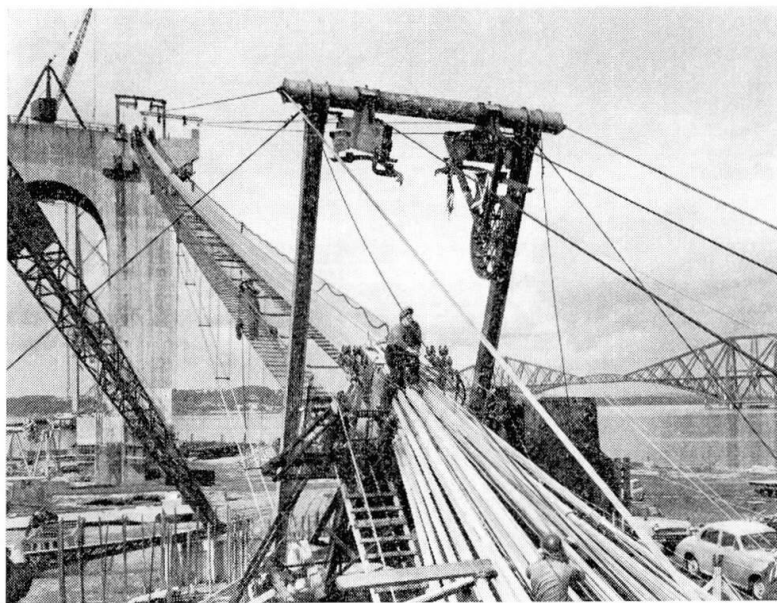
Fig. 5. Cable spinning nearly completed — the last spinning wheel leaving the South anchorage.
