Cardiff Arms Park Stand (United Kingdom)

Zeitschrift: **IABSE structures = Constructions AIPC = IVBH Bauwerke**

Band (Jahr): **4 (1980)**

8. Cardiff Arms Park Stand (United Kingdom)

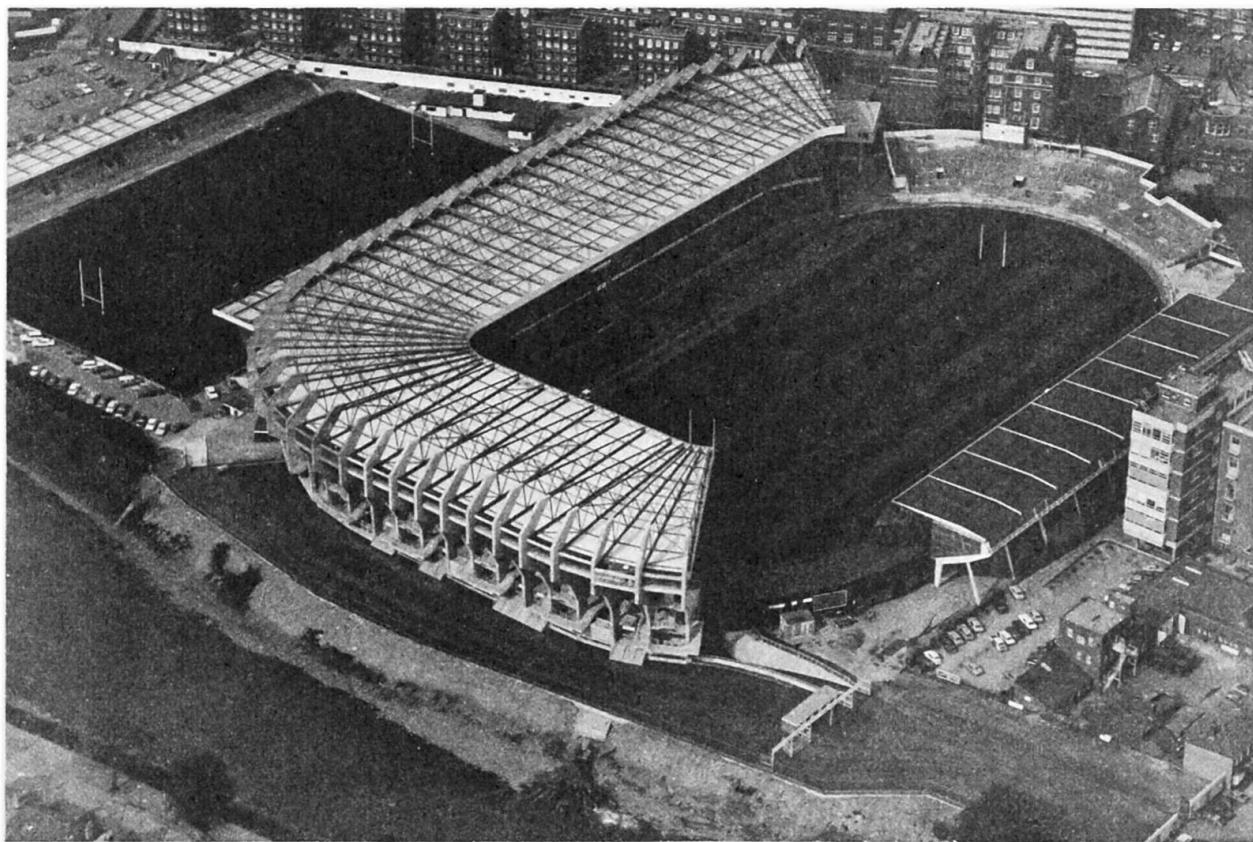
Aerial photograph of the Stadium taken in 1978

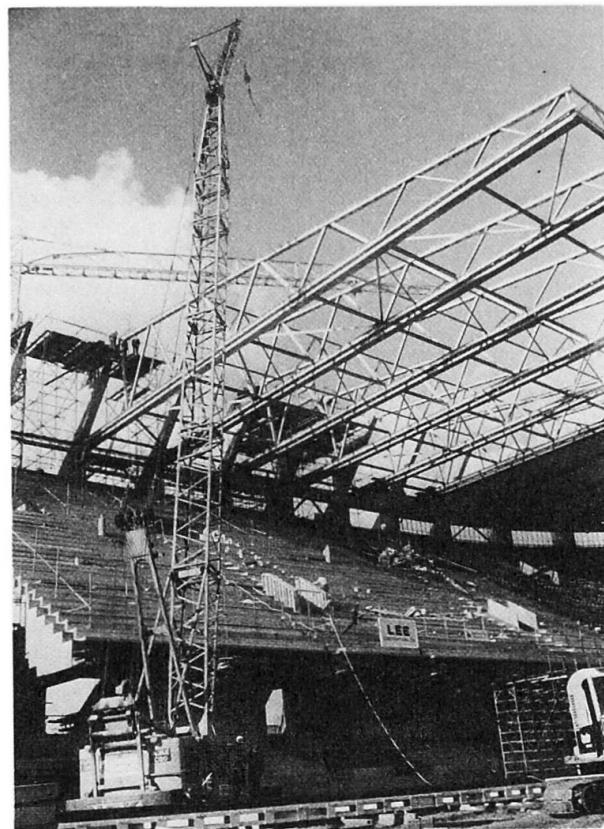
Construction: photograph taken in Dec 1977

The Main Raker Beam and Vertical Mast Section are encased in concrete to form a composite construction prior to the erection of the cantilever Roof Trusses.
