Artikel: The Sioux Narrows Bridge, Ontario (Canada)
Autor: Dorton, R.A.
DOI: <https://doi.org/10.5169/seals-20920>

1. The Sioux Narrows Bridge, Ontario (Canada)

Owner: Ministry of Transportation of Ontario
Design: Structural Office and Research and Development Branch
Work Duration: 6 months
Completion: 1982

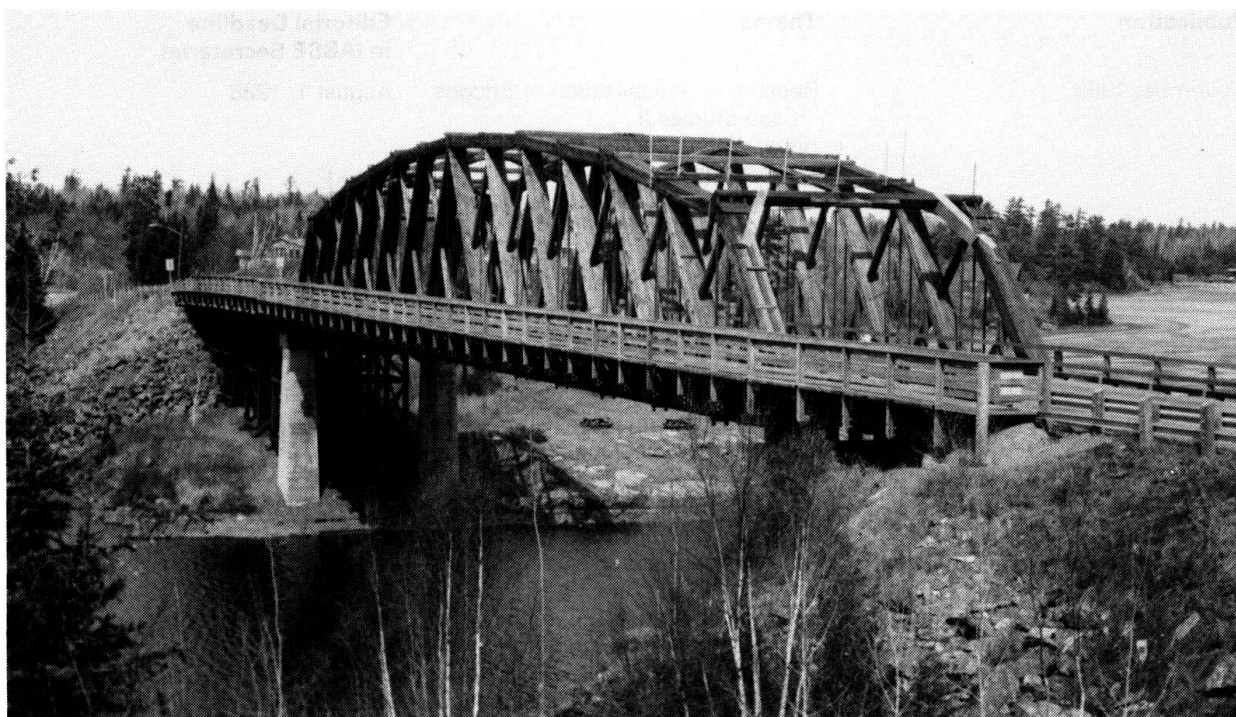
Fig. 1 General view of bridge

The Sioux Narrows Bridge is on Highway 71 linking Fort Frances and Kenora in northwest Ontario. The bridge was constructed in 1936 with a wooden Howe truss main span of 64 m, Figure 1. It is believed to be the longest single span wood highway bridge in North America.

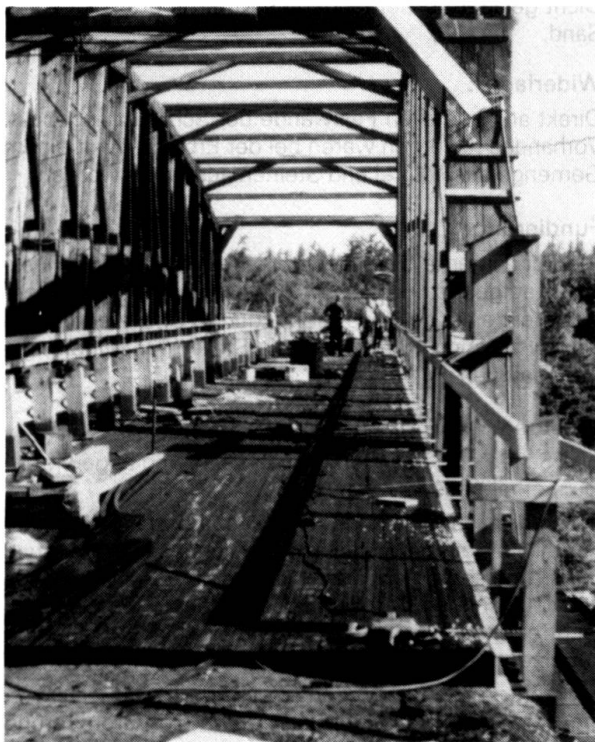
Fig. 3 Placing prestressed wood deck

The deck was replaced one lane at a time, Figure 3, so the bridge could remain open to traffic. The prestressing bars were coupled together for construction of the second lane. A new asphalt wearing surface was then applied to the wood deck.

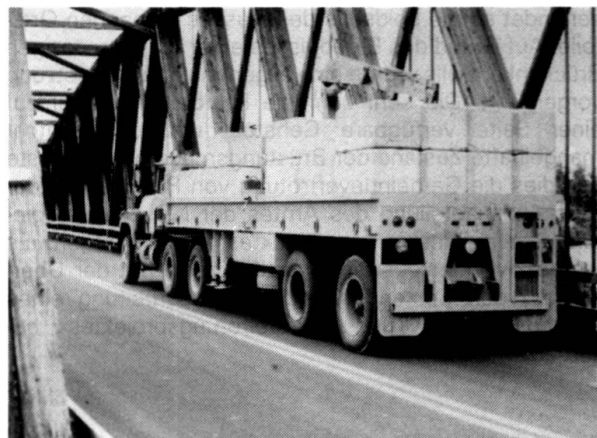
Fig. 4 Load testing the rehabilitated bridge

Full scale bridge testing using custom designed load vehicles, instrumentation and mobile laboratory for the computerized data acquisition system is a regular feature of the Ministry's evaluation procedures. Load testing of the deck system was carried out before deck replacement and after, Figure 4. Eight floor beams were instrumented by attaching strain gauges to the steel tie bars. The greatly improved longitudinal distribution characteristics of the prestressed deck was confirmed by a reduction of 35% in the truss bar strains for the same tests as carried out on the old deck. No further strengthening of the floor system is needed. The only other members that may need replacing are the main truss hanger bars, which will be tested shortly.
