Zeitschrift: IABSE structures = Constructions AIPC = IVBH Bauwerke
Band: 12 (1988)
Heft: C-46: Repair and rehabilitation of bridges: case studies I

1. The Sioux Narrows Bridge, Ontario (Canada)

Owner: Ministry of Transportation of Ontario

Completion: 1982

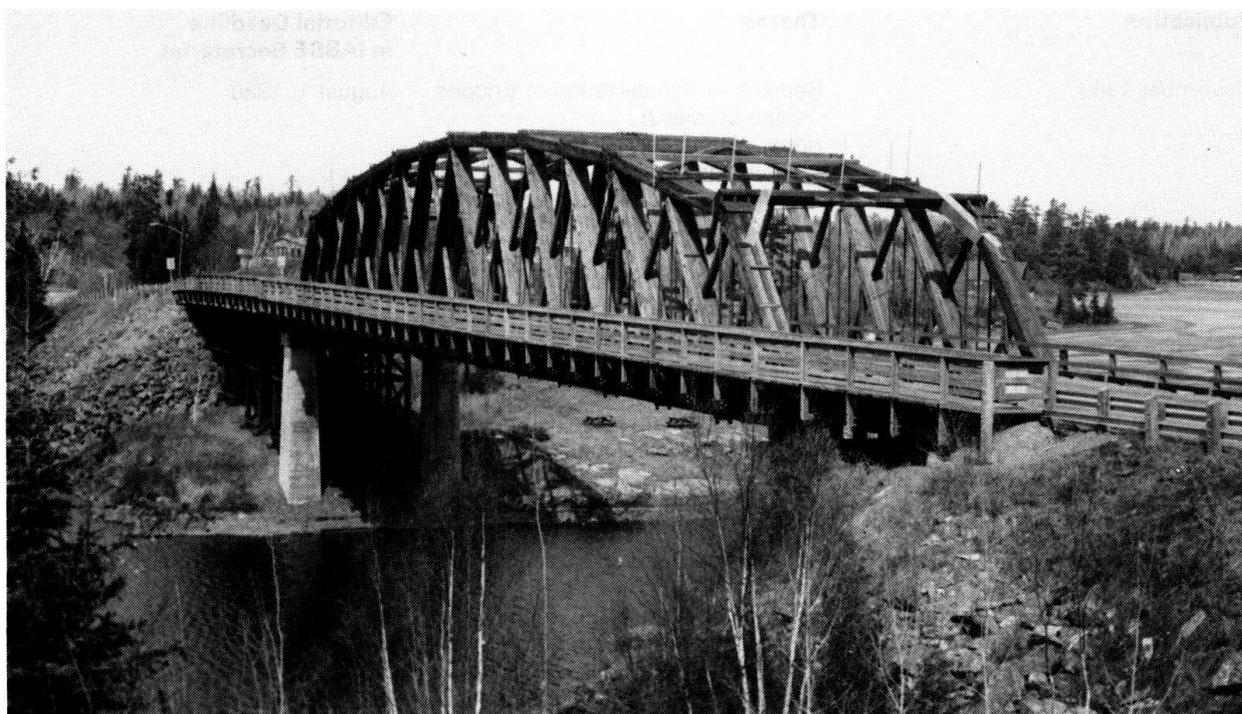
The Sioux Narrows Bridge is on Highway 71 linking Fort Frances and Kenora in northwest Ontario. The bridge was constructed in 1936 with a wooden Howe truss main span of 64 m, Figure 1. It is believed to be the longest single span wood highway bridge in North America.

Fig. 1 General view of bridge

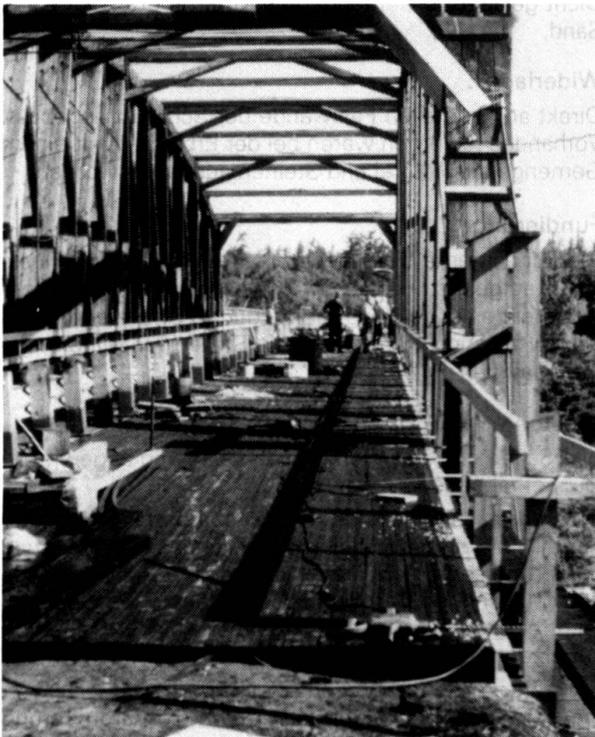
Fig. 3 Placing prestressed wood deck

The deck was replaced one lane at a time, Figure 3, so the bridge could remain open to traffic. The prestressing bars were coupled together for construction of the second lane. A new asphalt wearing surface was then applied to the wood deck.

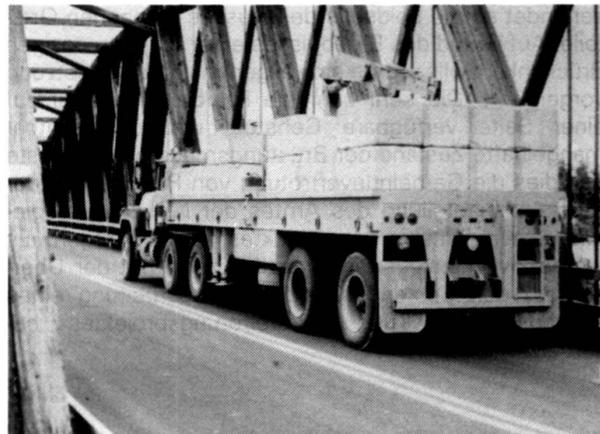
Full scale bridge testing using custom designed load vehicles, instrumentation and mobile laboratory for the computerized data acquisition system is a regular feature of the Ministry's evaluation procedures. Load testing of the deck system was carried out before deck replacement and after, Figure 4. Eight floor beams were instrumented by attaching strain gauges to the steel tie bars. The greatly improved longitudinal distribution characteristics of the prestressed deck was confirmed by a reduction of 35% in the truss bar strains for the same tests as carried out on the old deck. No further strengthening of the floor system is needed. The only other members that may need replacing are the main truss hanger bars, which will be tested shortly.

Fig. 4 Load testing the rehabilitated bridge
