Artikel: The Sioux Narrows Bridge, Ontario (Canada)
Autor: Dorton, R.A.
DOI: <https://doi.org/10.5169/seals-20920>

1. The Sioux Narrows Bridge, Ontario (Canada)

Owner: Ministry of Transportation of Ontario
Design: Structural Office and Research and Development Branch
Work Duration: 6 months
Completion: 1982

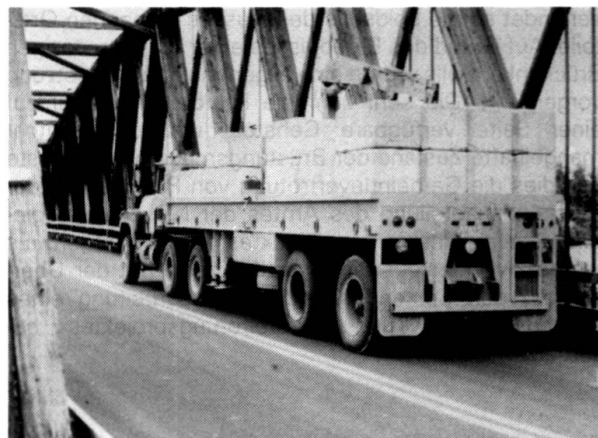
Fig. 4 Load testing the rehabilitated bridge

Full scale bridge testing using custom designed load vehicles, instrumentation and mobile laboratory for the computerized data acquisition system is a regular feature of the Ministry's evaluation procedures. Load testing of the deck system was carried out before deck replacement and after, Figure 4. Eight floor beams were instrumented by attaching strain gauges to the steel tie bars. The greatly improved longitudinal distribution characteristics of the prestressed deck was confirmed by a reduction of 35% in the truss bar strains for the same tests as carried out on the old deck. No further strengthening of the floor system is needed. The only other members that may need replacing are the main truss hanger bars, which will be tested shortly.
