Zeitschrift: IABSE structures = Constructions AIPC = IVBH Bauwerke
Band: 12 (1988)
Heft: C-46: Repair and rehabilitation of bridges: case studies I

1. The Sioux Narrows Bridge, Ontario (Canada)

<i>Owner:</i>	<i>Ministry of Transportation of Ontario</i>
<i>Design:</i>	<i>Structural Office and Research and Development Branch</i>
<i>Work Duration:</i>	<i>6 months</i>
<i>Completion:</i>	<i>1982</i>

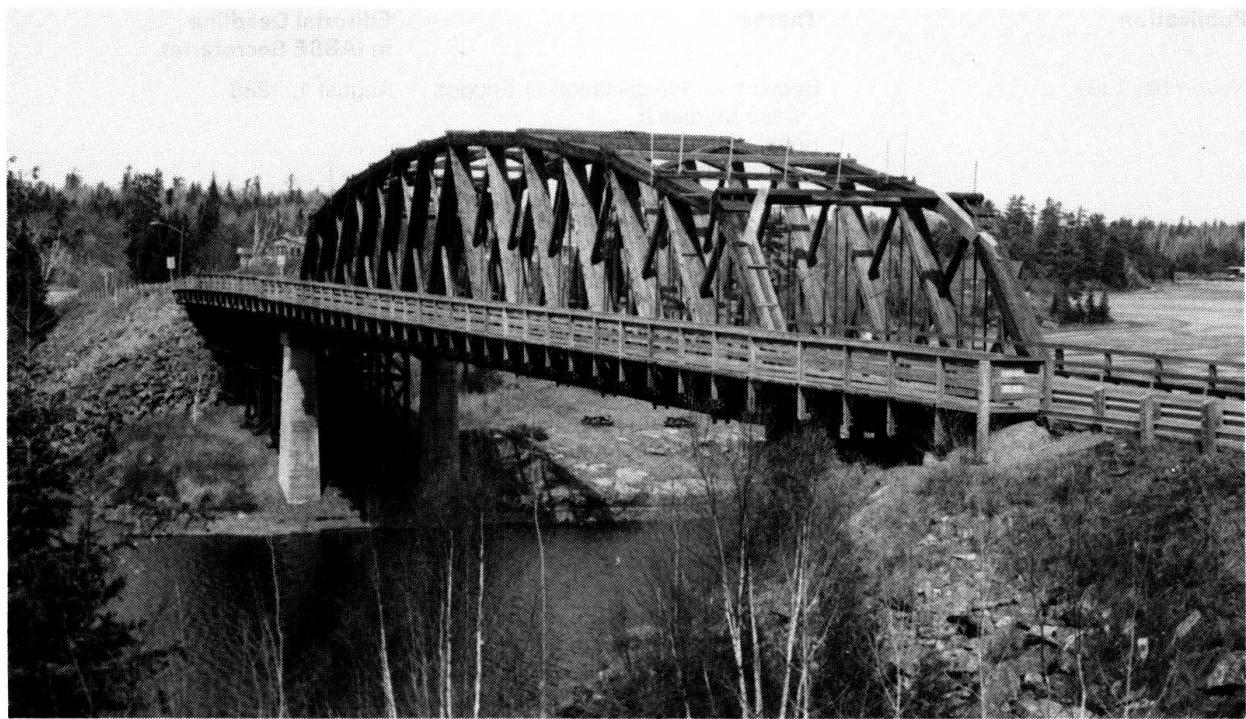
Fig. 1 General view of bridge

The Sioux Narrows Bridge is on Highway 71 linking Fort Frances and Kenora in northwest Ontario. The bridge was constructed in 1936 with a wooden Howe truss main span of 64 m, Figure 1. It is believed to be the longest single span wood highway bridge in North America.

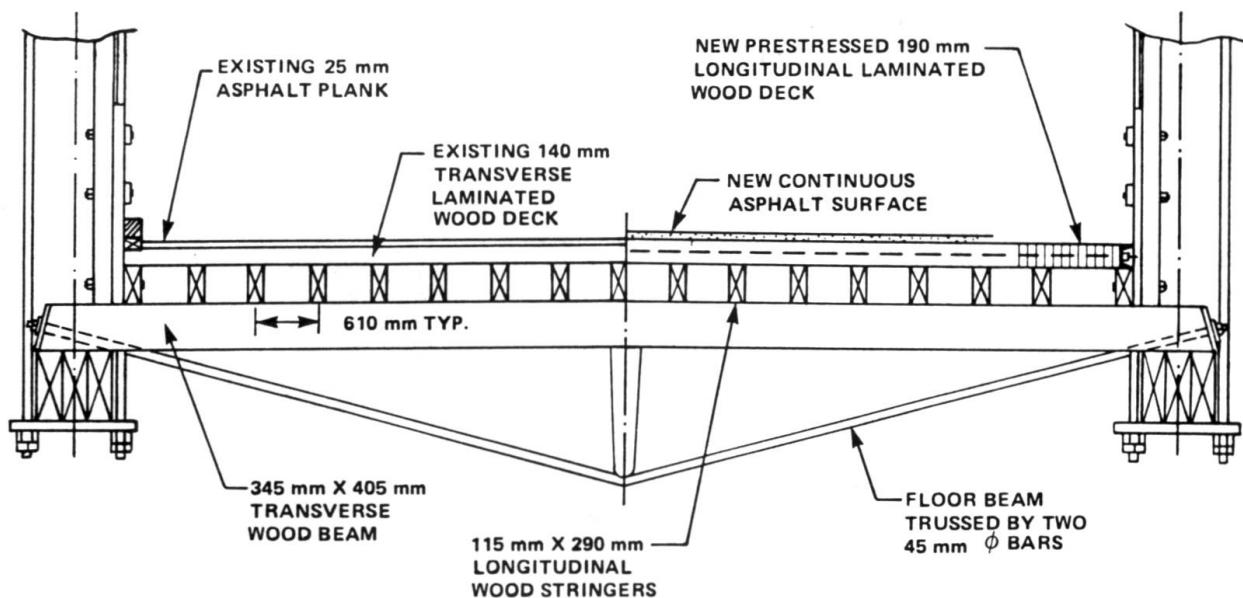
Fig. 2 Cross section of floor system

This bridge was one of the first to be listed under the Heritage Bridge Program of the Ontario Government, being an outstanding example of wood bridge construction, built of B.C. Douglas Fir in sizes no longer available. Most timber highway bridges have been replaced after about 40 years. Plans were prepared for the replacement of the Sioux Narrows bridge in 1975 when the deck was showing signs of deterioration, and the vehicle loads greatly exceeded the design loads. A condition survey showed the truss members to be in good condition, however, and studies were started to try to rehabilitate and keep this heritage bridge in service. Analysis indicated adequate load capacity in the main trusses, but a significant overstress in the transverse floor beam king post and tie bars, Figure 2. The floor system consisted of a traverse nailed laminated wood deck on longitudinal wood stringers, which were supported by transverse wood beams every 2.3 m.

At the time of these studies, the concept of a pre-stressed longitudinally laminated wood deck had been developed by the Ministry. This prestressed deck type acted like a homogeneous slab, and exhibited much better load distributed characteristics than the old nailed laminated decks. It was calculated that the longitudinal distribution would be improved enough to reduce the stresses in the floor beams to acceptable levels. The decision was made to replace the old deck with a new wood deck, with 190 mm deep laminated prestressed transversely with 25 mm bars at 1.525 m centres, tensioned by hydraulic jacks.

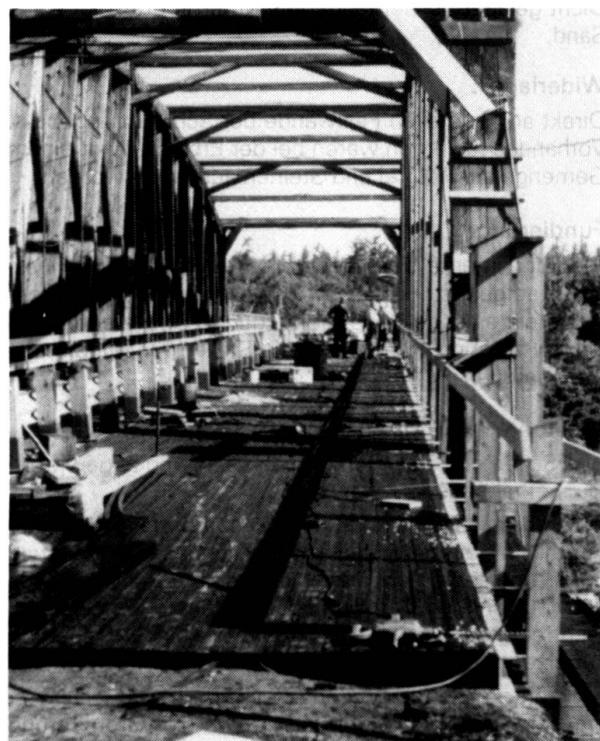
Fig. 3 Placing prestressed wood deck

The deck was replaced one lane at a time, Figure 3, so the bridge could remain open to traffic. The prestressing bars were coupled together for construction of the second lane. A new asphalt wearing surface was then applied to the wood deck.

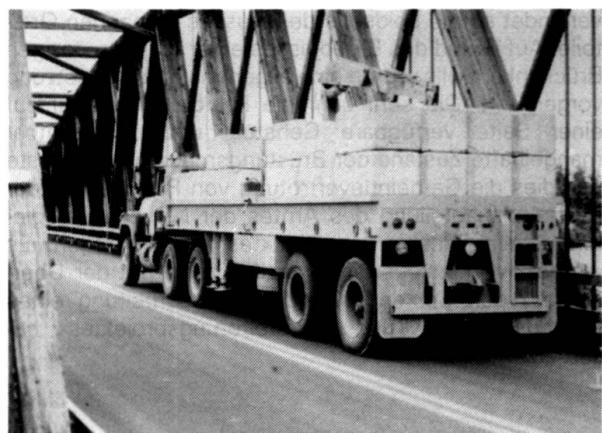
Fig. 4 Load testing the rehabilitated bridge

Full scale bridge testing using custom designed load vehicles, instrumentation and mobile laboratory for the computerized data acquisition system is a regular feature of the Ministry's evaluation procedures. Load testing of the deck system was carried out before deck replacement and after, Figure 4. Eight floor beams were instrumented by attaching strain gauges to the steel tie bars. The greatly improved longitudinal distribution characteristics of the prestressed deck was confirmed by a reduction of 35% in the truss bar strains for the same tests as carried out on the old deck. No further strengthening of the floor system is needed. The only other members that may need replacing are the main truss hanger bars, which will be tested shortly.
