Artikel: Steel strip reinforced concrete bridge (Denmark)
Autor: Kragerup, Jørgen Birger / Jonsen, Leif
DOI: <https://doi.org/10.5169/seals-20922>

3. Steel Strip Reinforced Concrete Bridge (Denmark)

Owner:	<i>The Danish Road Directorate by County of Frederiksborg</i>
Design and supervision:	<i>Cowiconsult, Consulting Engineers and Planners AS, Copenhagen</i>
Contractors:	<i>Armton A/S, Copenhagen</i>
Works Duration:	<i>May 10 – July 22, 1985</i>
Closed for traffic:	<i>June 6 – July 4, 1985</i>

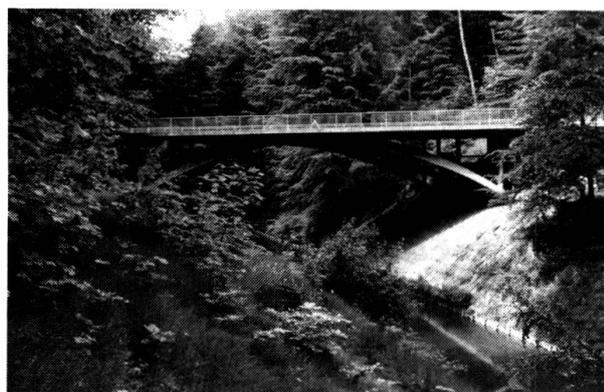
Canal Bridge at Frederiksværk.

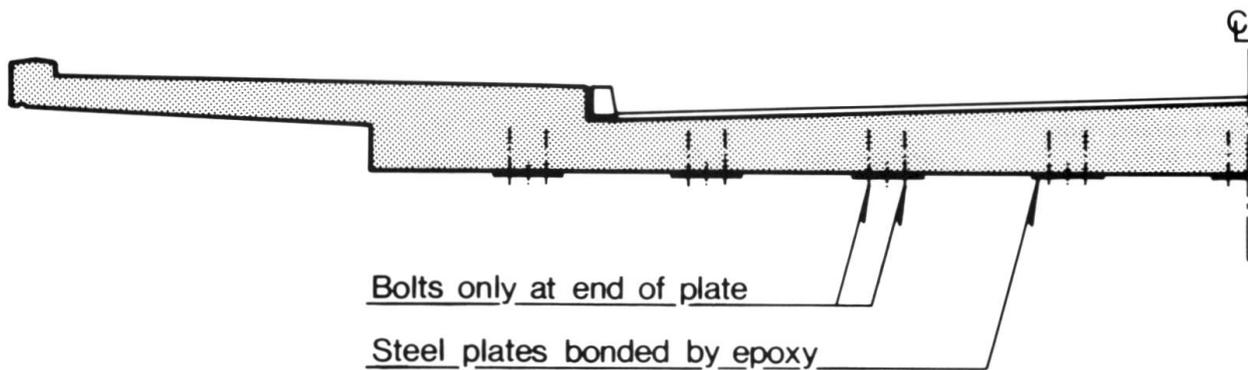
Cross section of bridge deck.

In each of the two end bays 9 steel plates (400 × 5850 × 6 mm, st. 37) were bonded to the concrete. When the bridge is subjected to the stipulated maximum load, the permissible tensile strength for the steel will only be 50% utilized. In addition, the shear force to be transferred by the glue joint is only 10% of the permissible force. In other words, reinforcement with plenty of built-in safety.

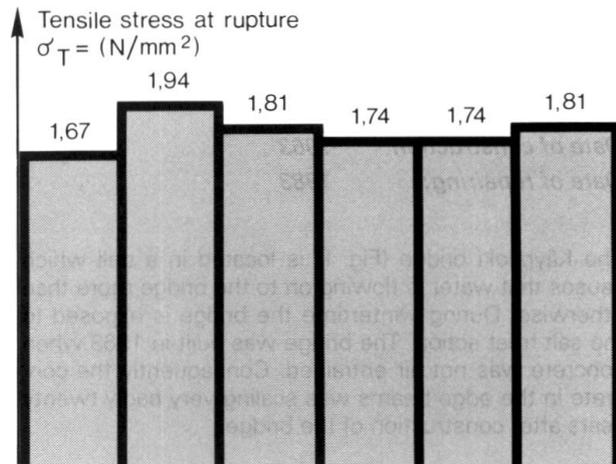
Before the actual work on reinforcing commenced, tests had to be made of the tensile strength of the bridge concrete and the adhesive properties of the bonding agent on the concrete surface. Altogether, tests were made with six plates all of which were tested to breaking point.

All ruptures occurred either in the concrete itself or on the surface between the concrete and the bonding agent. Based on the results, the compressive strength of the concrete was assessed as minimum 25 N/mm².

Adhesion of the bonding measured by tests on 6 test slabs.

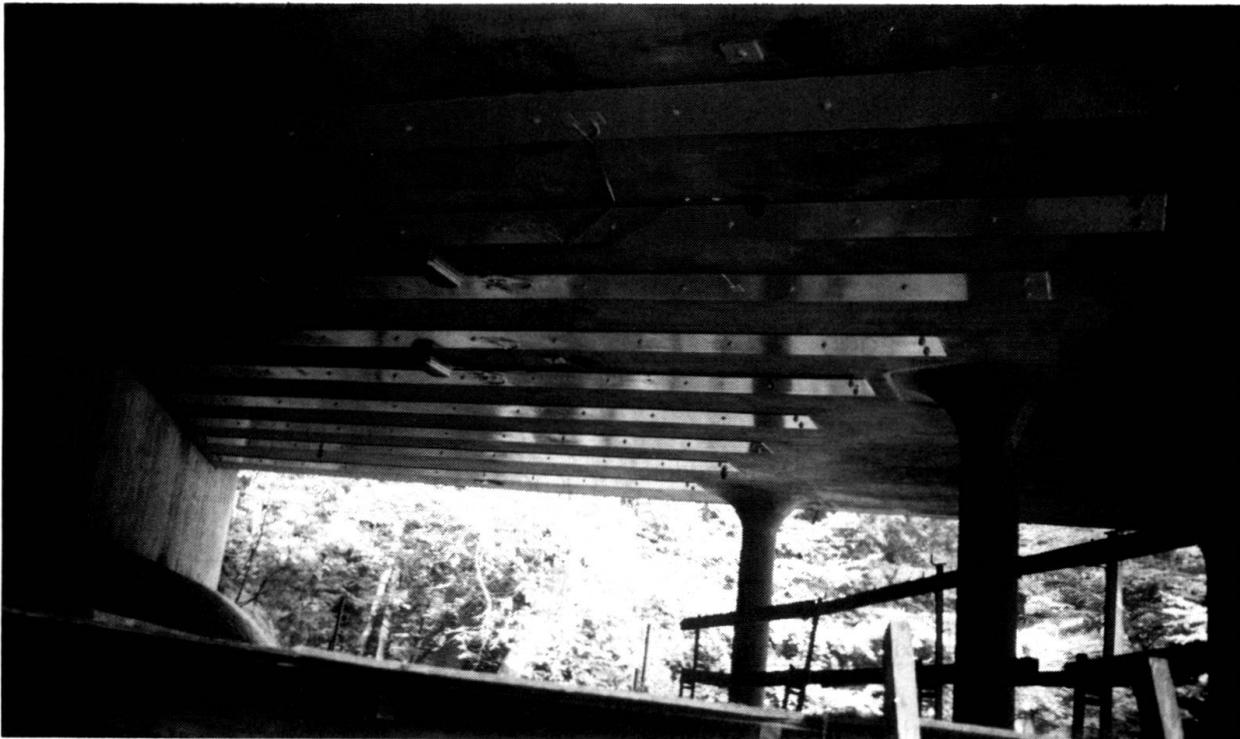
Bridge deck reinforced with bonded steel plates. The strain gauges were used to verify the efficiency of the bonding. The bolts are removed after completion.

From measurements taken in connection with a load-bearing test, it was established that the bonding agent fully transferred the shear forces between the concrete and the steel plates. In addition, the distribution of stresses in the steel plates as measured was in keeping with the calculated stress-conditions for cracked and uncracked concrete cross-section.
