Steel strip reinforced concrete bridge (Denmark)

3. Steel Strip Reinforced Concrete Bridge (Denmark)

Owner: *The Danish Road Directorate by County of Frederiksborg*

Design and supervision: *Cowiconsult, Consulting Engineers and Planners AS, Copenhagen*

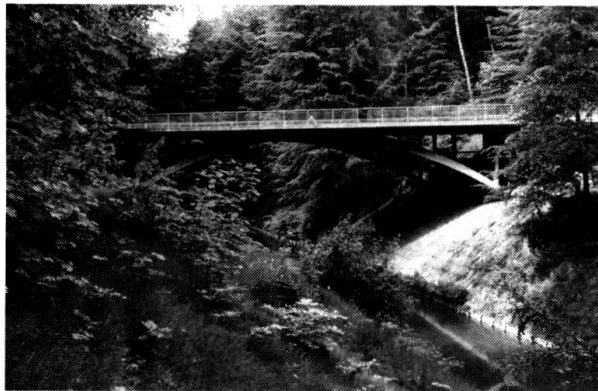
The reinforced concrete bridge in question is an arch bridge 45 m long, 13.5 m wide, built in 1950 and designed by Cowiconsult. Above the 27.5 m span of the arch itself, the bridge deck is divided into sections. At either end of the arch there is a 7 m bay.

Canal Bridge at Frederiksværk.

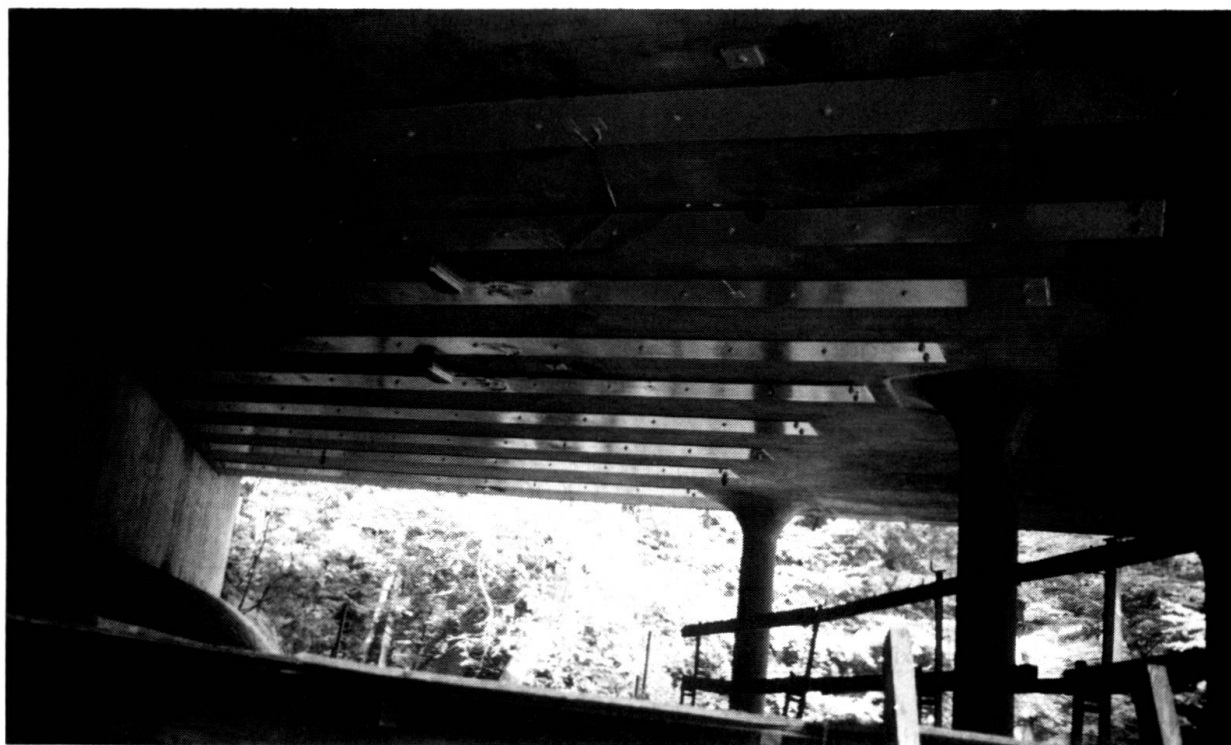
From measurements taken in connection with a load-bearing test, it was established that the bonding agent fully transferred the shear forces between the concrete and the steel plates. In addition, the distribution of stresses in the steel plates as measured was in keeping with the calculated stress-conditions for cracked and uncracked concrete cross-section.

Bridge deck reinforced with bonded steel plates. The strain gauges were used to verify the efficiency of the bonding. The bolts are removed after completion.

In each of the two end bays 9 steel plates (400 × 5850 × 6 mm, st. 37) were bonded to the concrete. When the bridge is subjected to the stipulated maximum load, the permissible tensile strength for the steel will only be 50% utilized. In addition, the shear force to be transferred by the glue joint is only 10% of the permissible force. In other words, reinforcement with plenty of built-in safety.

A load-bearing test carried out one year later produced little divergence in measurements from the year before.
