10. Repair and Rehabilitation of Roma-Viterbo Railway Bridges (Italy)

Owner: A. CO. TRA. L. – Azienda Consortile Trasporti Laziali

Design: Prof. Ing. Giorgio Croci

Contractor: NICIS S. P. A. – Roma

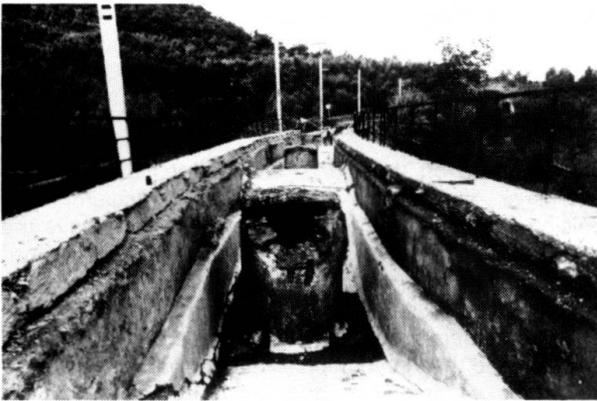
Fig. 2 A view of the inside of viaduct after removing of filling

The structural consolidation interventions consist in the realization of a reinforced concrete structure adherent on the existing masonry, after removing the internal filling (see fig. 2).

The slab on the extrados of the arcades has a thickness variable between 15 and 25 cm; the internal walls are 15 cm thick and follow the internal configuration of existing structures.
