**Artikel:** Repair of the Todsburg Bridge (Fed. Rep. of Germany)  
**Autor:** Hoscheid, R.  
**DOI:** <https://doi.org/10.5169/seals-20941>

## 11. Repair of the Todsburg bridge (Fed. Rep. of Germany)

<i>Owner:</i>	<i>Federal Republic of Germany</i>
<i>Year of construction:</i>	<i>1936/37</i>
<i>Repairs carried out in:</i>	<i>1983</i>
<i>Under the supervision of:</i>	<i>Heidenheim Motorway Authority</i>
<i>Contractors:</i>	<i>Weidle and Ludwig Fischer</i>

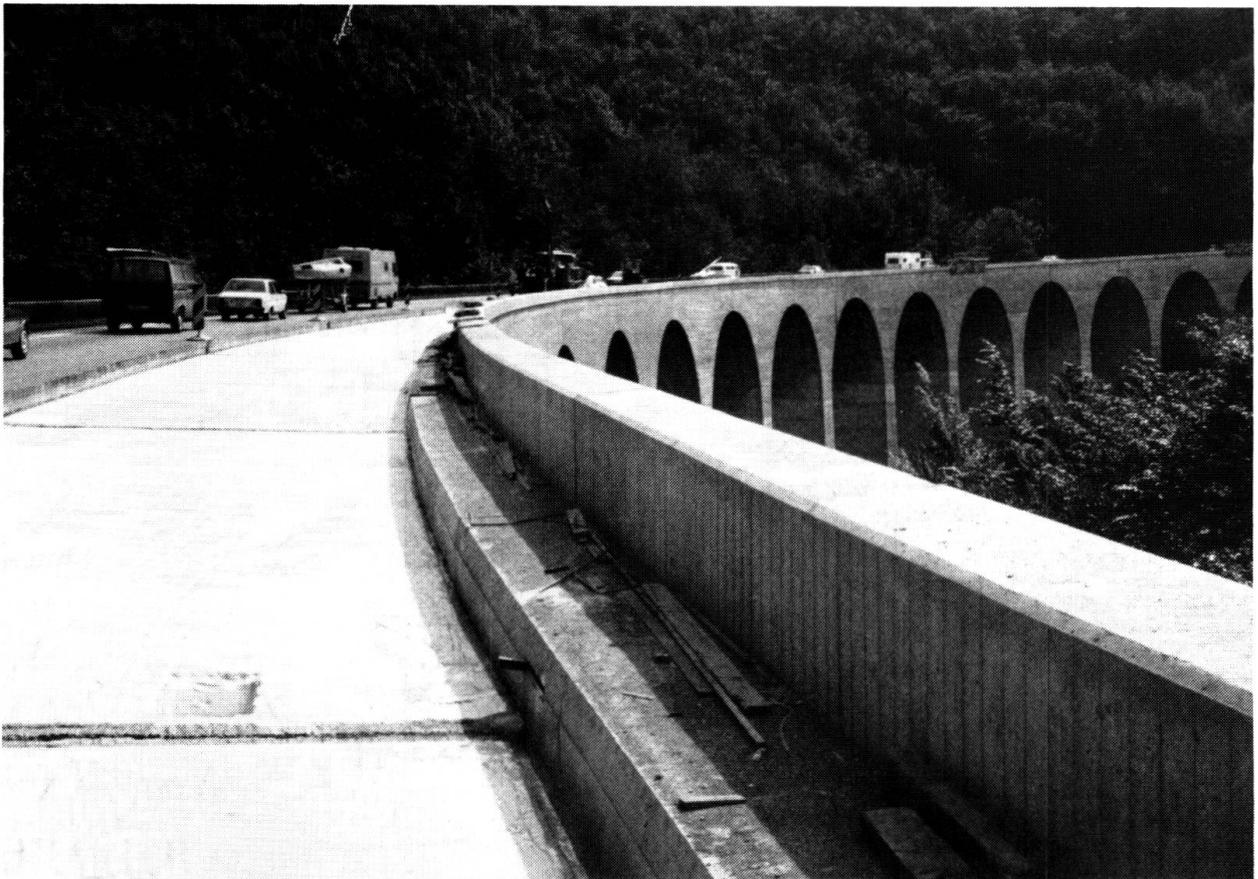
Fig. 1 The Todsburg bridge

The Todsburg bridge (Fig. 1) is located on the A 8 Autobahn between Stuttgart and Munich – one of the busiest sections of motorway in Germany. It stands between Stuttgart and Ulm at a point where the road climbs up into the Swabian Alb. For structural reasons, the two roadway sections are completely separate from each other. Some 30 000 vehicles pass over the bridge in each direction every day. By the beginning of the 1980's the concrete structure was in urgent need of repair – this stretch of motorway now being over 50 years old.

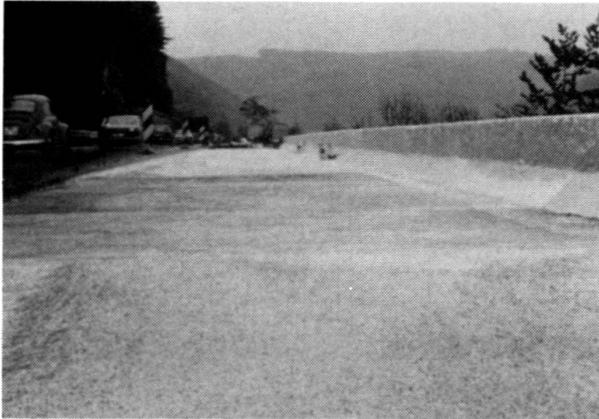
*Fig. 2 The finished waterproofing membrane*

5. Cleaning the area with high-pressure water jets
6. Applying epoxy mortar to the roadway platform to level those areas where concrete had been chipped away
7. Applying a bonding agents (1-component PU) and covering with silica sand 0.7–1.2 mm
8. Spraying on the liquid plastic waterproof membrane to a thickness of approx. 3 mm (Fig. 2)
9. Applying a bonding agent to the plastic membrane and covering it with granules to improve the shear bond between the membrane and the asphalt layers (the bridge has a gradient of approx. 6% along its length, and 3–5% from side to side)
10. Reconstruction of the new parapet on top of the waterproof membrane (Fig. 3)
11. Applying the bituminous mastic concrete protective layer, the bituminous mastic concrete load-bearing layer and the wearing layer (Fig. 4).

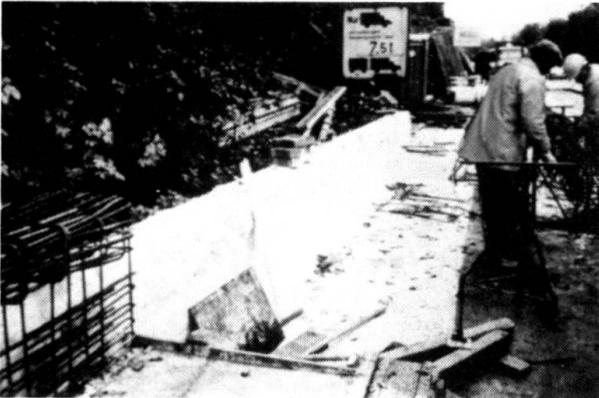
*Fig. 3 Working on reinforcements for the construction of the new parapet*

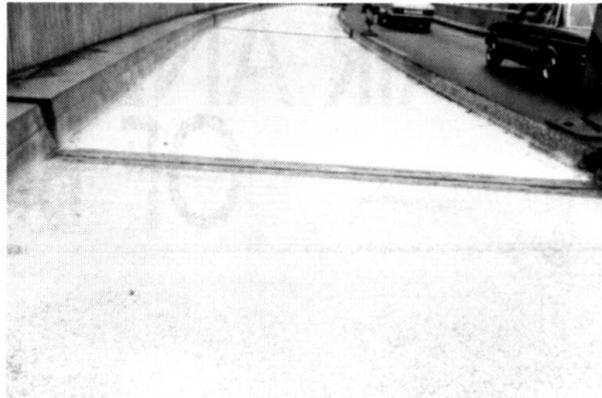
*Fig. 4 The bridge complete with its new parapet before surfacing with bituminous mastic concrete*
