Artikel: Repair of the Todsburg Bridge (Fed. Rep. of Germany)
Autor: Hoscheid, R.
DOI: <https://doi.org/10.5169/seals-20941>

11. Repair of the Todsburg bridge (Fed. Rep. of Germany)

Owner:	<i>Federal Republic of Germany</i>
Year of construction:	<i>1936/37</i>
Repairs carried out in:	<i>1983</i>
Under the supervision of:	<i>Heidenheim Motorway Authority</i>
Contractors:	<i>Weidle and Ludwig Fischer</i>

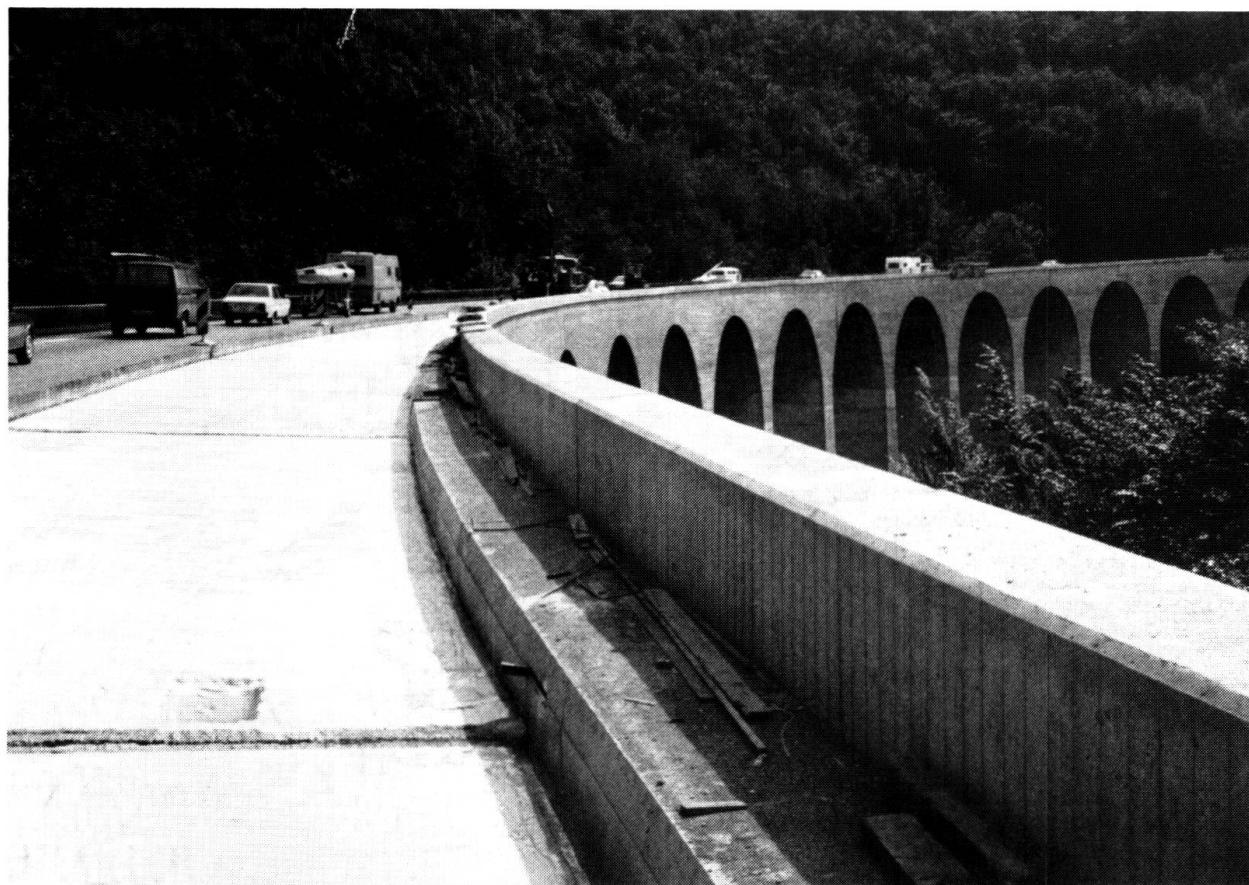
Fig. 1 The Todsburg bridge

The Todsburg bridge (Fig. 1) is located on the A 8 Autobahn between Stuttgart and Munich – one of the busiest sections of motorway in Germany. It stands between Stuttgart and Ulm at a point where the road climbs up into the Swabian Alb. For structural reasons, the two roadway sections are completely separate from each other. Some 30 000 vehicles pass over the bridge in each direction every day. By the beginning of the 1980's the concrete structure was in urgent need of repair – this stretch of motorway now being over 50 years old.

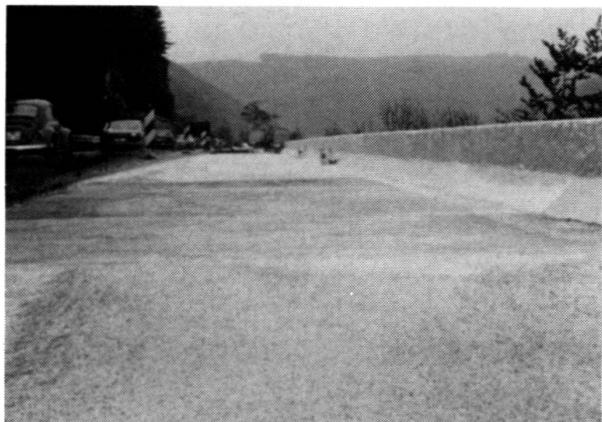
Fig. 2 The finished waterproofing membrane

5. Cleaning the area with high-pressure water jets
6. Applying epoxy mortar to the roadway platform to level those areas where concrete had been chipped away
7. Applying a bonding agent (1-component PU) and covering with silica sand 0.7–1.2 mm
8. Spraying on the liquid plastic waterproof membrane to a thickness of approx. 3 mm (Fig. 2)
9. Applying a bonding agent to the plastic membrane and covering it with granules to improve the shear bond between the membrane and the asphalt layers (the bridge has a gradient of approx. 6% along its length, and 3–5% from side to side)
10. Reconstruction of the new parapet on top of the waterproof membrane (Fig. 3)
11. Applying the bituminous mastic concrete protective layer, the bituminous mastic concrete load-bearing layer and the wearing layer (Fig. 4).

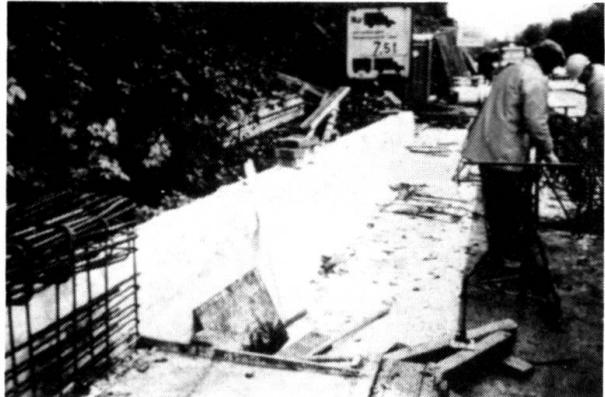
Fig. 3 Working on reinforcements for the construction of the new parapet

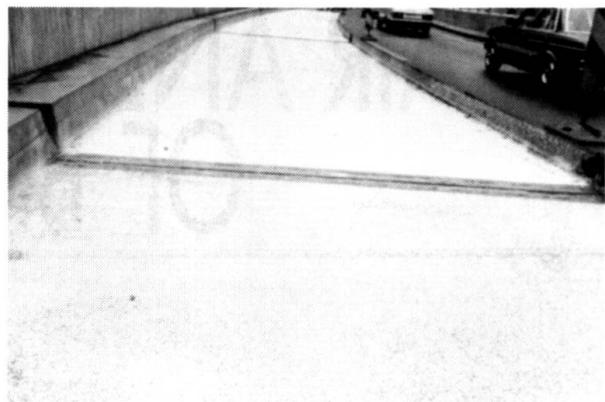
Fig. 4 The bridge complete with its new parapet before surfacing with bituminous mastic concrete
