Zeitschrift: IABSE proceedings = Mémoires AIPC = IVBH Abhandlungen
Band: 8 (1984)
Heft: P-74: Failure of stub-girders due to longitudinal shear

Artikel: Failure of stub-girders due to longitudinal shear
Autor: Gosselin, G.C. / Hosain, M.U.
DOI: <https://doi.org/10.5169/seals-38336>

Failure of Stub-Girders due to Longitudinal Shear

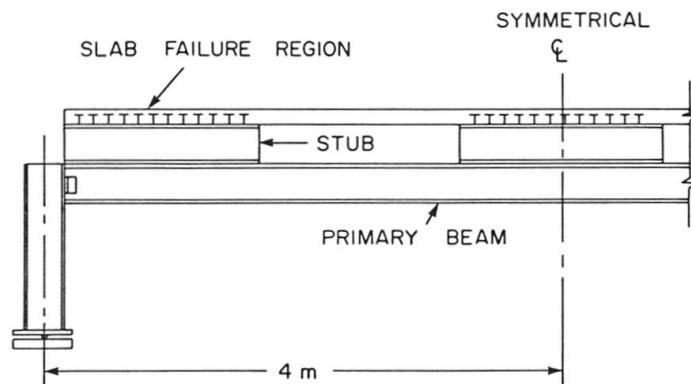
Fig.1 Longitudinal shear failure in test girder(Ref.3)

The stub-girder tested by Buckner et al. [3] incorporated a solid concrete slab which permitted placement of the transverse reinforcement near the bottom surface of the slab. This configuration, however, is not typical of any stub-girder system used to date. A stub-girder system invariably utilizes a ribbed metal deck which prevents the placement of transverse reinforcement in the bottom half of the slab. In a typical floor slab consisting of approximately 75 mm of concrete on top of a 76 mm metal deck, the transverse reinforcement ends up at best in the upper half of the slab after allowing for the minimum clear cover requirements. Moreover, since the ribs are normally parallel to the girders, the effective shear transfer area of the concrete is considerably reduced. The design criterion proposed by Buckner et al. is therefore not applicable to a stub-girder system which utilizes composite metal decks.

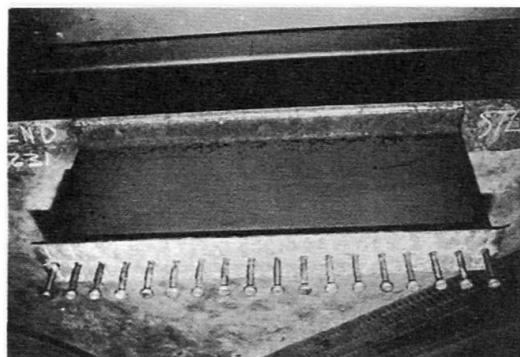
Fig.2 Headed stud arrangement used for phase one

This paper briefly summarizes the results of experiments performed on two full size stub-girders with slabs on ribbed metal decks. The main objective is to study the shear failure mechanism and the ultimate shear strength of stub-girders in relation to specific variables such as the length of the stub, the distance between stubs and other slab-related variables. As the first phase of a continuing investigation, this study considers the special case of stub-concrete connections with headed studs arranged in a single line as shown in Fig. 2.

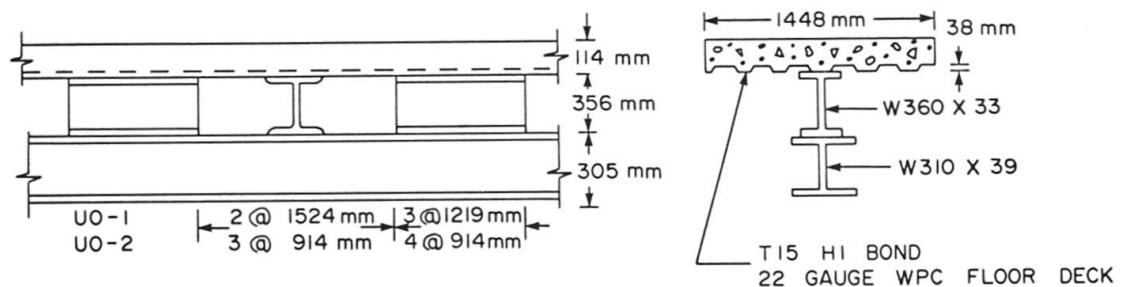
Fig.3 Specimen dimensions

A summary of the geometric properties of the two specimens is given in Fig. 3. The dimensions of the steel beams, the stubs and the concrete slab, which were identical for the two specimens, conformed to those for a stub-girder of 10 to 12 metre span. However, the span of the test beams was intentionally reduced to 7.31 m to induce failure through the stub-concrete connections. While the total length of the stubs was maintained at 3658 mm for both beams, the number of stubs was: three (1219 mm long with 24 studs) for specimen UO-1 and four (914 mm long with 18 studs) for specimen UO-2. Thus specimen UO-1 contained only two interior panels (1524 mm long) whereas three interior panels (914 mm long) were located within specimen UO-2. An 1829 mm long W360 X 33 section was placed at the midlength of each interior panel to simulate a floor beam. It was welded to the primary steel beam and connected to the concrete slab by means of eighteen studs. All headed shear studs were 76 mm long and 13 mm in diameter. For both specimens, the longitudinal reinforcement consisted of eight 13 mm diameter deformed bars whereas the same size bar at 305 mm centre to centre served as the transverse reinforcement. A clear cover of 25 mm was provided between the longitudinal reinforcement and the metal deck.

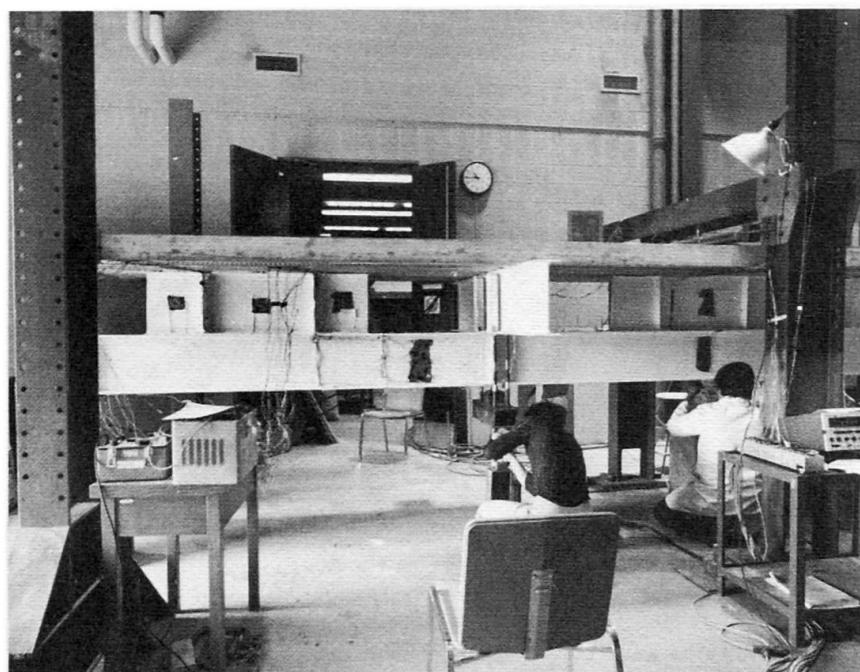
Fig.4 Test set-up

The test set-up used is shown in Fig. 4. Each stub-girder was mounted on load cells which were placed on concrete pedestals at each end of the stub-girder. The concrete slab was laterally braced at the supports and also at mid-span. The bracing system at midspan was based on Watt's mechanism [4] to permit free vertical movement. Vertical loads were applied through the floor beams in order to simulate the loading condition expected in an actual stub-girder system. This resulted in a 2-point loading arrangement for specimen U0-1 and a 3-point loading arrangement for specimen U0-2. The loads were applied by Enerpac hydraulic rams which were located below the test floor. Applied loads on each floor beam was monitored by four 25.4 mm diameter instrumented and precalibrated steel bars. Strains in the steel and in the concrete as well as deflections were recorded.

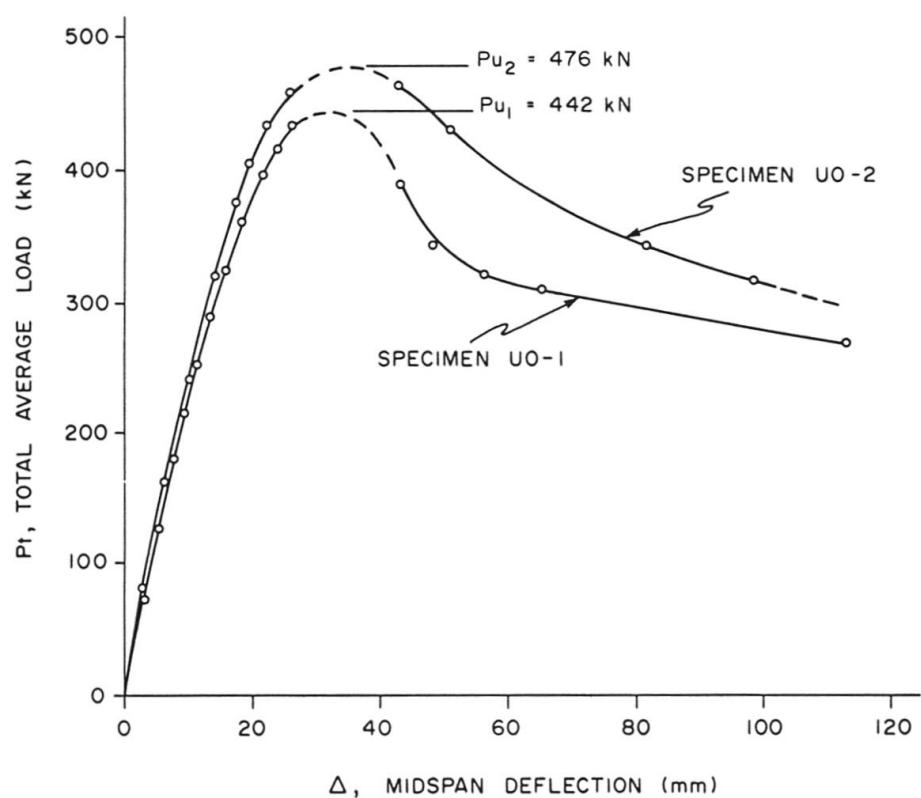
Fig.5 Load-deflection curves

The load vs midspan deflection curves for specimens U0-1 and U0-2 are presented in Fig. 5. For both specimens, the deviation from the initial elastic behavior was due to longitudinal cracking on the underside of the concrete slab on both sides of the end stubs. With increasing load these cracks widened and, eventually, a sudden drop in the load was observed. It is believed that this rapid unloading was caused by sufficient widening of the cracks to allow bending of the headed studs.

After the initial rapid drop, the load-deflection curve exhibited ductile behavior with relatively small reduction in load. This behavior is attributed to the transverse reinforcement becoming effective in restraining further splitting of the concrete. Simultaneous resistance to splitting from the concrete and transverse reinforcement steel was not achieved because the transverse reinforcement was located too high in the slab (near the head of the studs). As indicated earlier, this placement of the transverse steel was dictated by the floor deck and the clear cover requirement for the longitudinal reinforcement. This practical problem needs further study especially if the use of wire mesh is envisaged. Fig. 6 shows the slab failure region over the end stub.

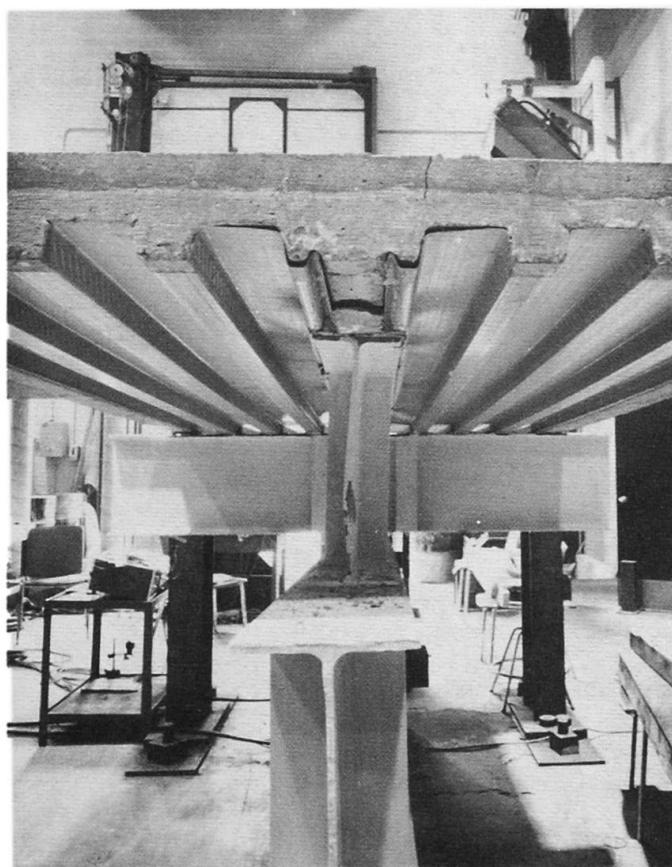
Fig.6 Slab failure region over the end stub

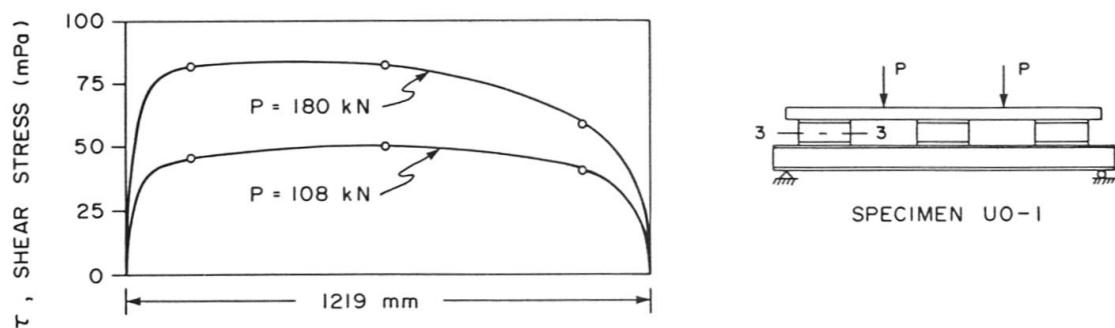
Fig. 7 Shear stress distribution across section 3-3

The observed shear stress distribution across one of the end stubs is shown in Fig. 7. The deviation from the basic parabolic shape which occurs at higher loads is believed to be caused by local concrete failure at the tensile (prying) end of the stub. Localized failure could reduce the shear resistance of studs subjected to tension, giving rise to the skewed distribution in Fig. 7. The design equation for headed studs of a conventional composite beam therefore, would not seem to be applicable to the

Using the shear stress distribution across the end stubs at the ultimate load (similar to Fig. 7), the maximum horizontal shear force was calculated for both specimens. This gave an average shear resistance per stud of 26.7 kN for specimen U0-1 and 33.68 kN for specimen U0-2. The maximum capacity that can be developed in shear, based on the CSA standard CAN3-S16.1-M78 [6] for conventional composite design, is 64.2 kN for the high strength concrete used. The difference between the observed and calculated shear resistances is due to several reasons. First, the use of a single row of studs resulted in a wedge action that triggered a somewhat premature concrete splitting along the end stubs. Second, both specimens were subjected to considerable prying. Due to higher prying force induced by the larger open panel in specimen U0-1, the resistance per stud was smaller compared to that of
