Zeitschrift: IABSE proceedings = Mémoires AIPC = IVBH Abhandlungen
Band: 8 (1984)
Heft: P-74: Failure of stub-girders due to longitudinal shear

Artikel: Failure of stub-girders due to longitudinal shear
Autor: Gosselin, G.C. / Hosain, M.U.
DOI: <https://doi.org/10.5169/seals-38336>

Failure of Stub-Girders due to Longitudinal Shear

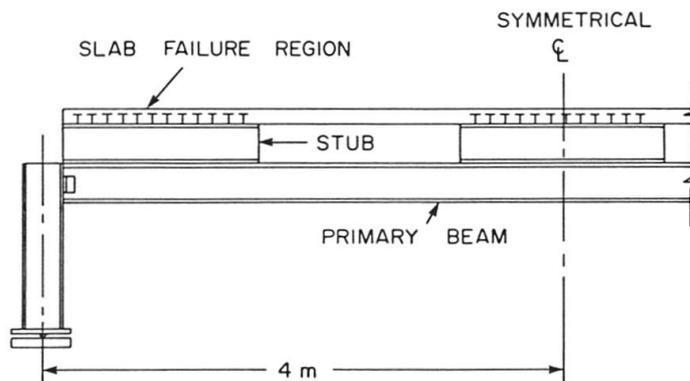
Fig.1 Longitudinal shear failure in test girder(Ref.3)

The stub-girder tested by Buckner et al. [3] incorporated a solid concrete slab which permitted placement of the transverse reinforcement near the bottom surface of the slab. This configuration, however, is not typical of any stub-girder system used to date. A stub-girder system invariably utilizes a ribbed metal deck which prevents the placement of transverse reinforcement in the bottom half of the slab. In a typical floor slab consisting of approximately 75 mm of concrete on top of a 76 mm metal deck, the transverse reinforcement ends up at best in the upper half of the slab after allowing for the minimum clear cover requirements. Moreover, since the ribs are normally parallel to the girders, the effective shear transfer area of the concrete is considerably reduced. The design criterion proposed by Buckner et al. is therefore not applicable to a stub-girder system which utilizes composite metal decks.

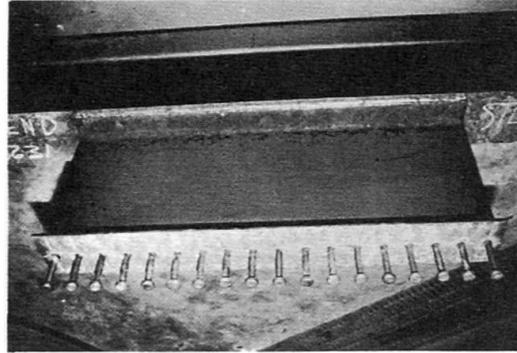
Fig.2 Headed stud arrangement used for phase one

This paper briefly summarizes the results of experiments performed on two full size stub-girders with slabs on ribbed metal decks. The main objective is to study the shear failure mechanism and the ultimate shear strength of stub-girders in relation to specific variables such as the length of the stub, the distance between stubs and other slab-related variables. As the first phase of a continuing investigation, this study considers the special case of stub-concrete connections with headed studs arranged in a single line as shown in Fig. 2.

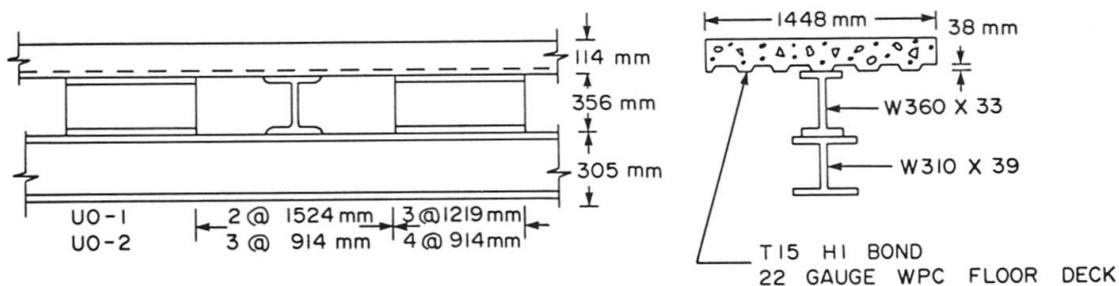
Fig.3 Specimen dimensions

A summary of the geometric properties of the two specimens is given in Fig. 3. The dimensions of the steel beams, the stubs and the concrete slab, which were identical for the two specimens, conformed to those for a stub-girder of 10 to 12 metre span. However, the span of the test beams was intentionally reduced to 7.31 m to induce failure through the stub-concrete connections. While the total length of the stubs was maintained at 3658 mm for both beams, the number of stubs was: three (1219 mm long with 24 studs) for specimen UO-1 and four (914 mm long with 18 studs) for specimen UO-2. Thus specimen UO-1 contained only two interior panels (1524 mm long) whereas three interior panels (914 mm long) were located within specimen UO-2. An 1829 mm long W360 X 33 section was placed at the midlength of each interior panel to simulate a floor beam. It was welded to the primary steel beam and connected to the concrete slab by means of eighteen studs. All headed shear studs were 76 mm long and 13 mm in diameter. For both specimens, the longitudinal reinforcement consisted of eight 13 mm diameter deformed bars whereas the same size bar at 305 mm centre to centre served as the transverse reinforcement. A clear cover of 25 mm was provided between the longitudinal reinforcement and the metal deck.

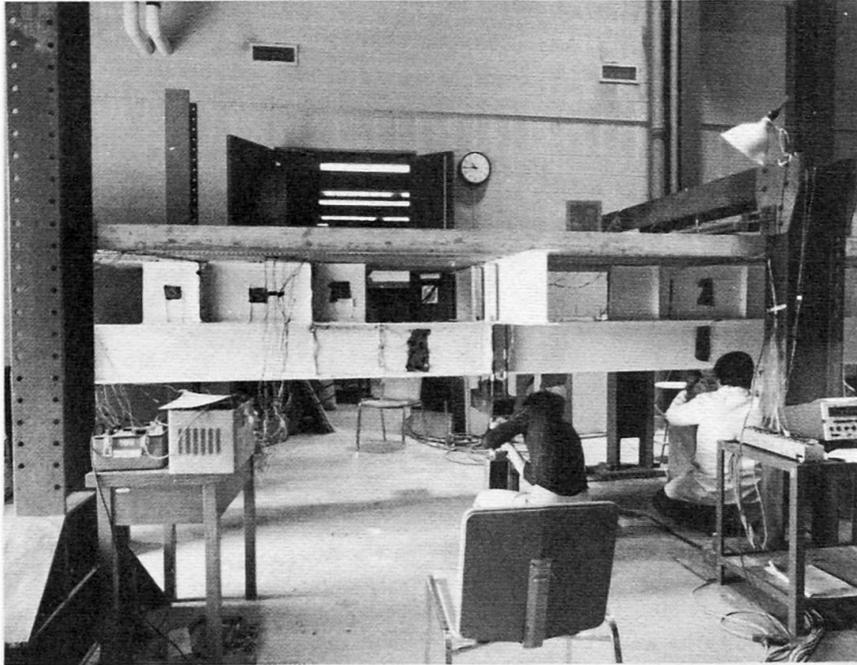
Fig.4 Test set-up

The test set-up used is shown in Fig. 4. Each stub-girder was mounted on load cells which were placed on concrete pedestals at each end of the stub-girder. The concrete slab was laterally braced at the supports and also at mid-span. The bracing system at midspan was based on Watt's mechanism [4] to permit free vertical movement. Vertical loads were applied through the floor beams in order to simulate the loading condition expected in an actual stub-girder system. This resulted in a 2-point loading arrangement for specimen U0-1 and a 3-point loading arrangement for specimen U0-2. The loads were applied by Enerpac hydraulic rams which were located below the test floor. Applied loads on each floor beam was monitored by four 25.4 mm diameter instrumented and precalibrated steel bars. Strains in the steel and in the concrete as well as deflections were recorded.

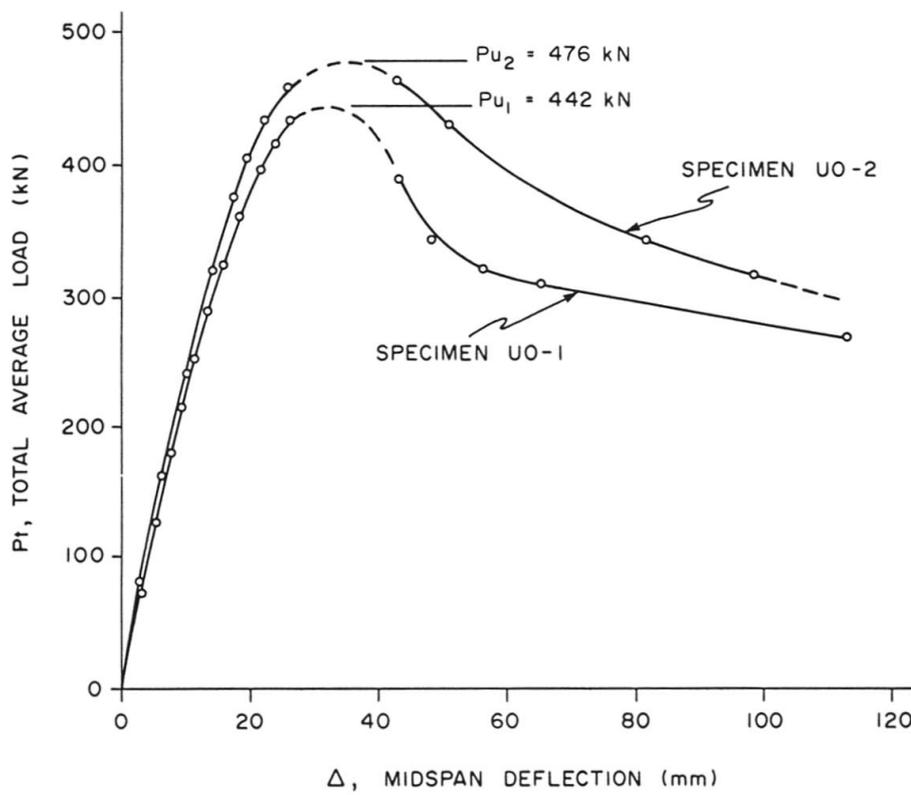
Fig.5 Load-deflection curves

The load vs midspan deflection curves for specimens U0-1 and U0-2 are presented in Fig. 5. For both specimens, the deviation from the initial elastic behavior was due to longitudinal cracking on the underside of the concrete slab on both sides of the end stubs. With increasing load these cracks widened and, eventually, a sudden drop in the load was observed. It is believed that this rapid unloading was caused by sufficient widening of the cracks to allow bending of the headed studs.

After the initial rapid drop, the load-deflection curve exhibited ductile behavior with relatively small reduction in load. This behavior is attributed to the transverse reinforcement becoming effective in restraining further splitting of the concrete. Simultaneous resistance to splitting from the concrete and transverse reinforcement steel was not achieved because the transverse reinforcement was located too high in the slab (near the head of the studs). As indicated earlier, this placement of the transverse steel was dictated by the floor deck and the clear cover requirement for the longitudinal reinforcement. This practical problem needs further study especially if the use of wire mesh is envisaged. Fig. 6 shows the slab failure region over the end stub.

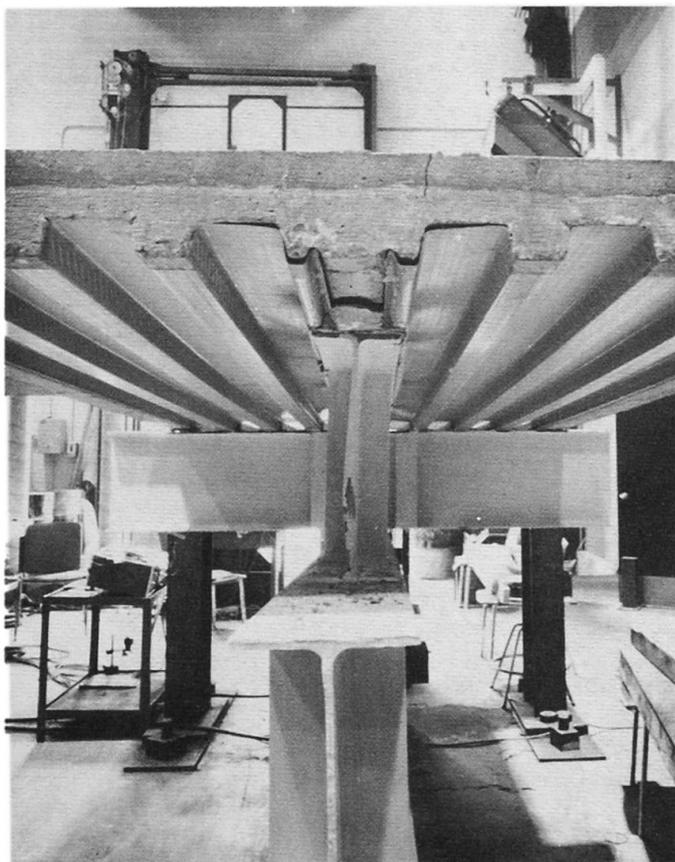
Fig.6 Slab failure region over the end stub

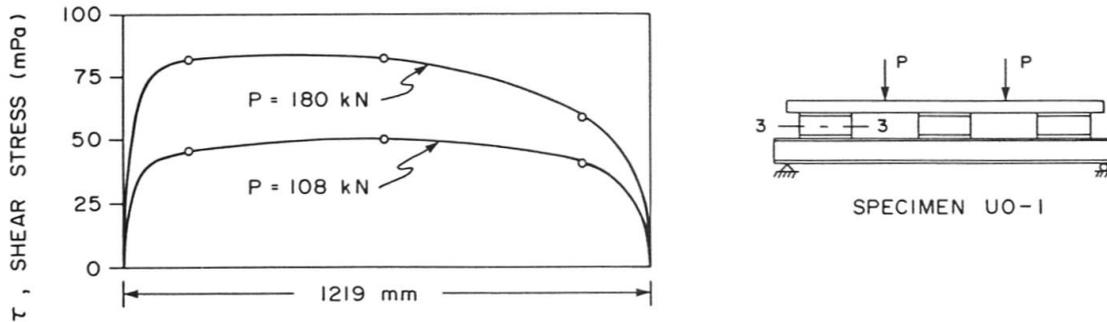
Fig.7 Shear stress distribution across section 3-3

The observed shear stress distribution across one of the end stubs is shown in Fig. 7. The deviation from the basic parabolic shape which occurs at higher loads is believed to be caused by local concrete failure at the tensile (prying) end of the stub. Localized failure could reduce the shear resistance of studs subjected to tension, giving rise to the skewed distribution in Fig. 7. The design equation for headed studs of a conventional composite beam therefore, would not seem to be applicable to the

Using the shear stress distribution across the end stubs at the ultimate load (similar to Fig. 7), the maximum horizontal shear force was calculated for both specimens. This gave an average shear resistance per stud of 26.7 kN for specimen UO-1 and 33.68 kN for specimen UO-2. The maximum capacity that can be developed in shear, based on the CSA standard CAN3-S16.1-M78 [6] for conventional composite design, is 64.2 kN for the high strength concrete used. The difference between the observed and calculated shear resistances is due to several reasons. First, the use of a single row of studs resulted in a wedge action that triggered a somewhat premature concrete splitting along the end stubs. Second, both specimens were subjected to considerable prying. Due to higher prying force induced by the larger open panel in specimen UO-1, the resistance per stud was smaller compared to that of
