Zeitschrift: IABSE proceedings = Mémoires AIPC = IVBH Abhandlungen
Band: 8 (1984)
Heft: P-74: Failure of stub-girders due to longitudinal shear

Artikel: Failure of stub-girders due to longitudinal shear
Autor: Gosselin, G.C. / Hosain, M.U.
DOI: <https://doi.org/10.5169/seals-38336>

Failure of Stub-Girders due to Longitudinal Shear

The paper summarizes the results of experiments performed on two full size stub-girders. In both beams, failure was caused by the longitudinal splitting of the concrete slab over the end stubs. A significant reduction in the shear strength of the stub-girders resulted from the prying and ineffective transverse reinforcement. The research reported here forms the first phase of a continuing investigation at the University of Saskatchewan.

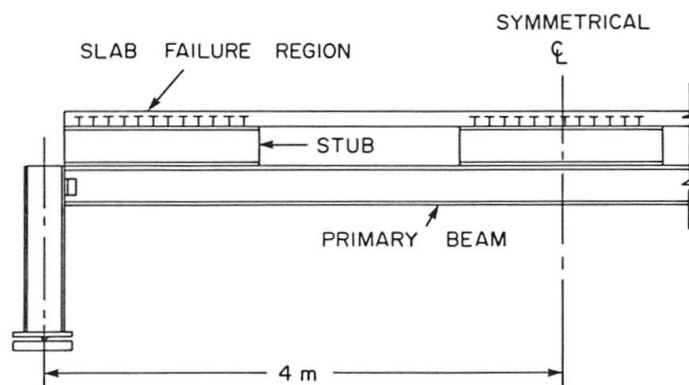
Fig.1 Longitudinal shear failure in test girder(Ref.3)

The stub-girder tested by Buckner et al. [3] incorporated a solid concrete slab which permitted placement of the transverse reinforcement near the bottom surface of the slab. This configuration, however, is not typical of any stub-girder system used to date. A stub-girder system invariably utilizes a ribbed metal deck which prevents the placement of transverse reinforcement in the bottom half of the slab. In a typical floor slab consisting of approximately 75 mm of concrete on top of a 76 mm metal deck, the transverse reinforcement ends up at best in the upper half of the slab after allowing for the minimum clear cover requirements. Moreover, since the ribs are normally parallel to the girders, the effective shear transfer area of the concrete is considerably reduced. The design criterion proposed by Buckner et al. is therefore not applicable to a stub-girder system which utilizes composite metal decks.

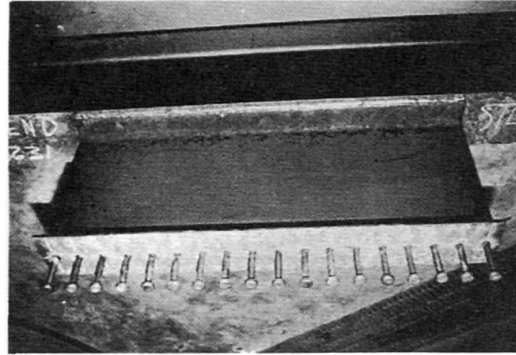
Fig.2 Headed stud arrangement used for phase one

This paper briefly summarizes the results of experiments performed on two full size stub-girders with slabs on ribbed metal decks. The main objective is to study the shear failure mechanism and the ultimate shear strength of stub-girders in relation to specific variables such as the length of the stub, the distance between stubs and other slab-related variables. As the first phase of a continuing investigation, this study considers the special case of stub-concrete connections with headed studs arranged in a single line as shown in Fig. 2.

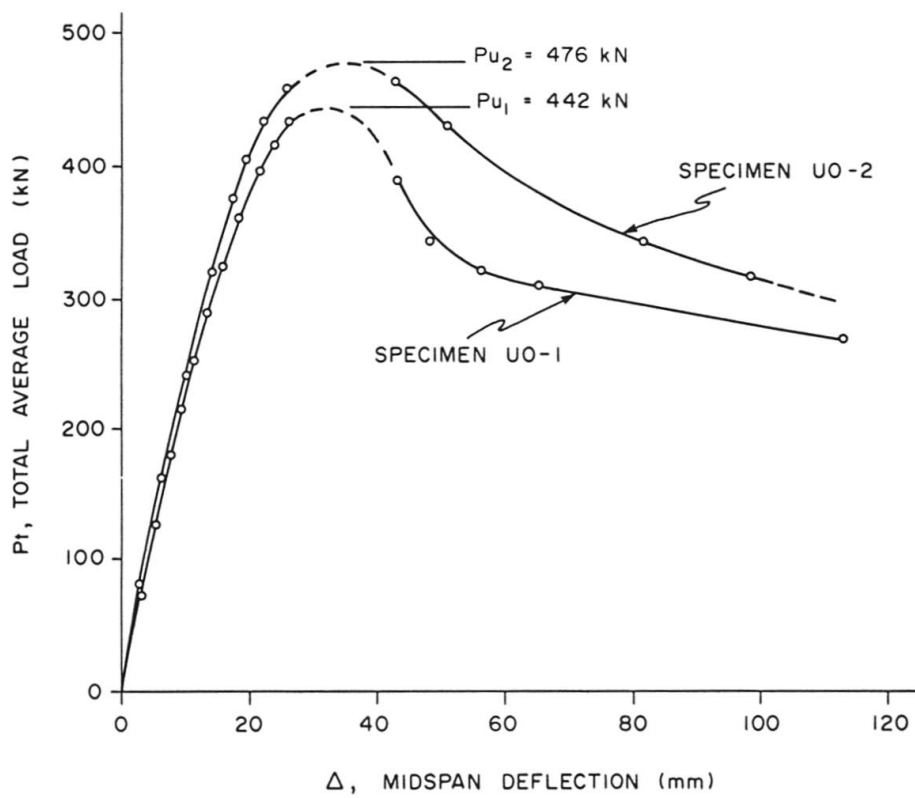
The load vs midspan deflection curves for specimens UO-1 and UO-2 are presented in Fig. 5. For both specimens, the deviation from the initial elastic behavior was due to longitudinal cracking on the underside of the concrete slab on both sides of the end stubs. With increasing load these cracks widened and, eventually, a sudden drop in the load was observed. It is believed that this rapid unloading was caused by sufficient widening of the cracks to allow bending of the headed studs.

Fig.5 Load-deflection curves

After the initial rapid drop, the load-deflection curve exhibited ductile behavior with relatively small reduction in load. This behavior is attributed to the transverse reinforcement becoming effective in restraining further splitting of the concrete. Simultaneous resistance to splitting from the concrete and transverse reinforcement steel was not achieved because the transverse reinforcement was located too high in the slab (near the head of the studs). As indicated earlier, this placement of the transverse steel was dictated by the floor deck and the clear cover requirement for the longitudinal reinforcement. This practical problem needs further study especially if the use of wire mesh is envisaged. Fig. 6 shows the slab failure region over the end stub.

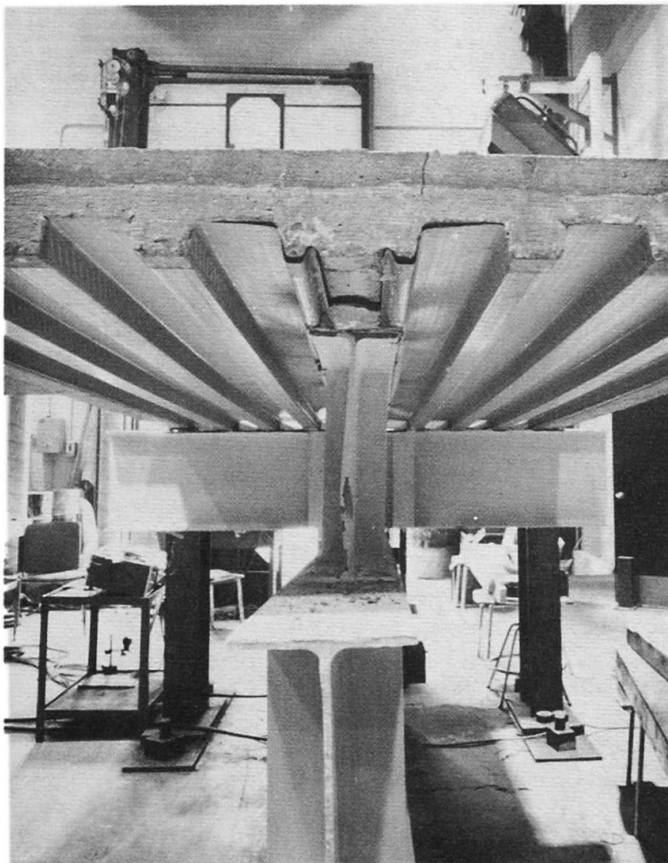
Fig.6 Slab failure region over the end stub

For the shear studs and concrete used in the tests, the ideal strength (q/ϕ) based on the CSA standard CAN3-S16.1-M78 [6] is 64.2 kN per connector. The observed average connector strength was 30.2 kN (47% of the ideal). Prying effects were responsible for part of the reductions. However, a more important consideration may be that placement of lateral reinforcement in both tests was ineffective in resisting concrete splitting and shearing. Though the transverse reinforcement area supplied was sufficient to satisfy the CSA requirement (transverse reinforcement ratio = 0.005), practical problems prevented placement in the bottom of the slab as required by the CSA. Although the CSA requirements do not depend on stud configuration, studs arranged in a single line produce a wedge action which would appear to make the concrete slab more susceptible to longitudinal splitting.

More full-scale tests should be conducted to investigate the effectiveness of different transverse reinforcement schemes such as varying the amount of reinforcement, widening the flute over the stubs or using irregular-shaped reinforcing bars.
