**Zeitschrift:** IABSE proceedings = Mémoires AIPC = IVBH Abhandlungen  
**Band:** 11 (1987)  
**Heft:** P-106: Flash floods on bridge piers

**Artikel:** Flash floods on bridge piers  
**Autor:** Krumdieck, Alfonso  
**DOI:** <https://doi.org/10.5169/seals-40366>

## Flash Floods on Bridge Piers

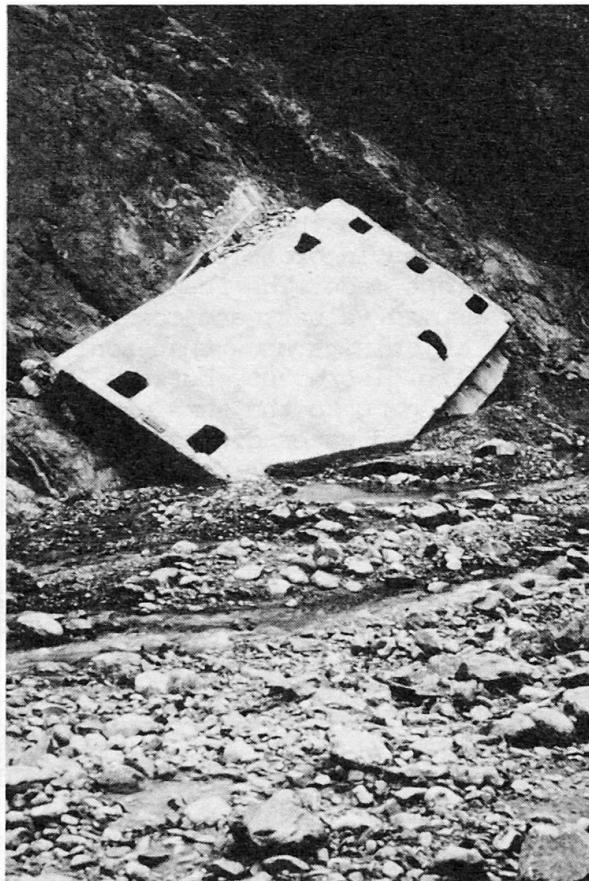
Huge quantities of bed material were reported to have been dragged along the river bed. The peak velocities which occurred during the event could not be directly measured. From eye witness accounts these were estimated to be about 30 to 60 km/h, however these must be judged critically. Taking into consideration that huge bridge slabs of 200 tons of weight or more were moved hundreds of meters downstream, it can be safely assumed, that peak velocities of approximately 50 km/h occurred, (see Fig. 2).

FIG. 2 200 Ton Bridge slab after the flash flood.

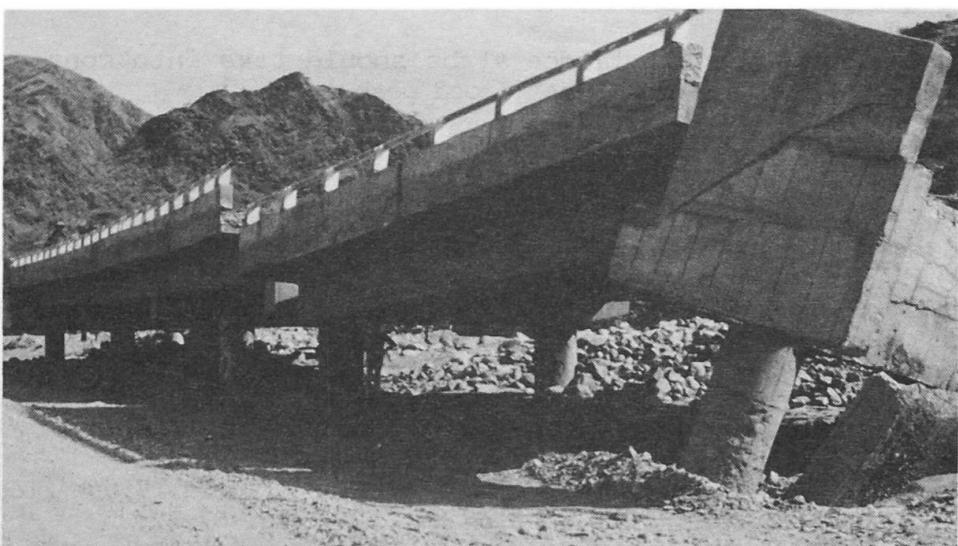
Figure 4 gives a schematical interpretation of the sequence of events suffered by at least one of the bridges of the catastrophic flash flood that occurred on February 13, 1982. The photographs of figures Nr. 5, 6 and 7 taken after the catastrophe, demonstrate that the piers have sunk and moved several decimeters and meters but where not broken, and the displacements are evident.

FIG. 6 Piers sunken due to fluidization of the river bed.
