Flash Floods on Bridge Piers

Alfonso KRUMDIECK

Civil Engineer
Electrowatt Eng. Services Ltd.
Zurich, Switzerland

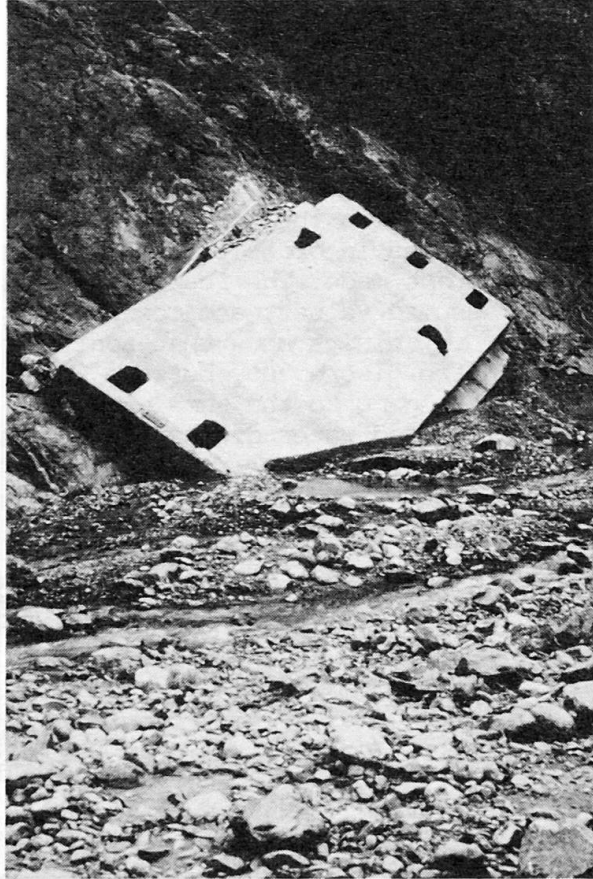
FIG. 2 200 Ton Bridge slab after the flash flood.

Huge quantities of bed material were reported to have been dragged along the river bed. The peak velocities which occurred during the event could not be directly measured. From eye witness accounts these were estimated to be about 30 to 60 km/h, however these must be judged critically. Taking into consideration that huge bridge slabs of 200 tons of weight or more were moved hundreds of meters downstream, it can be safely assumed, that peak velocities of approximately 50 km/h occurred, (see Fig. 2).
