Artikel: Flash floods on bridge piers
Autor: Krumdieck, Alfonso
DOI: <https://doi.org/10.5169/seals-40366>

Flash Floods on Bridge Piers

Alfonso KRUMDIECK

Civil Engineer
Electrowatt Eng. Services Ltd.
Zurich, Switzerland

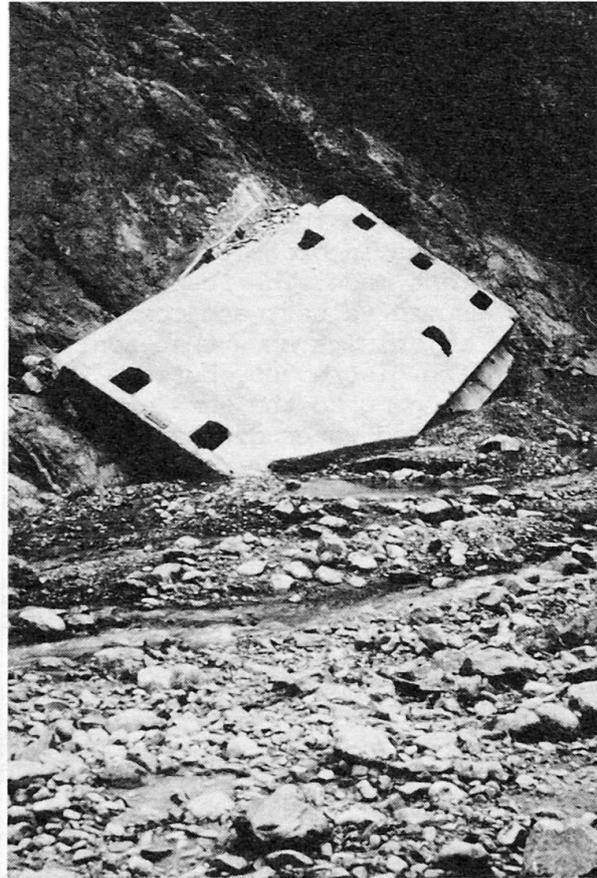
FIG. 2 200 Ton Bridge slab after the flash flood.

Huge quantities of bed material were reported to have been dragged along the river bed. The peak velocities which occurred during the event could not be directly measured. From eye witness accounts these were estimated to be about 30 to 60 km/h, however these must be judged critically. Taking into consideration that huge bridge slabs of 200 tons of weight or more were moved hundreds of meters downstream, it can be safely assumed, that peak velocities of approximately 50 km/h occurred, (see Fig. 2).
