**Artikel:** Flash floods on bridge piers

# Flash Floods on Bridge Piers

# Alfonso KRUMDIECK Civil Engineer Electrowatt Eng. Services Ltd. Zurich, Switzerland

#### 3.1 <u>Damage Records</u>

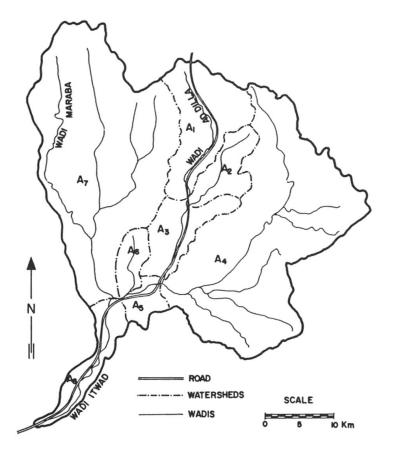
FIG. I CATCHMENT AREA.

This was caused by an instantaneous reduction of the shear resisting forces of the soil to practically zero, which led to loss of the soil bearing capacity and collapse of the piers. The catchment area of Wadi Itwad in Saudi Arabia comprises mainly of three subcatchments, i.e. the upper Wadi Itwad, the Wadi Ad-Dillah and the Wadi Maraba, totalling an area of 1425 km2 at the lower neck of their confluence (see Fig. 1). Road 54 connects the town of Taif through the Assir-Mountains to the town of Jizan in the western part of the country.

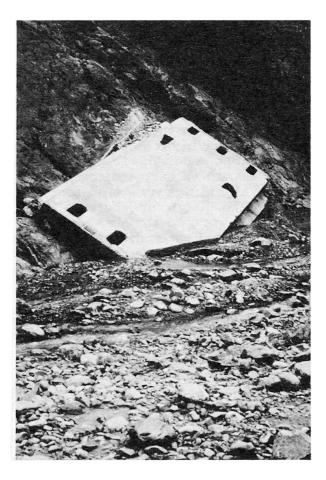
FIG. 2 200 Ton Bridge slab after the flash flood.

Huge quantities of bed material were reported to have been dragged along the river bed. The peak velocities which occurred during the event could not be directly measured. From eye witness accounts these were estimated to be about 30 to 60 km/h, however these must be judged critically. Taking into consideration that huge bridge slabs of 200 tons of weight or more were moved hundreds of meters downstream, it can be safely assumed, that peak velocities of approximately 50 km/h occurred, (see Fig. 2).

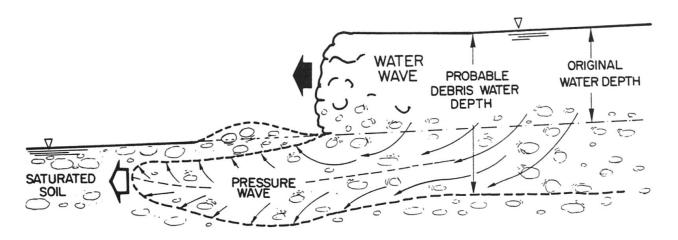
Wave-induced pore pressures and soil liquefaction in front of a water wave produced in saturated soils have been reported in recent years by several authors (e.g. Sleath [7]; Madsen [8]; Nataradja and Singh [9]; Zeevaert [10], etc.) Similarly in this case, it is postulated that the incoming water wave in the wadi bed generated a pressure wave in the saturated soil. This pressure wave has the ability or property to travel through the saturated granular soil at a velocity which is greater than the velocity of the water wave on the surface of the river bed (see Richart et al.,[11]). Therefore, the pressure wave will have to travel in a pulsating or intermitent form in front of the water wave (see Fig. 3).

FIG. 3 SCHEMATIC VIEW OF A FLASH FLOOD WAVE.

The pressure wave will increase the magnitude of its pressure when the water wave increases in size. If the size of the water wave continues to grow, there is a moment in which the pressure wave will reach a value equal to or greater than the effective confining pressure and the shear strength of the soil will become zero, i.e. it fluidizes. Fluidization, as opposed to liquefaction, is a mechanism by which a cohesionless material achieves a viscous liquid-like condition by forcing a fluid from an external source upward through the sediment, until the immersed weight of the grains is balances by the total fluid drag, (Othmer [12]; Leva [13]; Kunii and Levenspiel [14]).

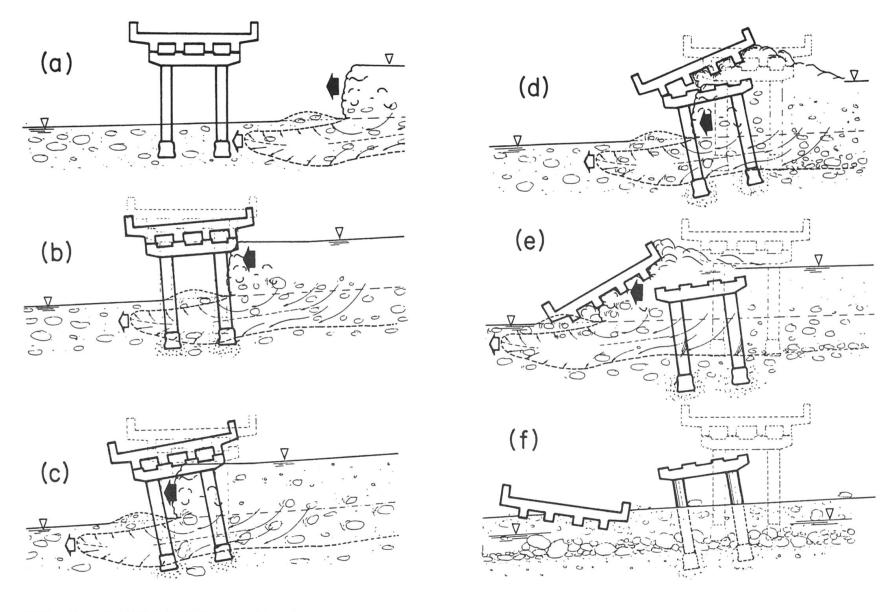
It is postulated that this temporary fluidization of the soil in front of the water wave caused those piers to collapse or to sink before erosion had time to act. This temporary fluidization of the soil is also the reason which allows the incoming water wave to enrich and to reinforce itself with not only the water retention pirated from the saturated soil, but also with the fluidized soil debris as well. This explain why the measured discharge runoff can be, in certain cases, far greater than the calculated discharges from the rainfall records alone.

Figure 4 gives a schematical interpretation of the sequence of events suffered by at least one of the bridges of the catastrophic flash flood that occurred on February 13, 1982. The photographs of figures Nr. 5, 6 and 7 taken after the catastrophe, demonstrate that the piers have sunk and moved several decimeters and meters but where not broken, and the displacements are evident.

FIG. 4 SCHEMATICAL VIEW OF PROPOSED FAILURE MECHANISM

Bridge piers in rivers which are likely to be affected by flash floods should be designed in the most conservative way.

- 1. To check with a thoroughly soil mechanics investigations, the possibilities that the soil may have on its surroundings to become fluidized in any time of the usefull life of the bridge.
- 2. The foundations of the bridge piers should be deep enough.
- 3. To provide pier protections, inclusive for the part below the surface of the river bed.
- 4. The design height for the bridge slabs should take into consideration the possibility of an incoming flash flood peak.

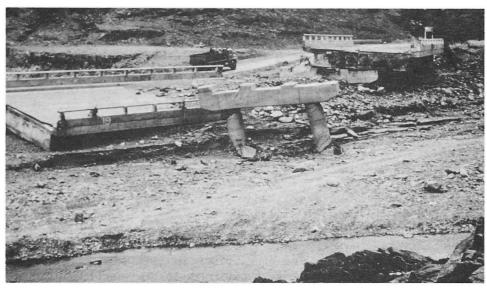
FIG. 5 Bridge destroyed by the flash flood of February 13, 1982.

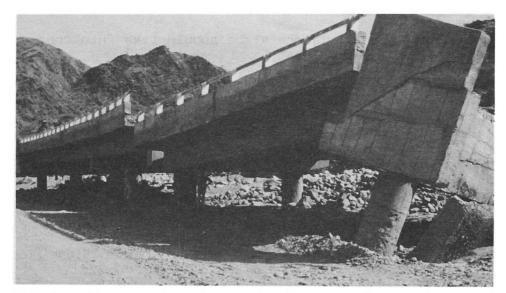
Piers sunken due to fluidization of the river bed.

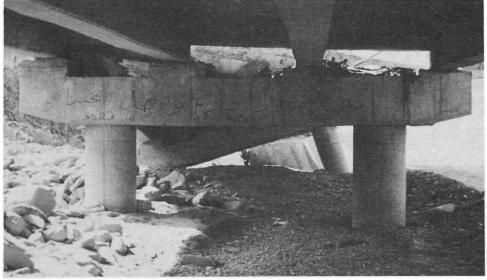
FIG. 7 Support structure damaged by the flash flood.
