Zeitschrift: IABSE proceedings = Mémoires AIPC = IVBH Abhandlungen
Band: 14 (1990)
Heft: P-150: Fatigue crack locations in orthotropic steel decks

Artikel: Fatigue crack locations in orthotropic steel decks
Autor: Cuninghame, J.R. / Beales, C.
DOI: <https://doi.org/10.5169/seals-42842>

Fatigue Crack Locations in Orthotropic Steel Decks

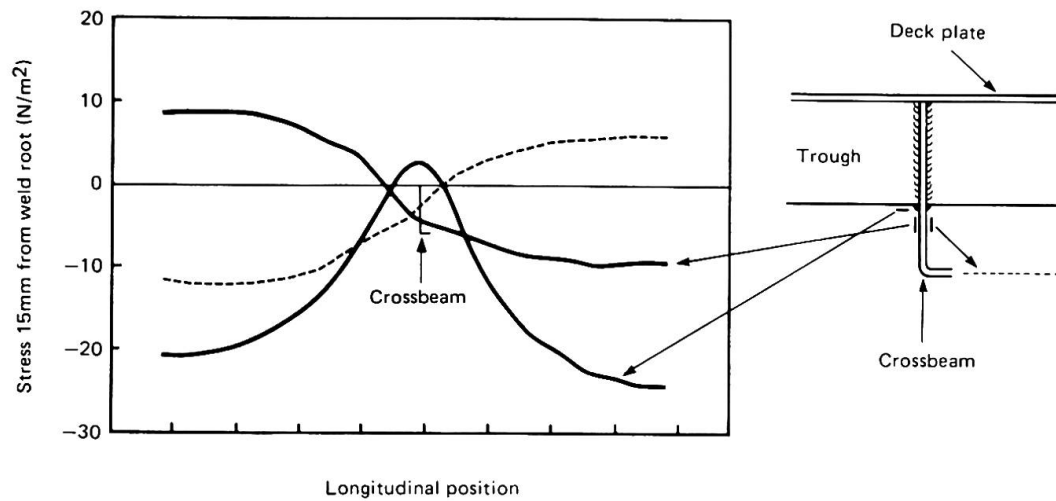
Fig.1 Stress influence lines for trough to crossbeam joint

Fatigue tests were carried out on a deck panel by loading alternately at two positions over the trough on either side of the crossbeam, coinciding with the stress peaks on the influence line. Small (1500 x 600mm) specimens were also tested.

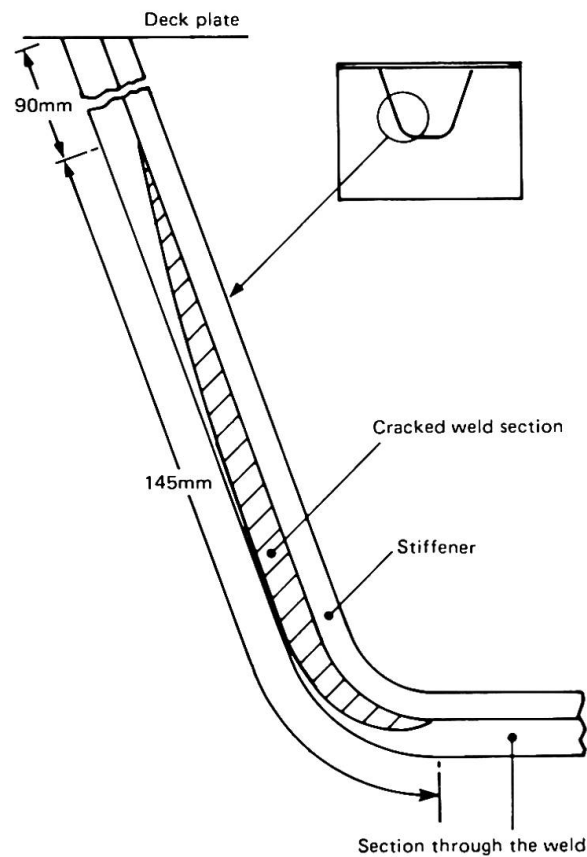
Most cracks, both in the fatigue tests and on the bridge, started at the weld root on the web of the trough in a region of tensile residual stress, and grew through the weld throat with the fracture surface parallel to the crossbeam. Fig 2 shows a crack just before it reached the weld surface and became visible.

Fig.2 Crack location in trough to crossbeam weld

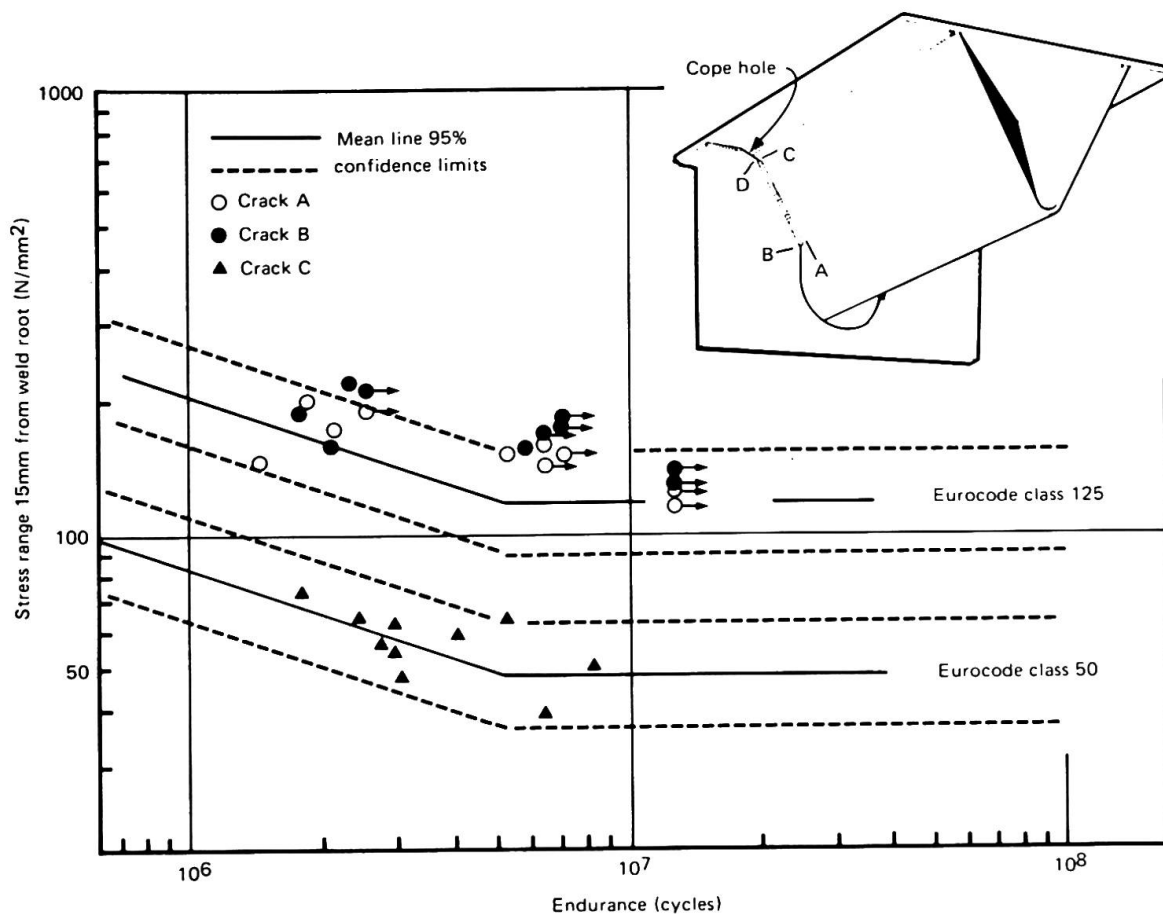
The crack locations and test results are shown in figure 3. Cracks also occurred at the lower end of the weld but at much longer endurances. The fatigue strength of the cope hole detail is consistent with BS 5400 class G or Eurocode class 50 [10]. The estimated life under design traffic loading is less than 5 years. Without the cope hole detail, the fatigue strength (for cracking at the weld toe at the lower end of the weld) is much higher than expected and is consistent with BS 5400 class C, or Eurocode class 125. The design life of the joint is then greater than the 120 years required by the UK design standard.

Fig.3 Crack locations and test results for trough to crossbeam joint

In two of the designs, the trough to crossbeam weld stops short of the deck plate and a cope hole is left in the crossbeam, to bridge the trough to deck plate weld. This avoids three welds meeting at a point. However, when these joints were fatigue tested cracks occurred in the trough and crossbeam at the upper end of the trough to crossbeam weld, ie at the edge of the cope hole.

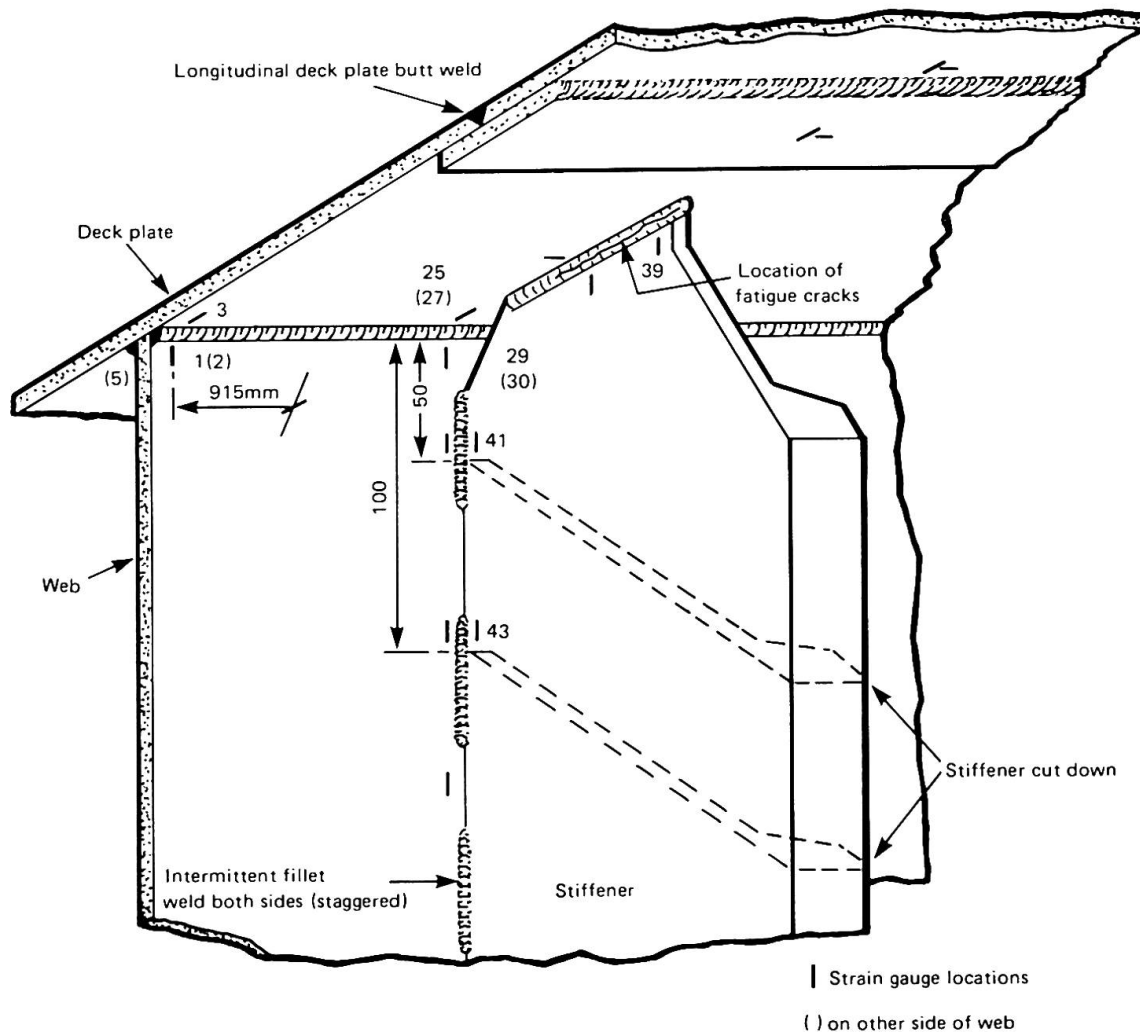
Cracks occurred at the joint shown in figure 4 under the nearside lane of a box girder bridge after 9 years in service.

The stiffener was then cut down, first to 50mm from the deck plate, then by a further 50mm to 100mm from the deck plate, see figure 4. The potential crack locations were then (i) the weld end at the top of the stiffener and (ii) the web to deck weld. The adjacent deck plate butt weld was also checked. Gauges were attached at all these locations and the load tests repeated.

Fig.4 Web stiffener to deck joint

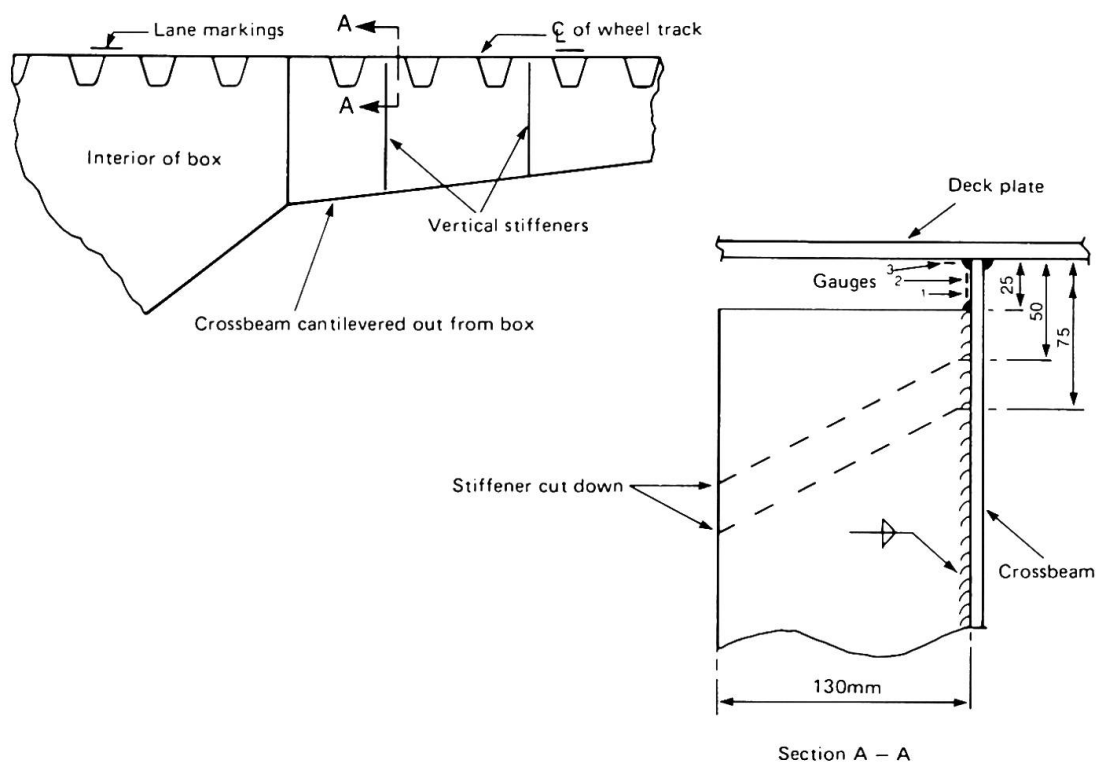
The webs of these beams are stiffened by two vertical stiffeners, figure 5 shows the arrangement. In this case a nominal 25mm gap was left between the top of the stiffener and the deck plate. A survey showed that the actual gap varied between 15mm and 40mm.

Fig.5 Crossbeam stiffener

Loading tests were carried out with the surfacing removed using the same, two axle, test vehicle. Strains were measured on the crossbeam web at the top of a stiffener and at the crossbeam to deck plate weld directly above, see figure 5.

The stress data was used to estimate the fatigue life of the joint by the same methods as described above. The highest stress occurred at the end of the stiffener to crossbeam weld between the top of the stiffener and the deck plate (gauge position 1, see figure 5).

have been found in this joint although the bridge is older and more heavily trafficked. Part of the reason for this is the effect of the transverse position of the traffic relative to the joint, see figure 5. With the present position of traffic lanes on the bridge, the joint is 450mm from the centre of the vehicle wheel track. It is calculated that this will increase the life to 12 years.
