**Zeitschrift:** IABSE proceedings = Mémoires AIPC = IVBH Abhandlungen  
**Band:** 14 (1990)  
**Heft:** P-150: Fatigue crack locations in orthotropic steel decks

**Artikel:** Fatigue crack locations in orthotropic steel decks  
**Autor:** Cuninghame, J.R. / Beales, C.  
**DOI:** <https://doi.org/10.5169/seals-42842>

## Fatigue Crack Locations in Orthotropic Steel Decks

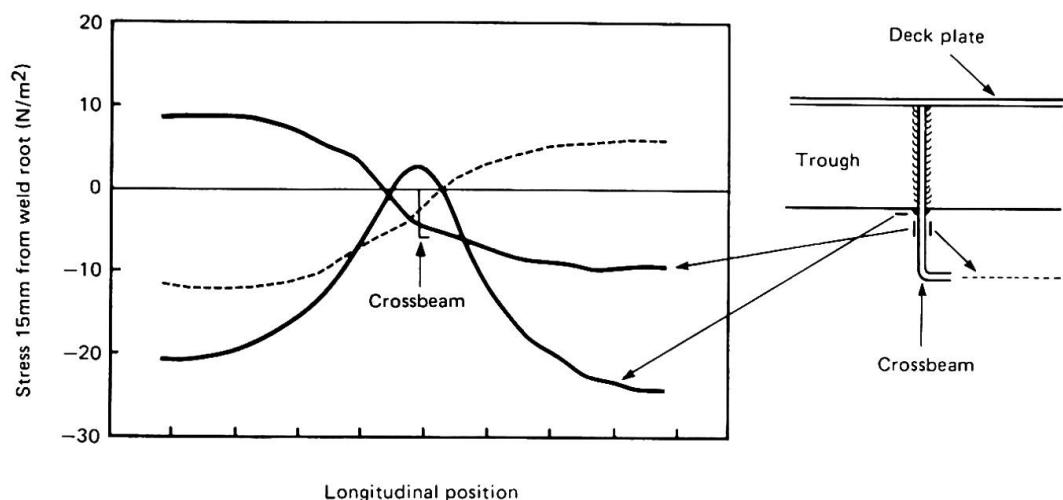
Fig.1 Stress influence lines for trough to crossbeam joint

Fatigue tests were carried out on a deck panel by loading alternately at two positions over the trough on either side of the crossbeam, coinciding with the stress peaks on the influence line. Small (1500 x 600mm) specimens were also tested.

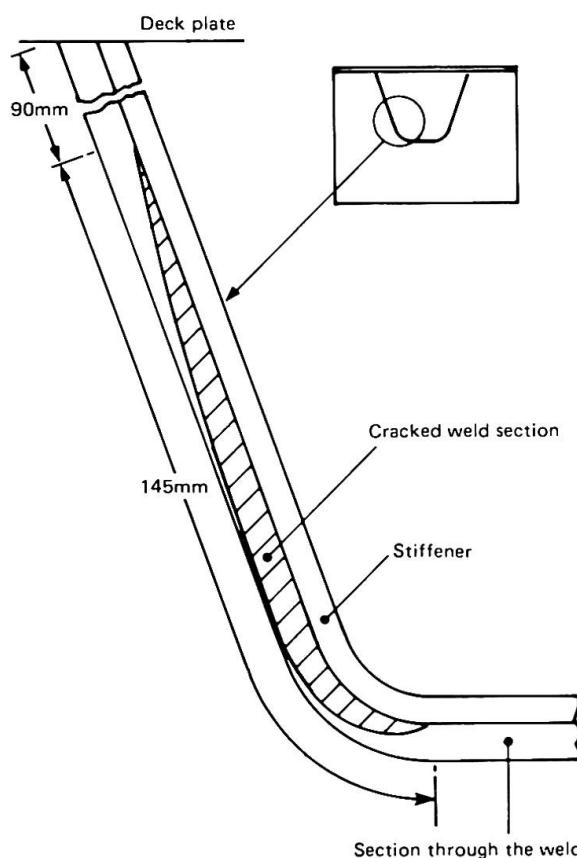
Most cracks, both in the fatigue tests and on the bridge, started at the weld root on the web of the trough in a region of tensile residual stress, and grew through the weld throat with the fracture surface parallel to the crossbeam. Fig 2 shows a crack just before it reached the weld surface and became visible.

Fig.2 Crack location in trough to crossbeam weld

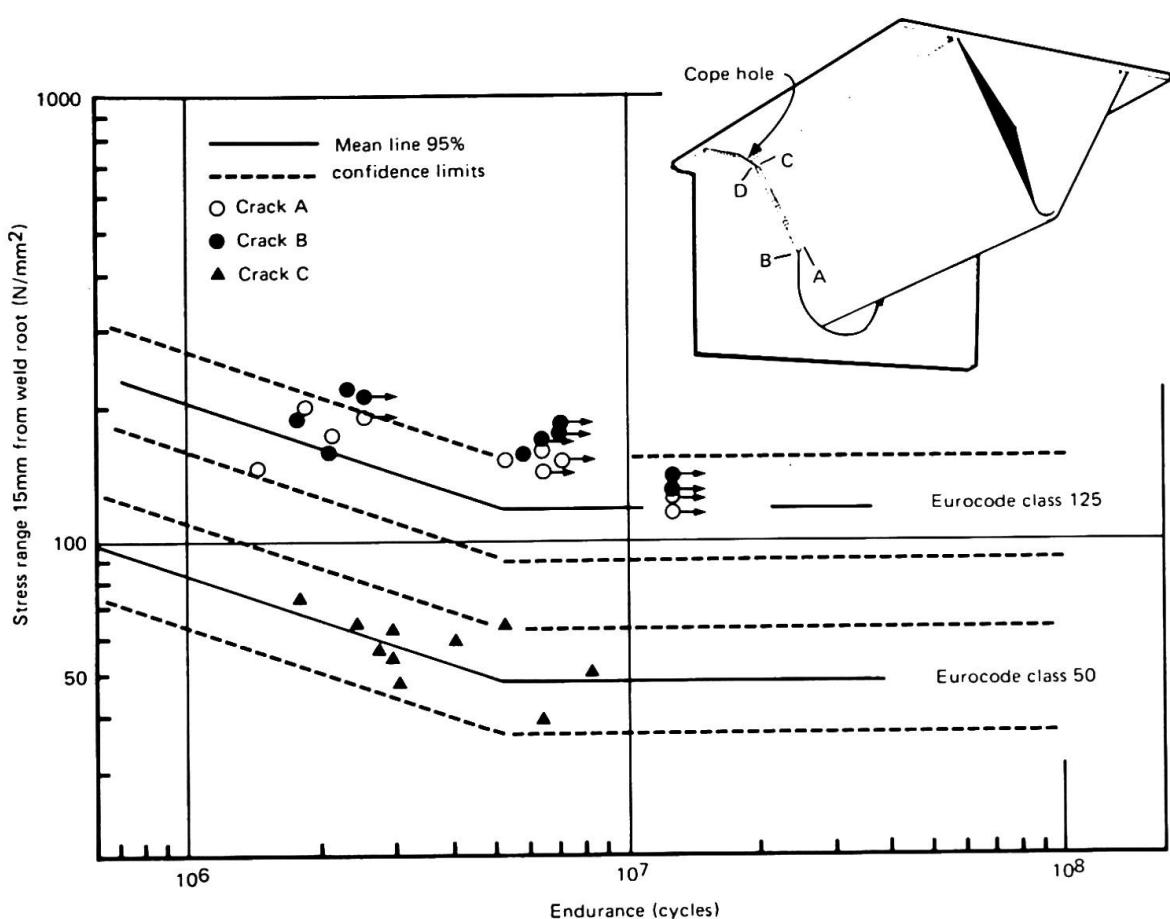
The crack locations and test results are shown in figure 3. Cracks also occurred at the lower end of the weld but at much longer endurances. The fatigue strength of the cope hole detail is consistent with BS 5400 class G or Eurocode class 50 [10]. The estimated life under design traffic loading is less than 5 years. Without the cope hole detail, the fatigue strength (for cracking at the weld toe at the lower end of the weld) is much higher than expected and is consistent with BS 5400 class C, or Eurocode class 125. The design life of the joint is then greater than the 120 years required by the UK design standard.

Fig.3 Crack locations and test results for trough to crossbeam joint

In two of the designs, the trough to crossbeam weld stops short of the deck plate and a cope hole is left in the crossbeam, to bridge the trough to deck plate weld. This avoids three welds meeting at a point. However, when these joints were fatigue tested cracks occurred in the trough and crossbeam at the upper end of the trough to crossbeam weld, ie at the edge of the cope hole.

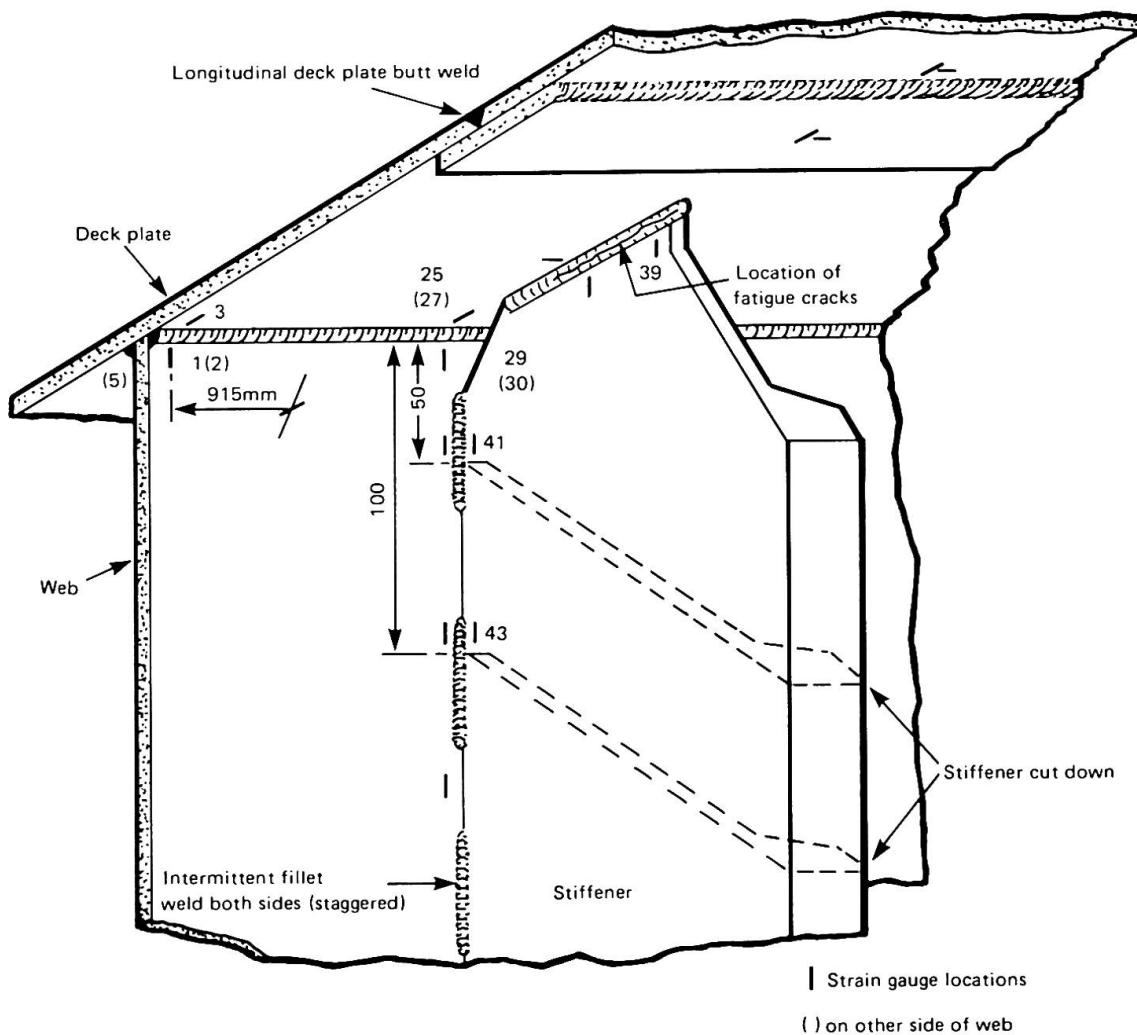
Cracks occurred at the joint shown in figure 4 under the nearside lane of a box girder bridge after 9 years in service.

The stiffener was then cut down, first to 50mm from the deck plate, then by a further 50mm to 100mm from the deck plate, see figure 4. The potential crack locations were then (i) the weld end at the top of the stiffener and (ii) the web to deck weld. The adjacent deck plate butt weld was also checked. Gauges were attached at all these locations and the load tests repeated.

Fig.4 Web stiffener to deck joint

In order to assess the joint and develop a repair, load tests were carried out on an uncracked joint. An area of the asphalt surfacing 8m long by 2m wide was removed and loads were applied by a two axle test vehicle. As the influence lines are short, strains due to a single front wheel could be measured directly. Single gauges were attached close to the weld toe at each potential crack location, and stress influence lines were calculated from the measured strains. The weld was then removed so that the stiffener was no longer attached to the deck plate and the load test repeated.

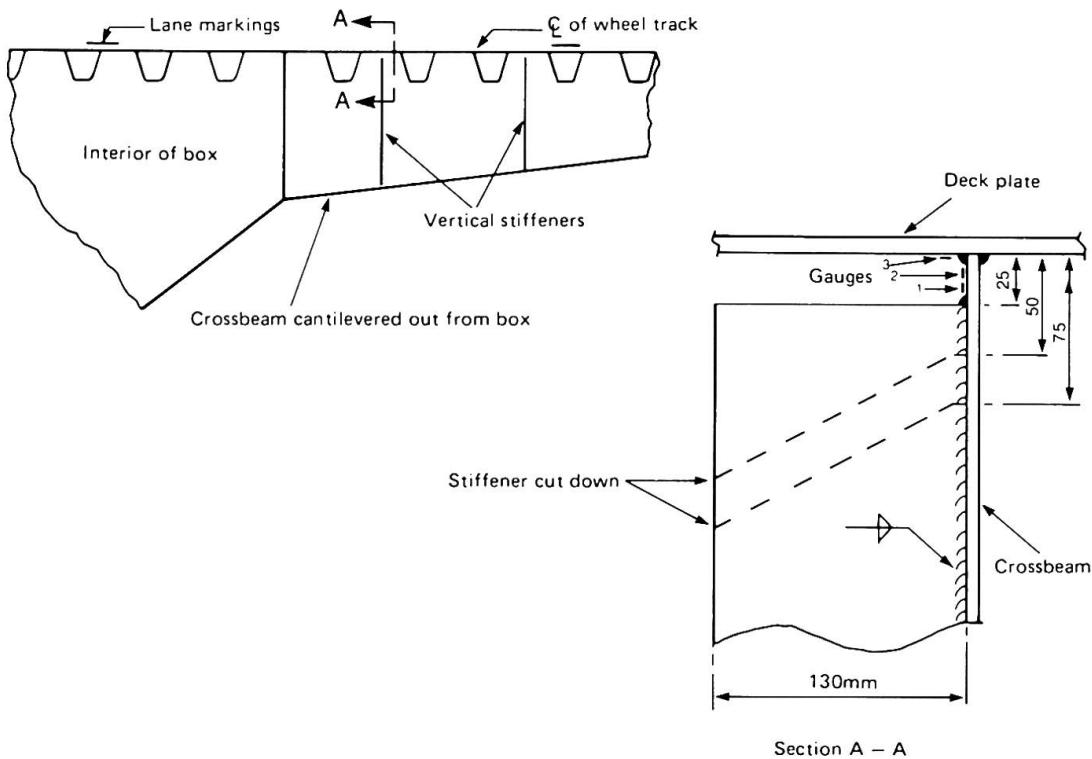
The webs of these beams are stiffened by two vertical stiffeners, figure 5 shows the arrangement. In this case a nominal 25mm gap was left between the top of the stiffener and the deck plate. A survey showed that the actual gap varied between 15mm and 40mm.

Fig.5 Crossbeam stiffener

Loading tests were carried out with the surfacing removed using the same, two axle, test vehicle. Strains were measured on the crossbeam web at the top of a stiffener and at the crossbeam to deck plate weld directly above, see figure 5.

The stress data was used to estimate the fatigue life of the joint by the same methods as described above. The highest stress occurred at the end of the stiffener to crossbeam weld between the top of the stiffener and the deck plate (gauge position 1, see figure 5).

have been found in this joint although the bridge is older and more heavily trafficked. Part of the reason for this is the effect of the transverse position of the traffic relative to the joint, see figure 5. With the present position of traffic lanes on the bridge, the joint is 450mm from the centre of the vehicle wheel track. It is calculated that this will increase the life to 12 years.
