Zeitschrift: IABSE proceedings = Mémoires AIPC = IVBH Abhandlungen
Band: 14 (1990)
Heft: P-150: Fatigue crack locations in orthotropic steel decks

Artikel: Fatigue crack locations in orthotropic steel decks
Autor: Cuninghame, J.R. / Beales, C.
DOI: <https://doi.org/10.5169/seals-42842>

Fatigue Crack Locations in Orthotropic Steel Decks

J. R. CUNINGHAME

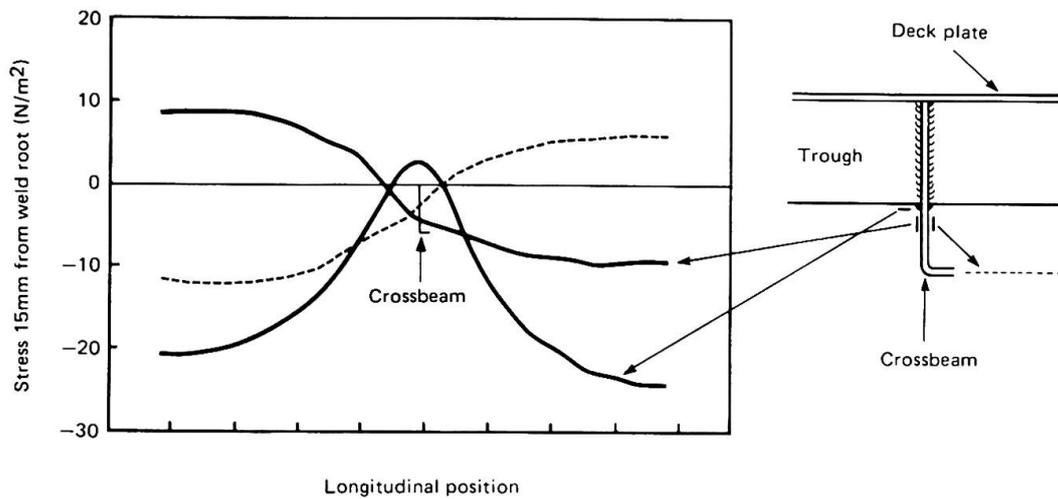
Fig.1 Stress influence lines for trough to crossbeam joint

Fatigue tests were carried out on a deck panel by loading alternately at two positions over the trough on either side of the crossbeam, coinciding with the stress peaks on the influence line. Small (1500 x 600mm) specimens were also tested.

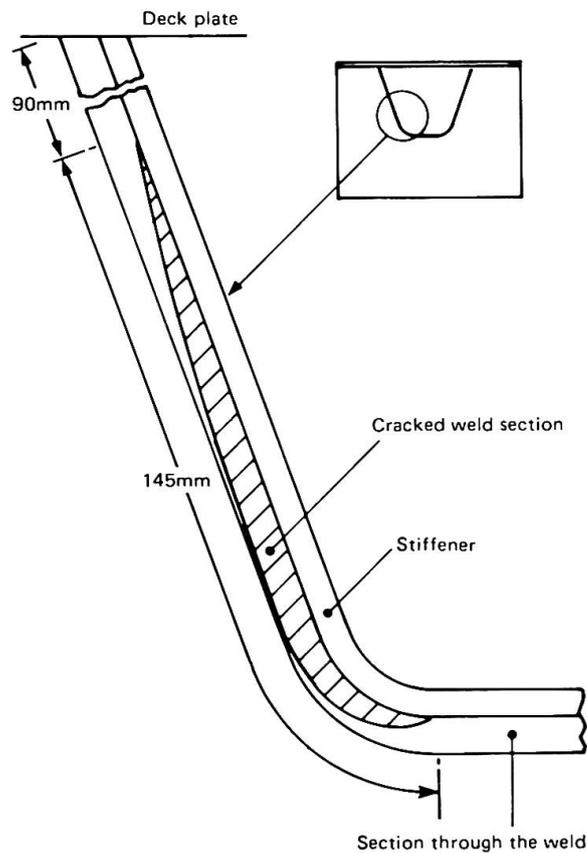
Fig.2 Crack location in trough to crossbeam weld

Most cracks, both in the fatigue tests and on the bridge, started at the weld root on the web of the trough in a region of tensile residual stress, and grew through the weld throat with the fracture surface parallel to the crossbeam. Fig 2 shows a crack just before it reached the weld surface and became visible.

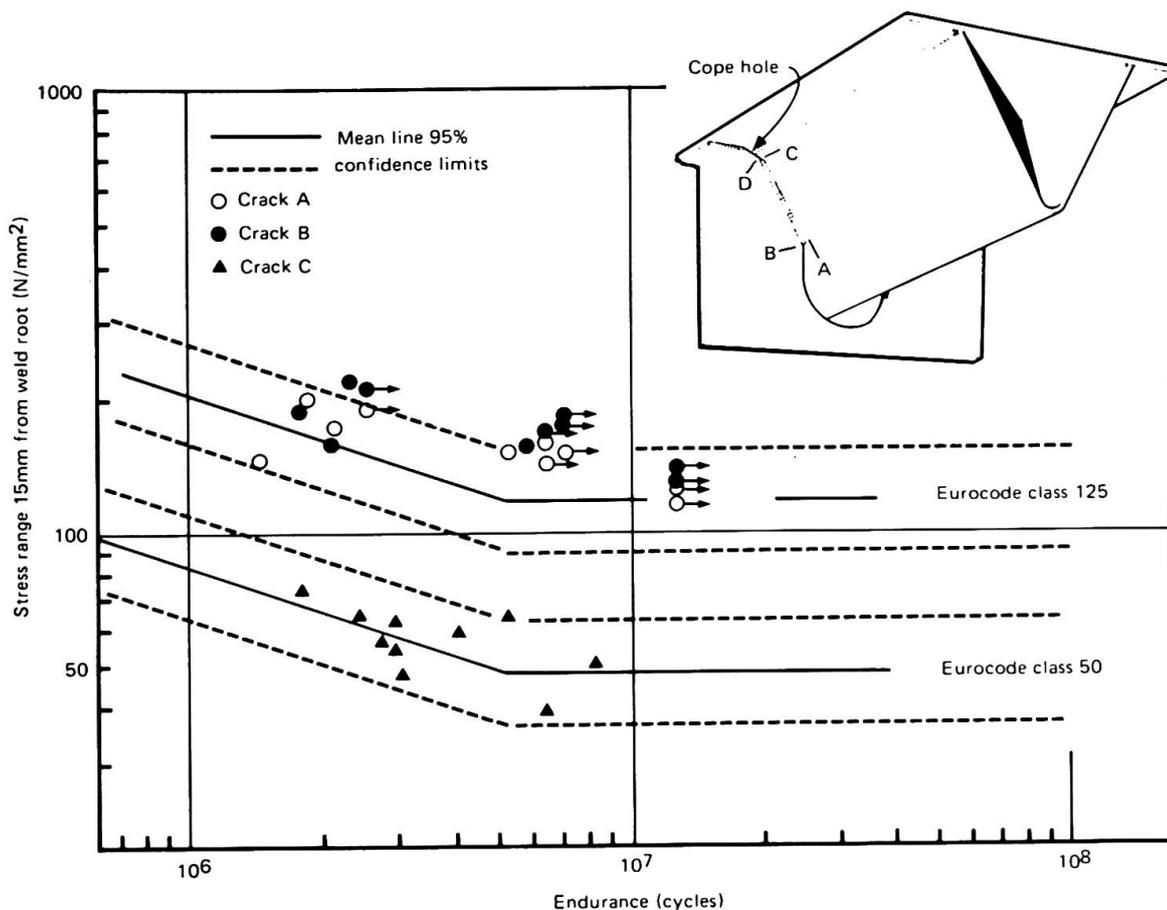
The crack locations and test results are shown in figure 3. Cracks also occurred at the lower end of the weld but at much longer endurances. The fatigue strength of the cope hole detail is consistent with BS 5400 class G or Eurocode class 50 [10]. The estimated life under design traffic loading is less than 5 years. Without the cope hole detail, the fatigue strength (for cracking at the weld toe at the lower end of the weld) is much higher than expected and is consistent with BS 5400 class C, or Eurocode class 125. The design life of the joint is then greater than the 120 years required by the UK design standard.

Fig.3 Crack locations and test results for trough to crossbeam joint

In two of the designs, the trough to crossbeam weld stops short of the deck plate and a cope hole is left in the crossbeam, to bridge the trough to deck plate weld. This avoids three welds meeting at a point. However, when these joints were fatigue tested cracks occurred in the trough and crossbeam at the upper end of the trough to crossbeam weld, ie at the edge of the cope hole.

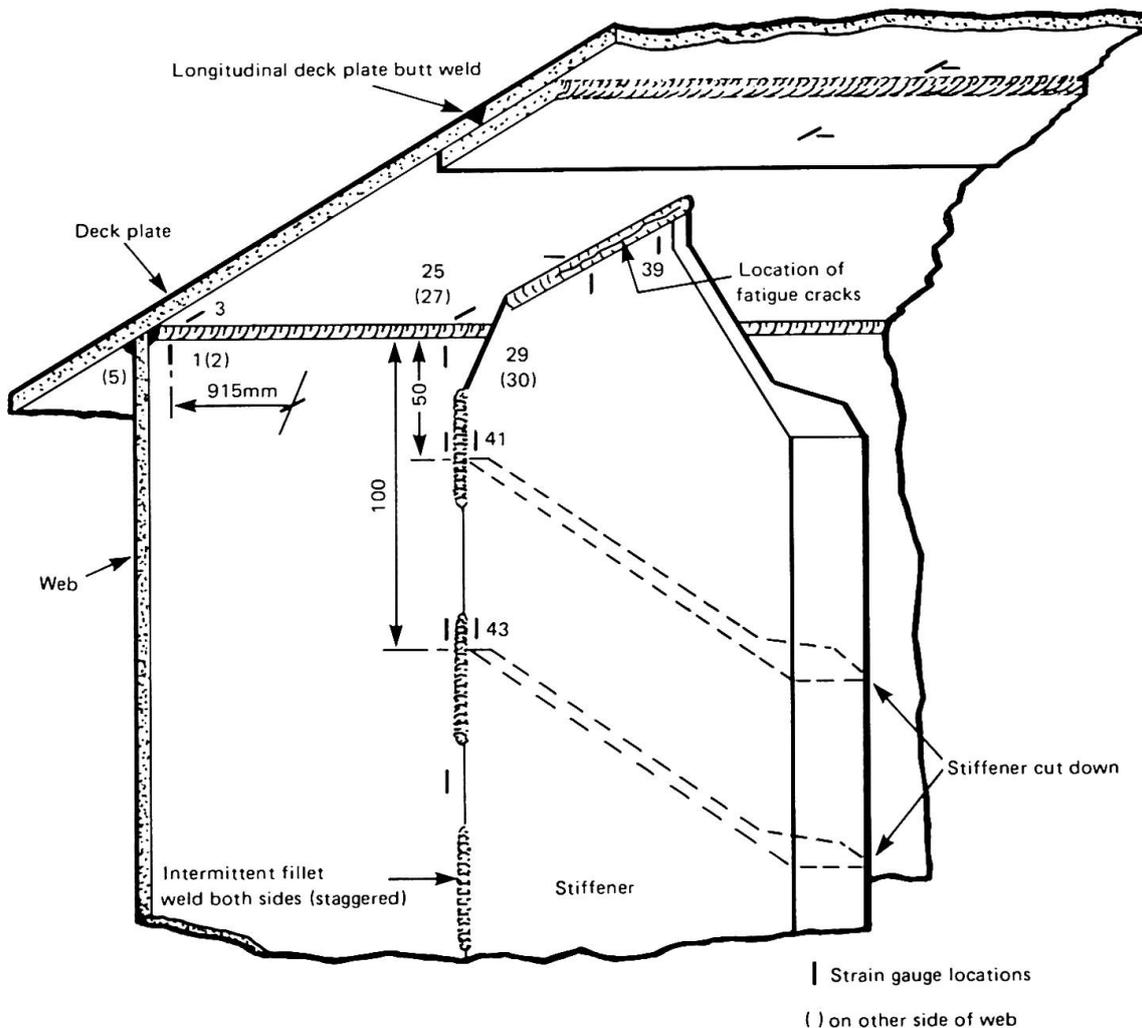
Cracks occurred at the joint shown in figure 4 under the nearside lane of a box girder bridge after 9 years in service.

Fig.4 Web stiffener to deck joint

The stiffener was then cut down, first to 50mm from the deck plate, then by a further 50mm to 100mm from the deck plate, see figure 4. The potential crack locations were then (i) the weld end at the top of the stiffener and (ii) the web to deck weld. The adjacent deck plate butt weld was also checked. Gauges were attached at all these locations and the load tests repeated.

With the weld removed, the weakest point is the web to deck joint above the stiffener (13 years). Cutting the stiffener down to 50mm from the deck plate increased this to 24 years, which is similar to the life of the web to deck joint remote from the vertical stiffener. Cutting the stiffener down to 100mm from the deck plate did not increase the life further.

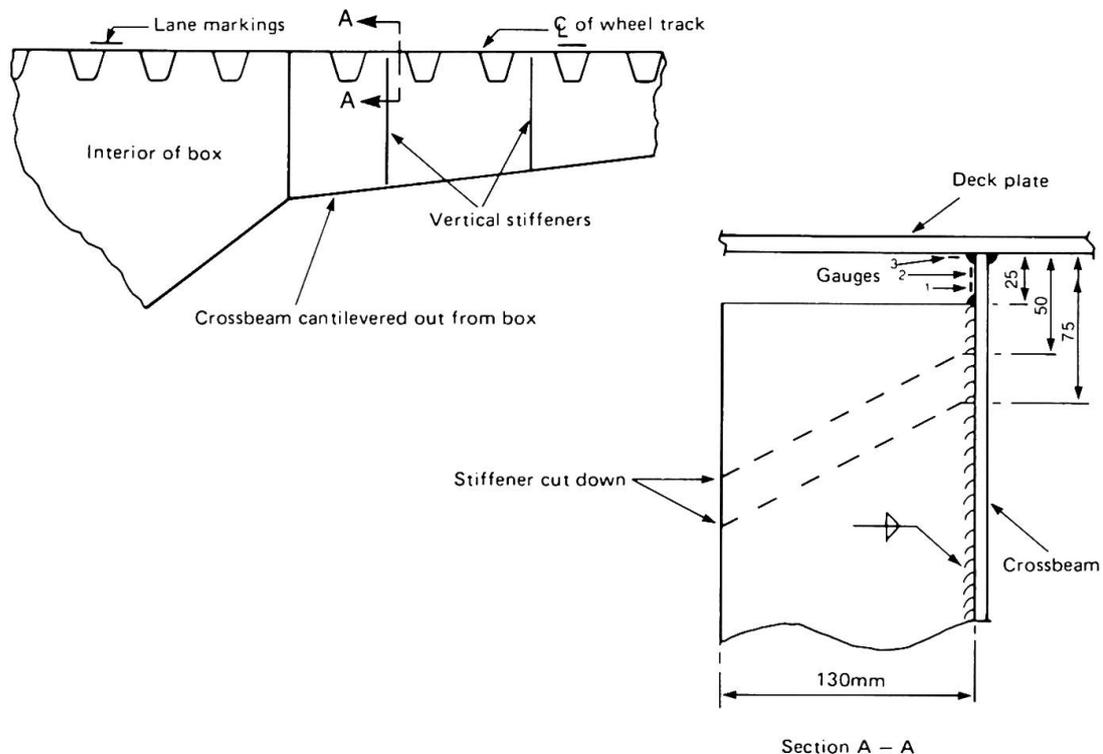
The webs of these beams are stiffened by two vertical stiffeners, figure 5 shows the arrangement. In this case a nominal 25mm gap was left between the top of the stiffener and the deck plate. A survey showed that the actual gap varied between 15mm and 40mm.

Fig.5 Crossbeam stiffener

Loading tests were carried out with the surfacing removed using the same, two axle, test vehicle. Strains were measured on the crossbeam web at the top of a stiffener and at the crossbeam to deck plate weld directly above, see figure 5.

The stress data was used to estimate the fatigue life of the joint by the same methods as described above. The highest stress occurred at the end of the stiffener to crossbeam weld between the top of the stiffener and the deck plate (gauge position 1, see figure 5).

have been found in this joint although the bridge is older and more heavily trafficked. Part of the reason for this is the effect of the transverse position of the traffic relative to the joint, see figure 5. With the present position of traffic lanes on the bridge, the joint is 450mm from the centre of the vehicle wheel track. It is calculated that this will increase the life to 12 years.
