Zeitschrift: IABSE proceedings = Mémoires AIPC = IVBH Abhandlungen
Band: 14 (1990)
Heft: P-150: Fatigue crack locations in orthotropic steel decks

Fatigue Crack Locations in Orthotropic Steel Decks

Crack locations in orthotropic steel bridge decks are discussed with reference to the main types of welded joint. Instances of cracking in service are given and assessment and strengthening methods described. Joints discussed include two types of web stiffener to deck, web to deck, longitudinal stiffener to crossbeam and to deck, and stiffener splice joints.

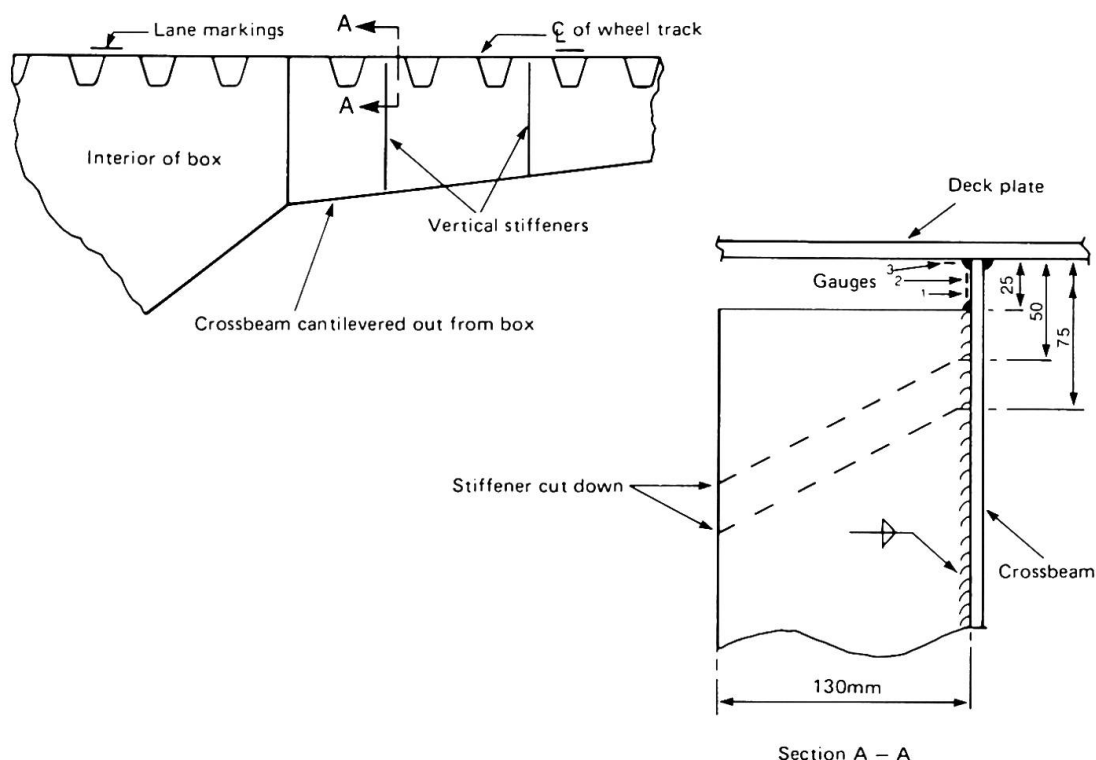
Fig.5 Crossbeam stiffener

The webs of these beams are stiffened by two vertical stiffeners, figure 5 shows the arrangement. In this case a nominal 25mm gap was left between the top of the stiffener and the deck plate. A survey showed that the actual gap varied between 15mm and 40mm.

Loading tests were carried out with the surfacing removed using the same, two axle, test vehicle. Strains were measured on the crossbeam web at the top of a stiffener and at the crossbeam to deck plate weld directly above, see figure 5.

The stress data was used to estimate the fatigue life of the joint by the same methods as described above. The highest stress occurred at the end of the stiffener to crossbeam weld between the top of the stiffener and the deck plate (gauge position 1, see figure 5).

have been found in this joint although the bridge is older and more heavily trafficked. Part of the reason for this is the effect of the transverse position of the traffic relative to the joint, see figure 5. With the present position of traffic lanes on the bridge, the joint is 450mm from the centre of the vehicle wheel track. It is calculated that this will increase the life to 12 years.

Location (refer to fig 5)	Type of surfacing *	Gap at top of stiffener	Vehicle speed (Km/hr)	Asphalt temp. (°C)	Stress (N/mm ²)		
					Max	Min	Range
1	none	23	static		+48	-92	140
	RB+MA	25	13	15	+4	-18	22
	RB+MA	25	31	15	+4	-12	16
	RB+MA	25	45	15	+4	-13	17
	RB+MA	50	11	15	+3	-29	32
	RB+MA	50	31	15	+5	-25	30
	RB+MA	50	45	15	+5	-22	27
	RB+MA	75	11	18	+3	-29	32
	RB+MA	75	33	18	+4	-26	30
	RB+MA	75	46	18	+5	-25	30
2	None	23	static		+51	-75	126
	RB+MA	25	13	15	0	-10	10
	RB+MA	50	11	15	0	-17	17
	RB+MA	75	11	18	0	-20	20
3	None	23	static		+1	-59	60
	RB+MA	25	13	15	-1	-9	8
	RB+MA	50	11	15	-1	-16	15
	RB+MA	75	11	18	-1	-19	18
