Artikel: Fatigue crack locations in orthotropic steel decks
Autor: Cuninghame, J.R. / Beales, C.
DOI: <https://doi.org/10.5169/seals-42842>

Fatigue Crack Locations in Orthotropic Steel Decks

Crack locations in orthotropic steel bridge decks are discussed with reference to the main types of welded joint. Instances of cracking in service are given and assessment and strengthening methods described. Joints discussed include two types of web stiffener to deck, web to deck, longitudinal stiffener to crossbeam and to deck, and stiffener splice joints.

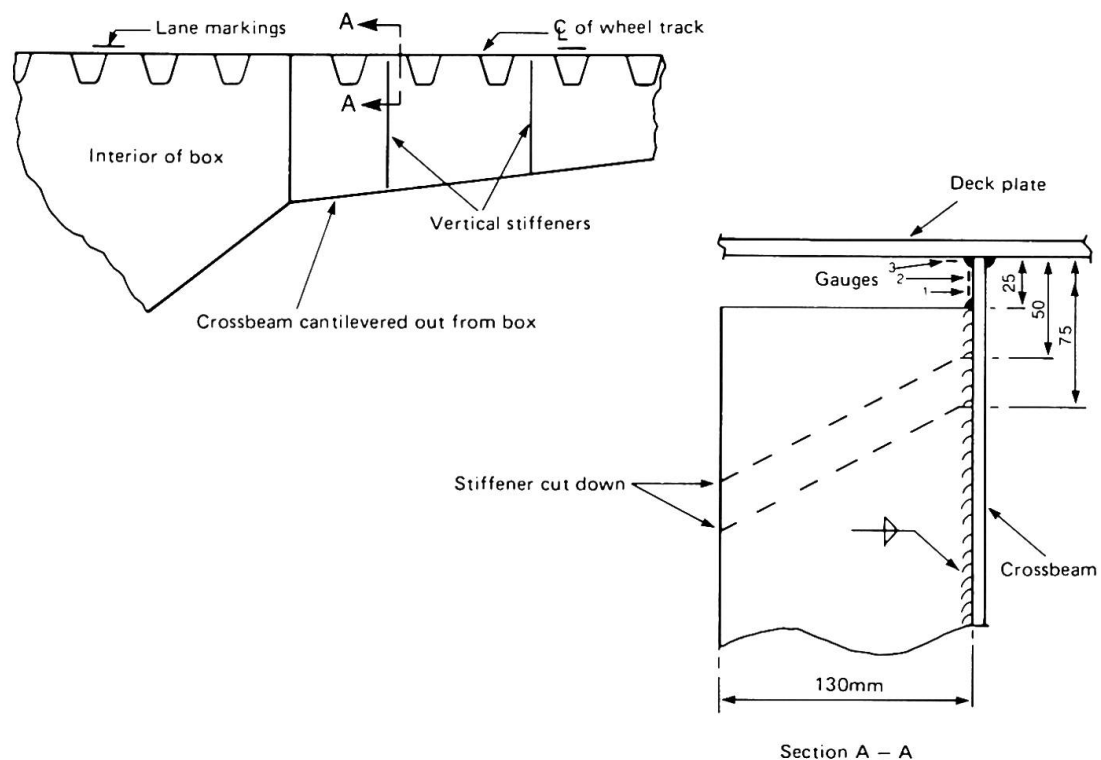
Fig.5 Crossbeam stiffener

The webs of these beams are stiffened by two vertical stiffeners, figure 5 shows the arrangement. In this case a nominal 25mm gap was left between the top of the stiffener and the deck plate. A survey showed that the actual gap varied between 15mm and 40mm.

Loading tests were carried out with the surfacing removed using the same, two axle, test vehicle. Strains were measured on the crossbeam web at the top of a stiffener and at the crossbeam to deck plate weld directly above, see figure 5.

The stress data was used to estimate the fatigue life of the joint by the same methods as described above. The highest stress occurred at the end of the stiffener to crossbeam weld between the top of the stiffener and the deck plate (gauge position 1, see figure 5).

have been found in this joint although the bridge is older and more heavily trafficked. Part of the reason for this is the effect of the transverse position of the traffic relative to the joint, see figure 5. With the present position of traffic lanes on the bridge, the joint is 450mm from the centre of the vehicle wheel track. It is calculated that this will increase the life to 12 years.

Location (refer to fig 5)	Type of surfacing *	Gap at top of stiffener	Vehicle speed (Km/hr)	Asphalt temp. (°C)	Stress (N/mm ²)		
					Max	Min	Range
1	none	23	static		+48	-92	140
	RB+MA	25	13	15	+4	-18	22
	RB+MA	25	31	15	+4	-12	16
	RB+MA	25	45	15	+4	-13	17
	RB+MA	50	11	15	+3	-29	32
	RB+MA	50	31	15	+5	-25	30
	RB+MA	50	45	15	+5	-22	27
	RB+MA	75	11	18	+3	-29	32
	RB+MA	75	33	18	+4	-26	30
	RB+MA	75	46	18	+5	-25	30
2	None	23	static		+51	-75	126
	RB+MA	25	13	15	0	-10	10
	RB+MA	50	11	15	0	-17	17
	RB+MA	75	11	18	0	-20	20
3	None	23	static		+1	-59	60
	RB+MA	25	13	15	-1	-9	8
	RB+MA	50	11	15	-1	-16	15
	RB+MA	75	11	18	-1	-19	18
