Artikel: Surfacings on an experimental deck panel in a highway

SURFACINGS ON AN EXPERIMENTAL DECK PANEL IN A HIGHWAY

W.I.J. PRICE Head of Bridges Section Road Research Laboratory

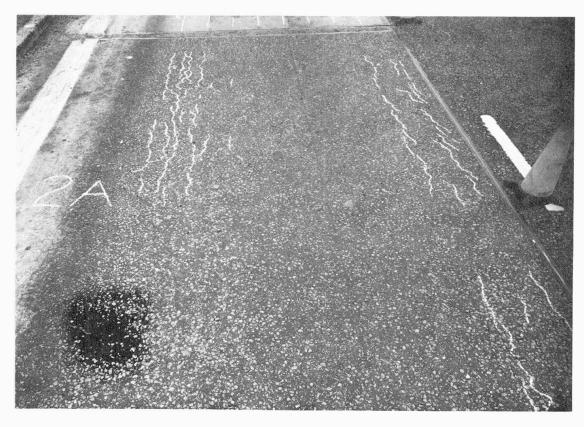
FIG. 4 CRACKING ON ROLLED ASPHALT OVER GRITTED EPOXY RESIN, NOVEMBER, 1967

A very fine crack, a few inches long, appeared during the Spring of 1964 in the nearside wheel track. It remained largely unchanged until the Winter of 1964/5 when the crack lengthened to extend almost over the length of the section by the Spring of 1965. By that time two intermittent cracks had developed in the outer wheel tracks, near the edge of the panel. During 1966, parallel cracks developed in the near side wheel track over the webs of the underlying stiffener, that is 6 in. (15 mm) on either side of the existing crack. By November. 1967, when the photograph in Fig. 4 was taken, a crazed pattern of cracks was established over a 12 in (300 mm) wide strip, with short crack appearing over the line of the next stiffener towards the centre of the panel. When last observed in July, 1968 (Fig. 5) a depression about $\frac{1}{4}$ in (6 mm) deep had formed in the centre of the strip. Cracks along the off-side wheel tracks had become more continuous, but these are not such good indicators of performance, because of the proximity of the edge of the panel. It is significant that cracks have not run over the transverse disphragm of the deck panel, but have terminated some 9 in (225 mm) from it.

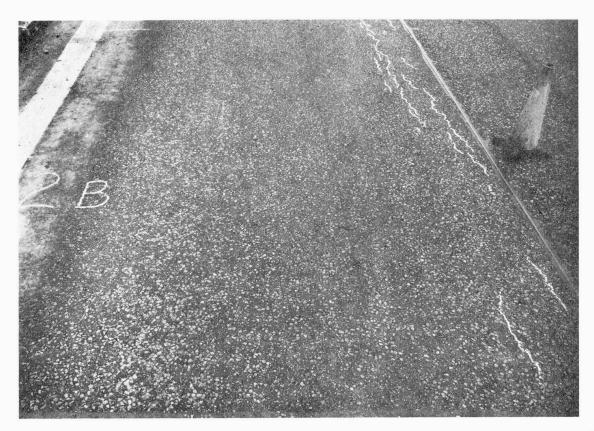
FIG. 6 CRACKING IN ROLLED ASPHALT ON FILLED RUBBER BITUMEN, NOVEMBER, 1967

In February, 1965, short intermittent cracks were noticed in the off-side wheel tracks near the edge of the panel. These cracks occur mid-way between lines of stiffeners. They have continued to develop, until in November, 1967 there were two fairly definite lines of cracks about 12 in. (300 mm) apart with some interconnecting cracks (Fig. 6). Again the cracks disappear within about 9 in (225 mm) of the position of the transverse stiffener.

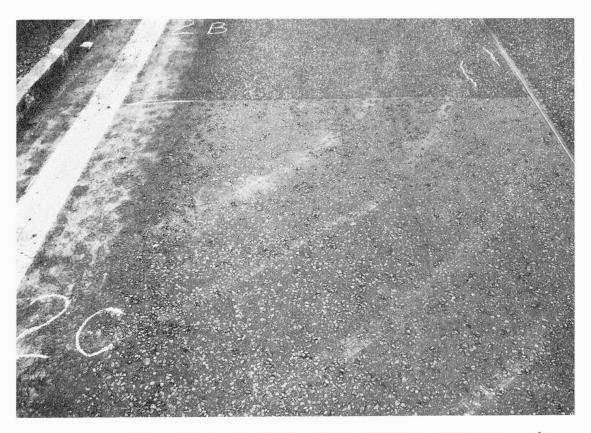
FIG. 7 MASTIC ASPHALT ON FILLED RUBBER BITUMEN, NOVEMBER, 1967

No cracking has so far occurred in this section. In the Spring of 1964, however, a blister about 9 in. to 12 in (225 to 300 mm) dia. appeared near the centre of the section. When it was cut out and repaired

in September, 1964, it was observed that separation had occurred between the layer of filled rubber bitumen and the mastic asphalt wearing course (Fig. 7).

One blister formed in the mastic asphalt on Section 2C, about 6 months after laying. Blister formation is sometimes an unfortunate feature of mastic asphalt surfacing and it seems to be associated with one or several of the following factors: the presence of water or of a volatile liquid, or of trapped air, relatively high temperatures and high temperature gradients. Blisters have not been widespread on steel decks in Britain hitherto, but where they have occurred, they have been satisfactorily treated either by puncturing at the time of formation, resealing the puncture with sealing compound, or by cutting out and replacing the surfacing system.
