**Artikel:** Surfacing on an experimental deck panel in a highway

## SURFACINGS ON AN EXPERIMENTAL DECK PANEL IN A HIGHWAY

W.I.J. PRICE  
Head of Bridges Section  
Road Research Laboratory

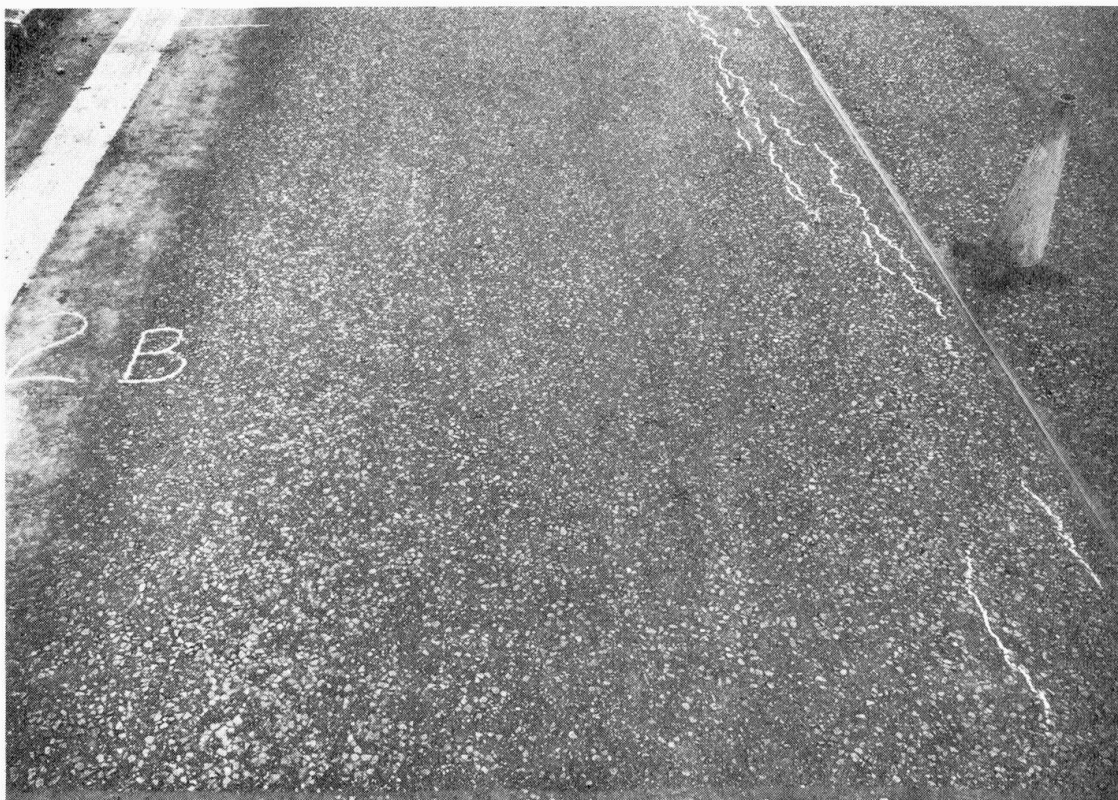
In February, 1965, short intermittent cracks were noticed in the off-side wheel tracks near the edge of the panel. These cracks occur mid-way between lines of stiffeners. They have continued to develop, until in November, 1967 there were two fairly definite lines of cracks about 12 in. (300 mm) apart with some interconnecting cracks (Fig. 6). Again the cracks disappear within about 9 in (225 mm) of the position of the transverse stiffener.

FIG. 6 CRACKING IN ROLLED ASPHALT ON FILLED RUBBER BITUMEN, NOVEMBER, 1967

In terms of freedom from cracking and deformation, this trial confirms that mastic asphalt gives a better performance than rolled asphalt or resin-based systems. The cracking in Section 2B (rolled asphalt on an insulating layer of filled rubber bitumen) could be attributed to proximity to the edge of the panel and so is not to be taken as typical of such a surfacing on orthotropic decks in general. However, the mastic asphalt was subjected to similar conditions of stress and deformation and it has withstood them successfully hitherto.

The filled rubber bitumen under the rolled asphalt on Section 2B has probably contributed to the better condition of this Section compared with Section 2A. On both Sections the rolled asphalt has cracked most extensively between lines of stiffeners, which is contrary to the experience with mastic asphalt in earlier trials on deck panels reported by Trott and Wilson<sup>(1)</sup> where the cracking occurred over the stiffeners. Hennecke<sup>(3)</sup>. has advanced the explanation that the inter-stiffener cracking is caused by tensile stresses in the base of the asphalt at the interface with the steel and that it is preceded by flow of the asphalt from the region over the stiffener to the region in between, causing a longitudinal rut in the surfacing over the stiffener. This is not in accord with the behaviour of Section A, because in this case a rut of about  $\frac{1}{4}$  in. (6 mm) deep developed between the webs of the trapezoidal stiffener under the near-side wheel track. The temperature differential effect referred to by Thul<sup>(4)</sup> would account for the position of the trough, but there seems no entirely satisfactory explanation of the crack development prior to the appearance of the rut.

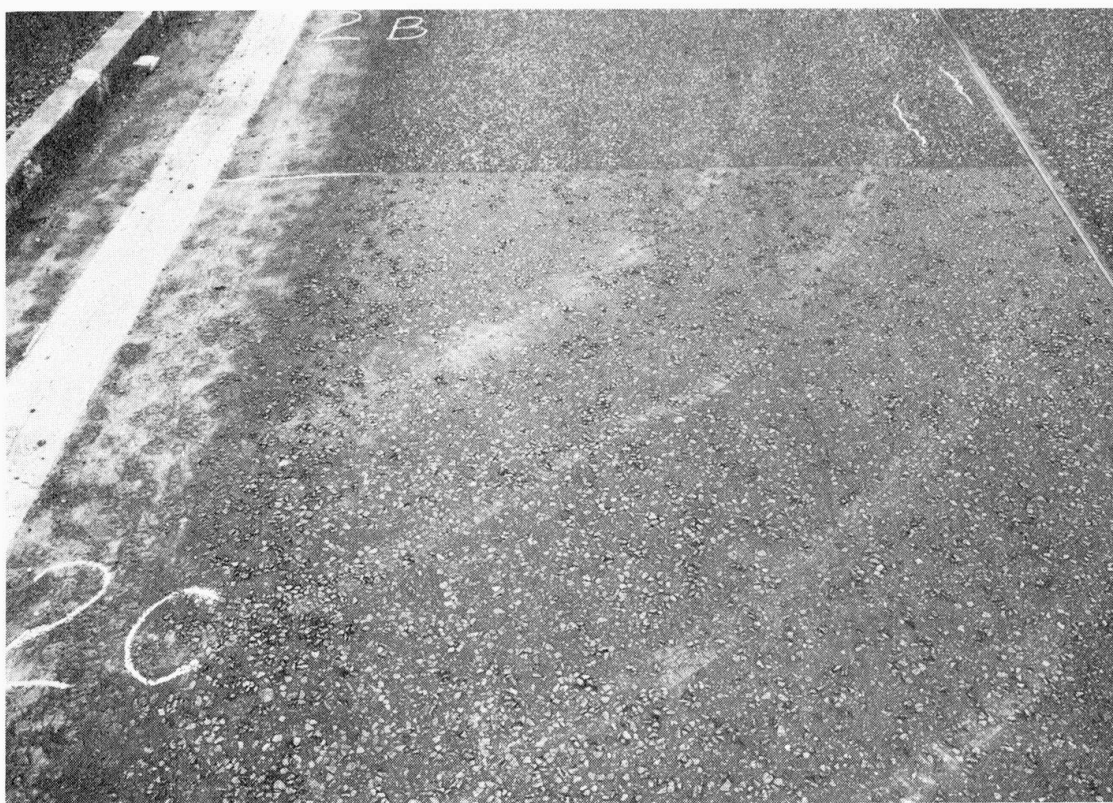
No cracking has so far occurred in this section. In the Spring of 1964, however, a blister about 9 in. to 12 in (225 to 300 mm) dia. appeared near the centre of the section, When it was cut out and repaired

in September, 1964, it was observed that separation had occurred between the layer of filled rubber bitumen and the mastic asphalt wearing course (Fig. 7).

FIG. 7 MASTIC ASPHALT ON FILLED RUBBER BITUMEN, NOVEMBER, 1967

One blister formed in the mastic asphalt on Section 2C, about 6 months after laying. Blister formation is sometimes an unfortunate feature of mastic asphalt surfacing and it seems to be associated with one or several of the following factors: the presence of water or of a volatile liquid, or of trapped air, relatively high temperatures and high temperature gradients. Blisters have not been widespread on steel decks in Britain hitherto, but where they have occurred, they have been satisfactorily treated either by puncturing at the time of formation, resealing the puncture with sealing compound, or by cutting out and replacing the surfacing system.
