**Zeitschrift:** IABSE reports of the working commissions = Rapports des commissions de travail AIPC = IVBH Berichte der Arbeitskommissionen

**Rubrik:** Theme III: Thin wearing surfaces

## INTRODUCTORY REPORT

## LABORATORY AND FIELD EVALUATIONS OF THIN WEARING SURFACES FOR ORTHOTROPIC STEEL DECK BRIDGES

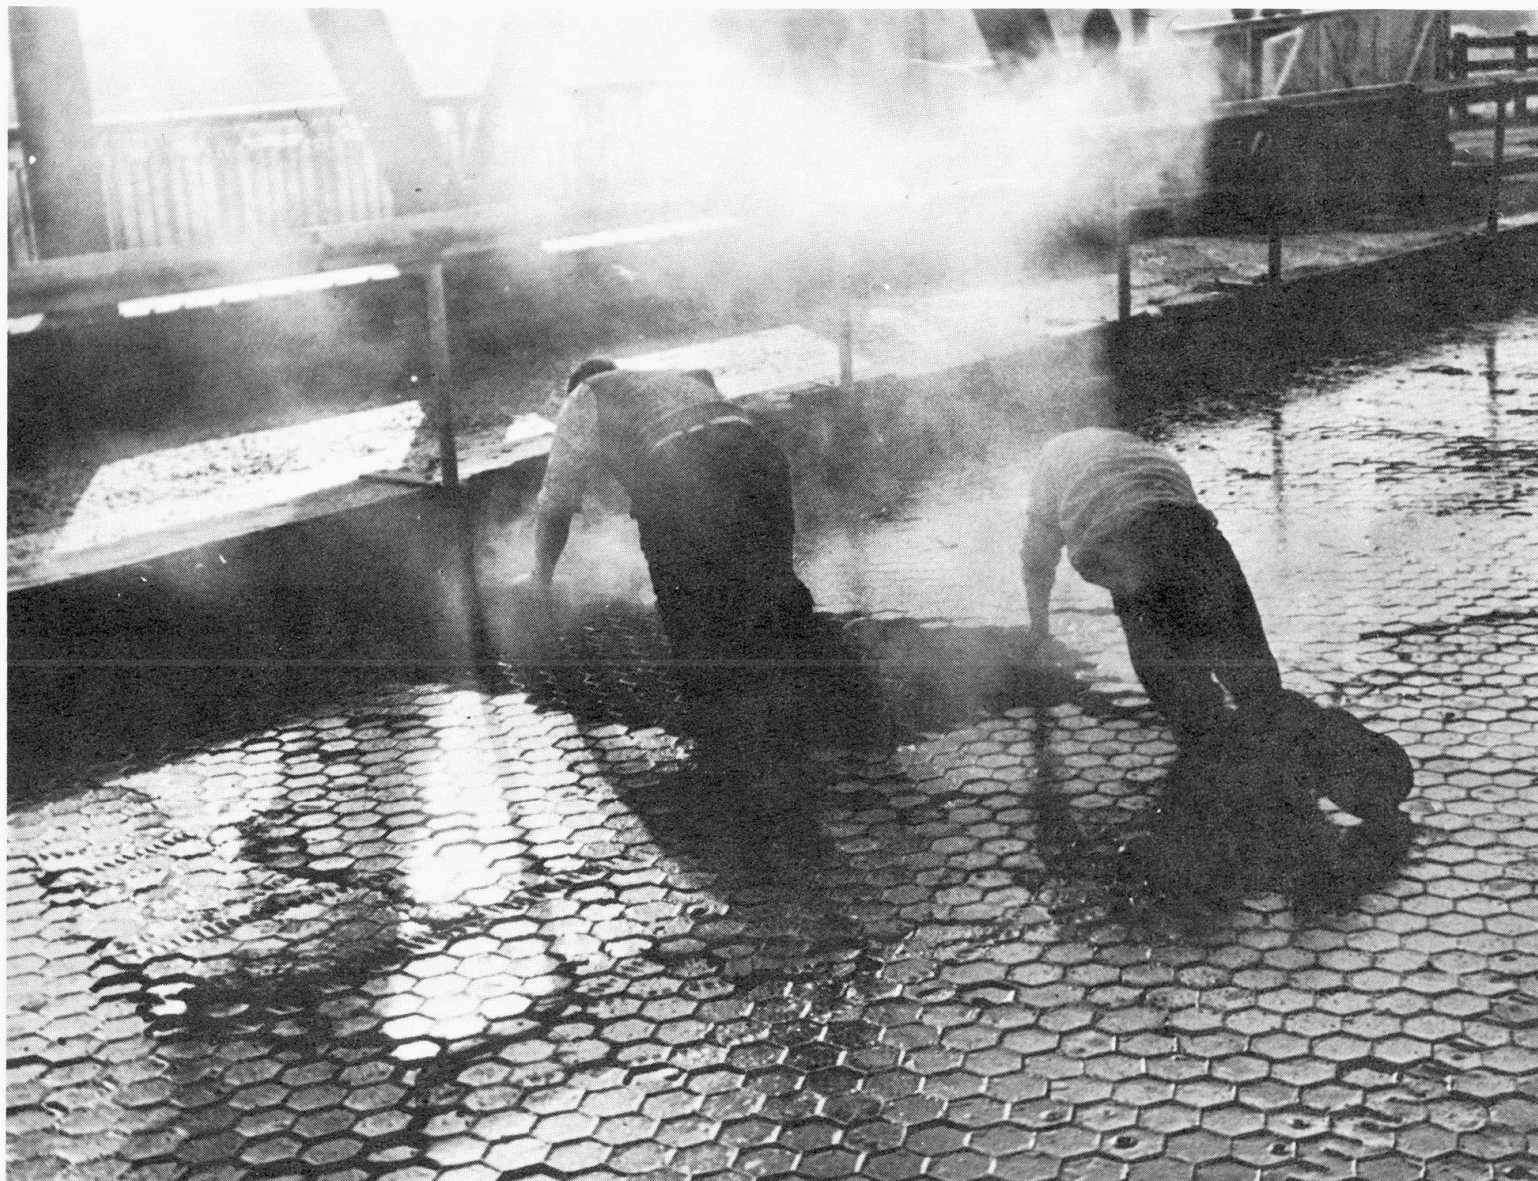
FIG. 1 HEXAGONAL GRID 1 in (25 mm) DEEP, ON AN ALUMINIUM DECK OF A BASCULE BRIDGE IN HULL.
