**Rubrik:** Theme I: Asphaltic wearing surfaces

## INTRODUCTORY REPORT

H. THUL – F.K. REINITZHUBER  
Germany

### 1. The Orthotropic Plate

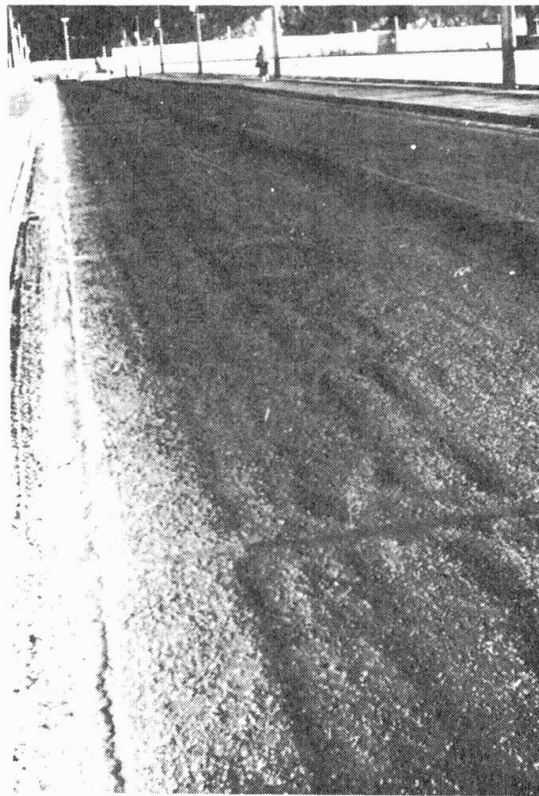
Rutting is a frequent problem, caused at high temperatures by a bitumen content either too rich or too soft. Ruts may be spaced regularly corresponding to the longitudinal stiffeners. See figure 6.

Figure 6: Rutting (transverse waving)

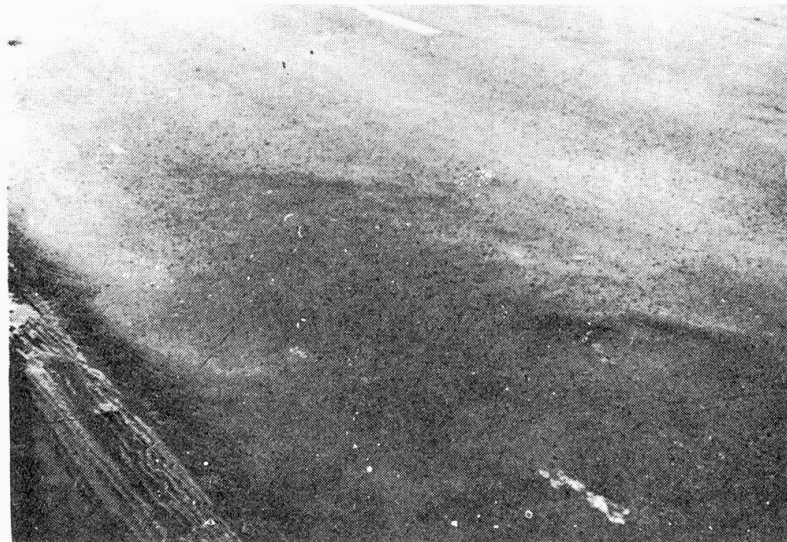
The surfacing may, however, have become so soft that, due to traffic, lateral shoving occurs over long distances forming wide ruts superimposed on the aforementioned undulations, spaced like the stiffeners. See figure 7.

Figure 7: Big-sized shoving,  
up to 7 cm deep

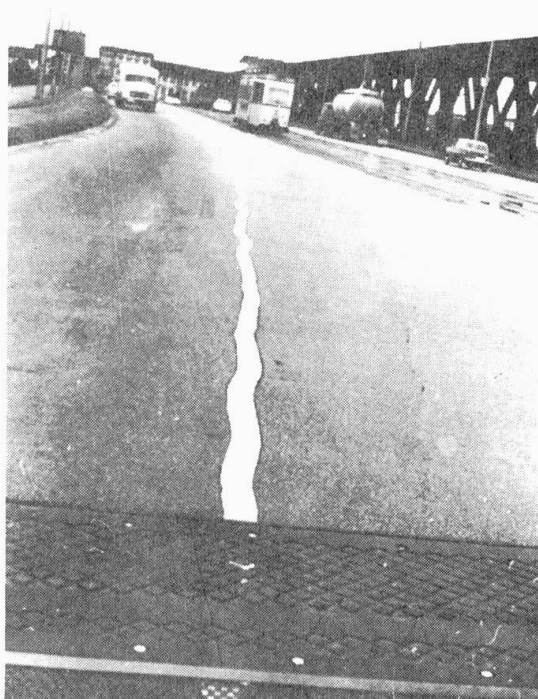
Even shoving and flowing of big areas has been observed on the top surface. See figure 10.

Figure 10: Shoving visible from  
deformed marking strip

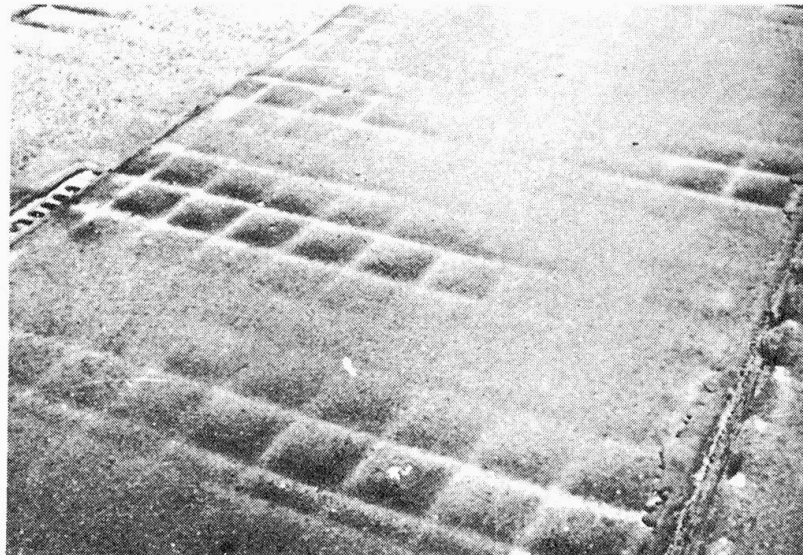
Any surfacing will be destroyed within short time due to insufficient shear strength or bond. It has been tried, therefore, to dowel the surfacing to the steel plates by mechanical means, e.g. by welding mesh reinforcing steel on studs to the plate. This method has not been successful. Due to different thermal expansions of steel and asphalt square targets in size of the mesh appeared on the top surface, presumably indicating insufficient bond. Small furrows up to 2,5 cm = 1" deep may develop atop of the mesh rods, causing cracks in harder types of asphalt and, eventually, destruction in total. See figure 13.

Figure 13: Steel mesh anchoring;  
plasterlike top surface

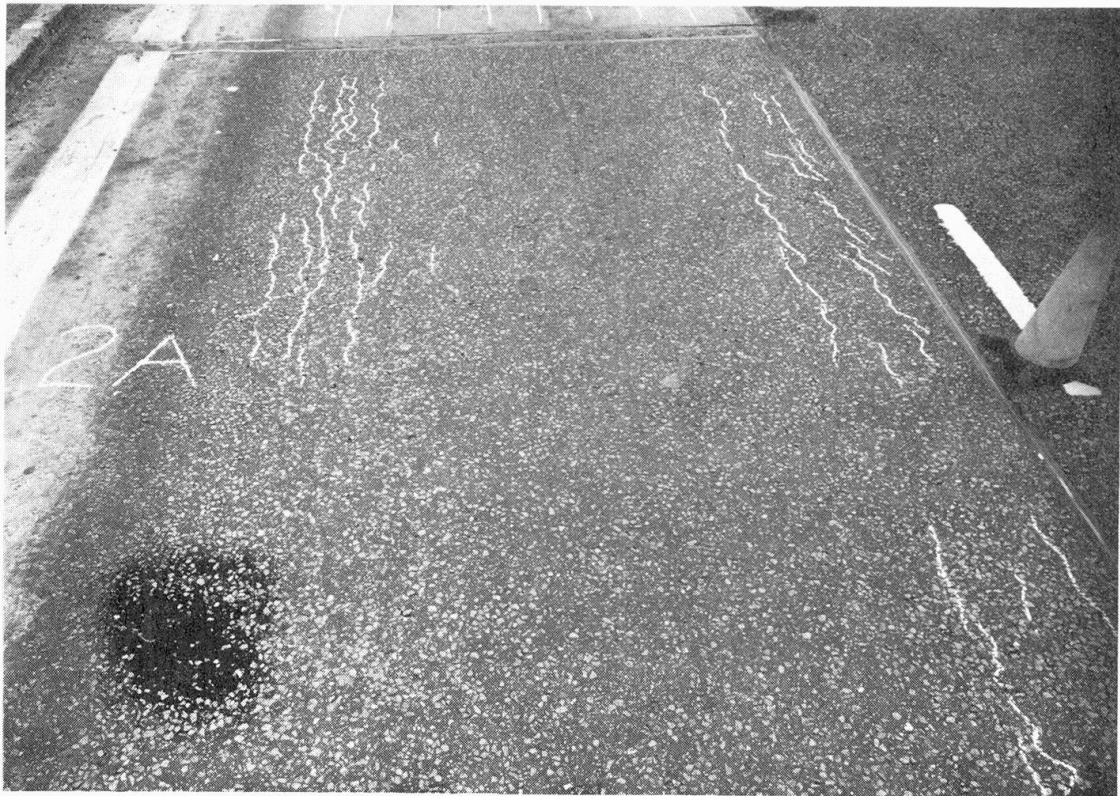
FIG. 4 CRACKING ON ROLLED ASPHALT OVER GRITTED EPOXY RESIN, NOVEMBER, 1967

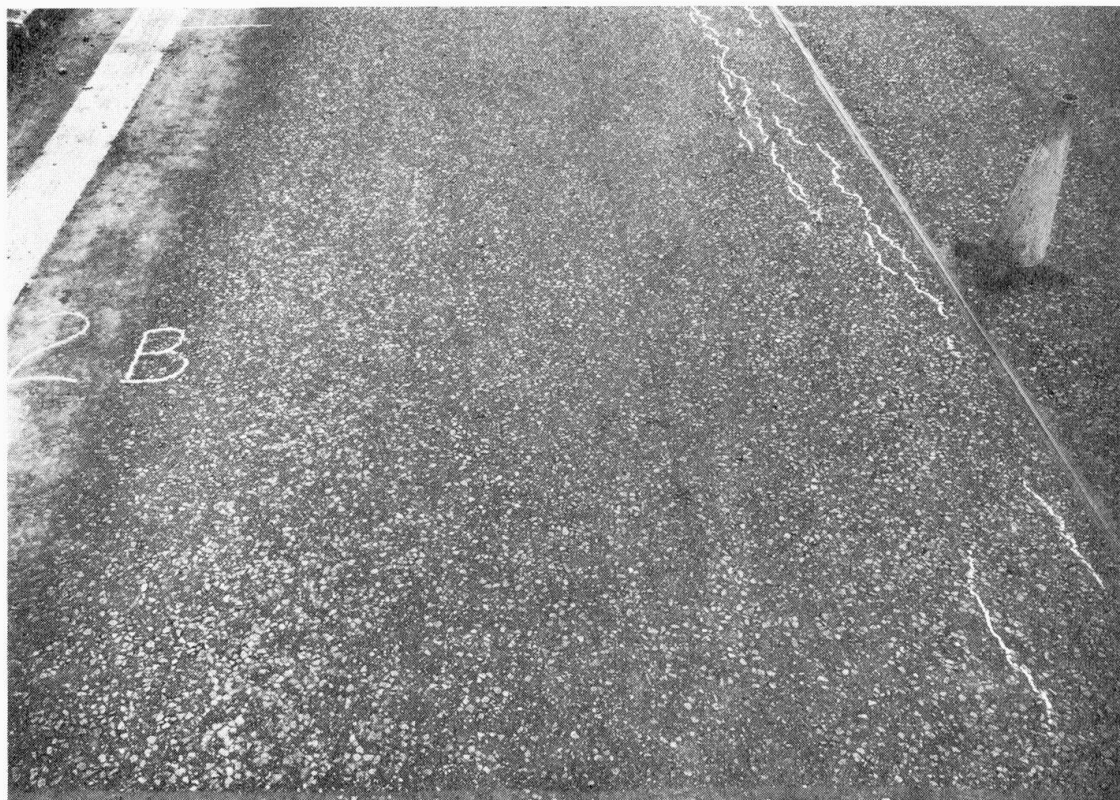
FIG. 6 CRACKING IN ROLLED ASPHALT ON FILLED RUBBER BITUMEN, NOVEMBER, 1967

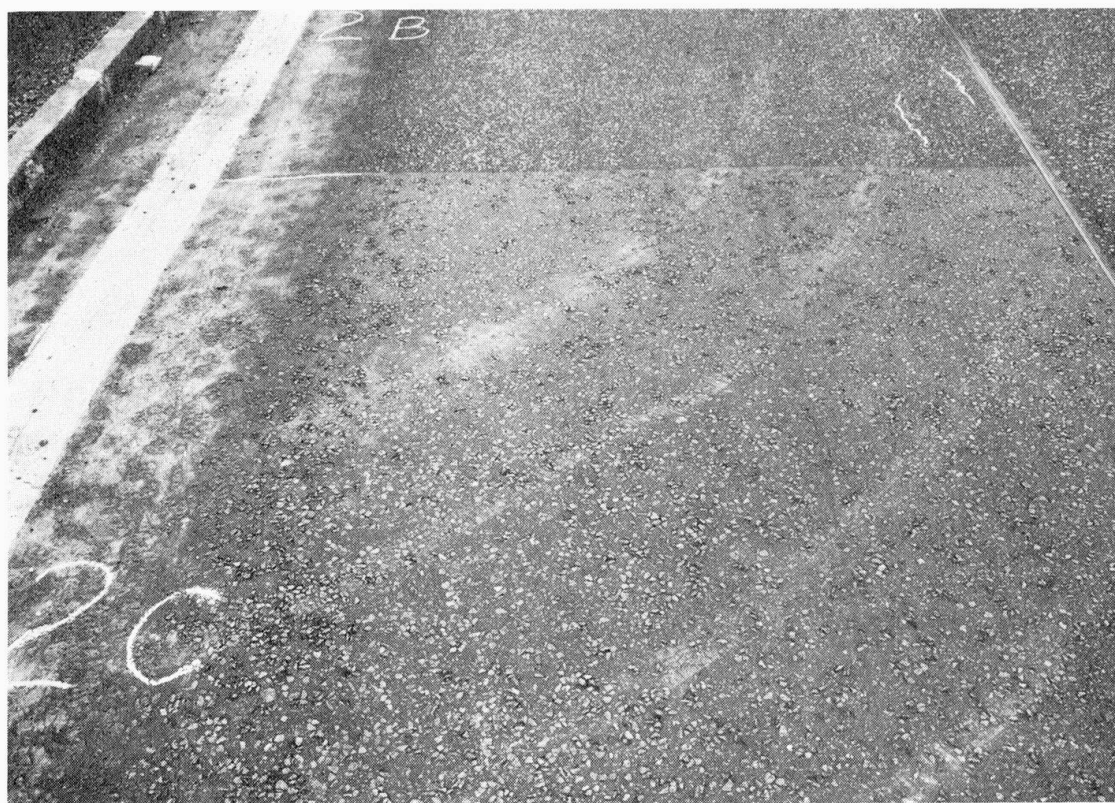
FIG. 7 MASTIC ASPHALT ON FILLED RUBBER BITUMEN, NOVEMBER, 1967
