**Zeitschrift:** IABSE reports of the working commissions = Rapports des commissions de travail AIPC = IVBH Berichte der Arbeitskommissionen

**Rubrik:** Theme I: Asphaltic wearing surfaces

## INTRODUCTORY REPORT

H. THUL – F.K. REINITZHUBER  
Germany1. The Orthotropic Plate

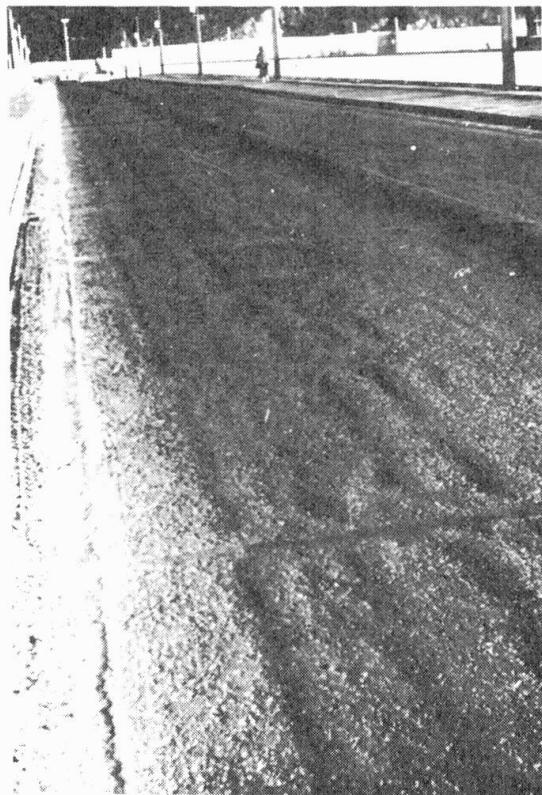
Figure 6: Rutting (transverse waving)

Rutting is a frequent problem, caused at high temperatures by a bitumen content either too rich or too soft. Ruts may be spaced regularly corresponding to the longitudinal stiffeners. See figure 6.

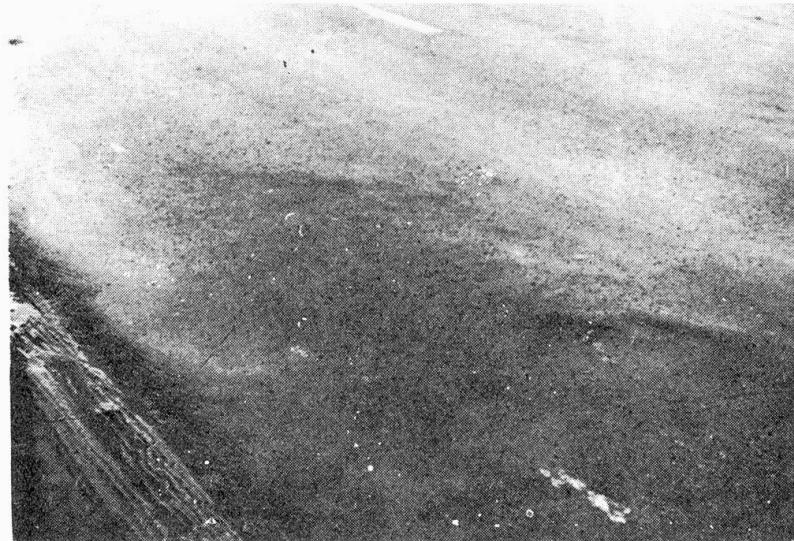
Figure 7: Big-sized shoving,  
up to 7 cm deep

The surfacing may, however, have become so soft that, due to traffic, lateral shoving occurs over long distances forming wide ruts superimposed on the aforementioned undulations, spaced like the stiffeners. See figure 7.

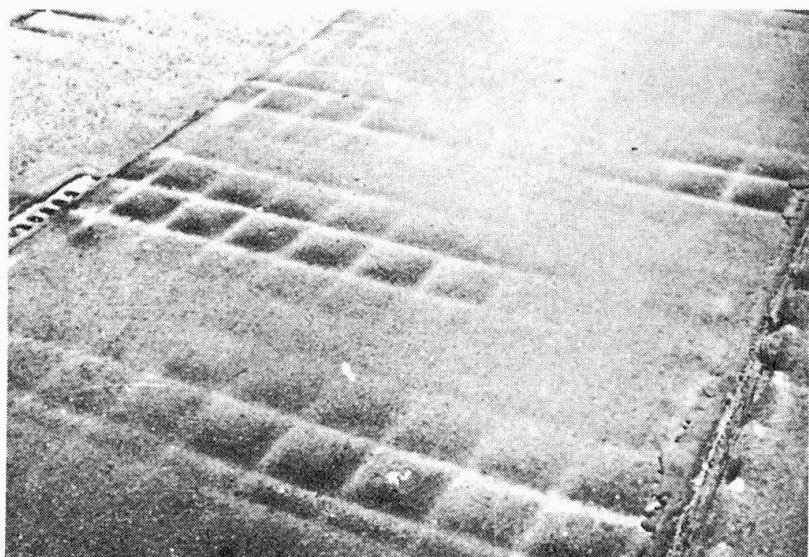
Figure 13: Steel mesh anchoring;  
plasterlike top surface

Any surfacing will be destroyed within short time due to insufficient shear strength or bond. It has been tried, therefore, to dowel the surfacing to the steel plates by mechanical means, e.g. by welding mesh reinforcing steel on studs to the plate. This method has not been successful. Due to different thermal expansions of steel and asphalt square targets in size of the mesh appeared on the top surface, presumably indicating insufficient bond. Small furrows up to 2,5 cm = 1" deep may develop atop of the mesh rods, causing cracks in harder types of asphalt and, eventually, destruction in total. See figure 13.

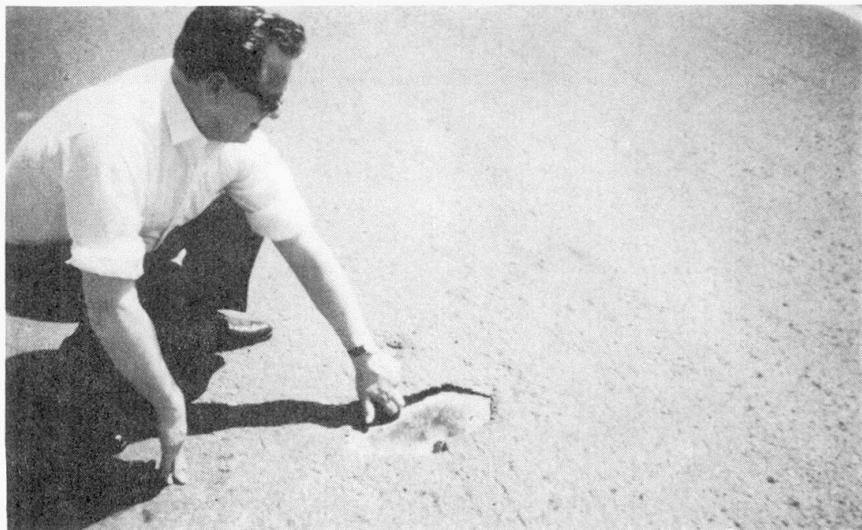
FIGRE 5. BREAKOUT OF WEARING COURSE OVER SPLICE PLATE ON CONCORDIA BRIDGE AFTER TWO YEARS OF SERVICE

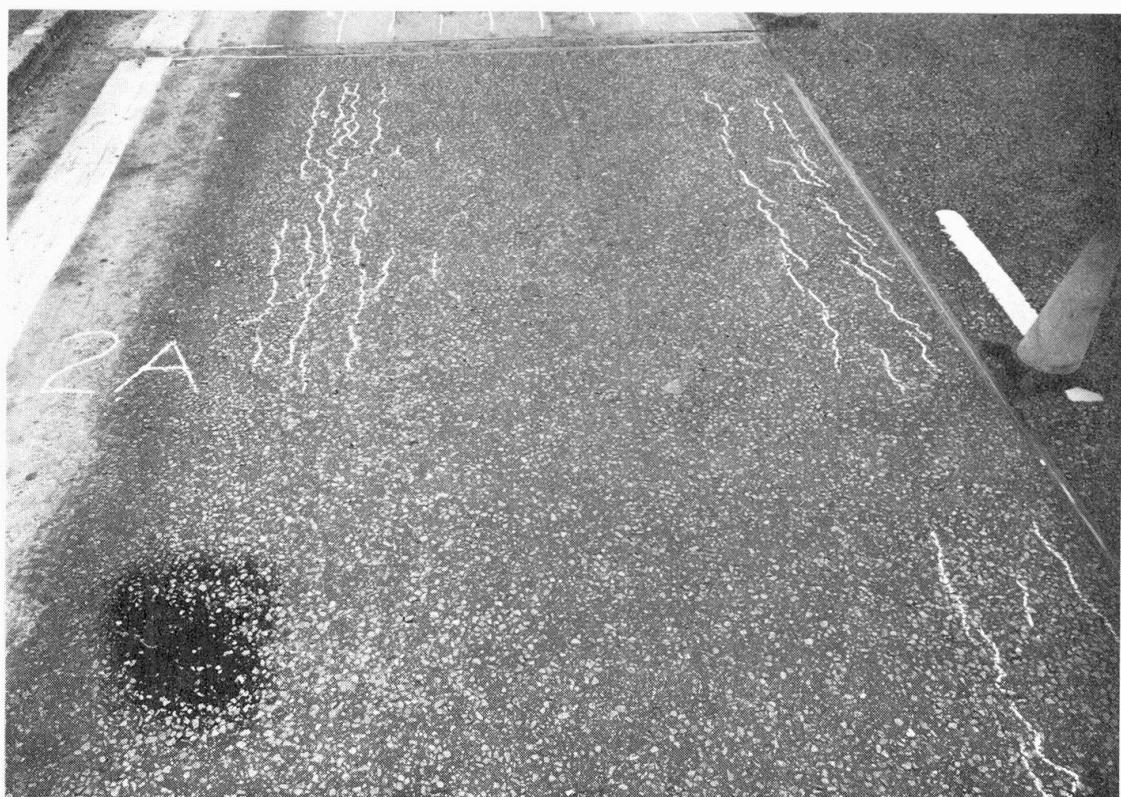
FIG. 4 CRACKING ON ROLLED ASPHALT OVER GRITTED EPOXY RESIN, NOVEMBER, 1967

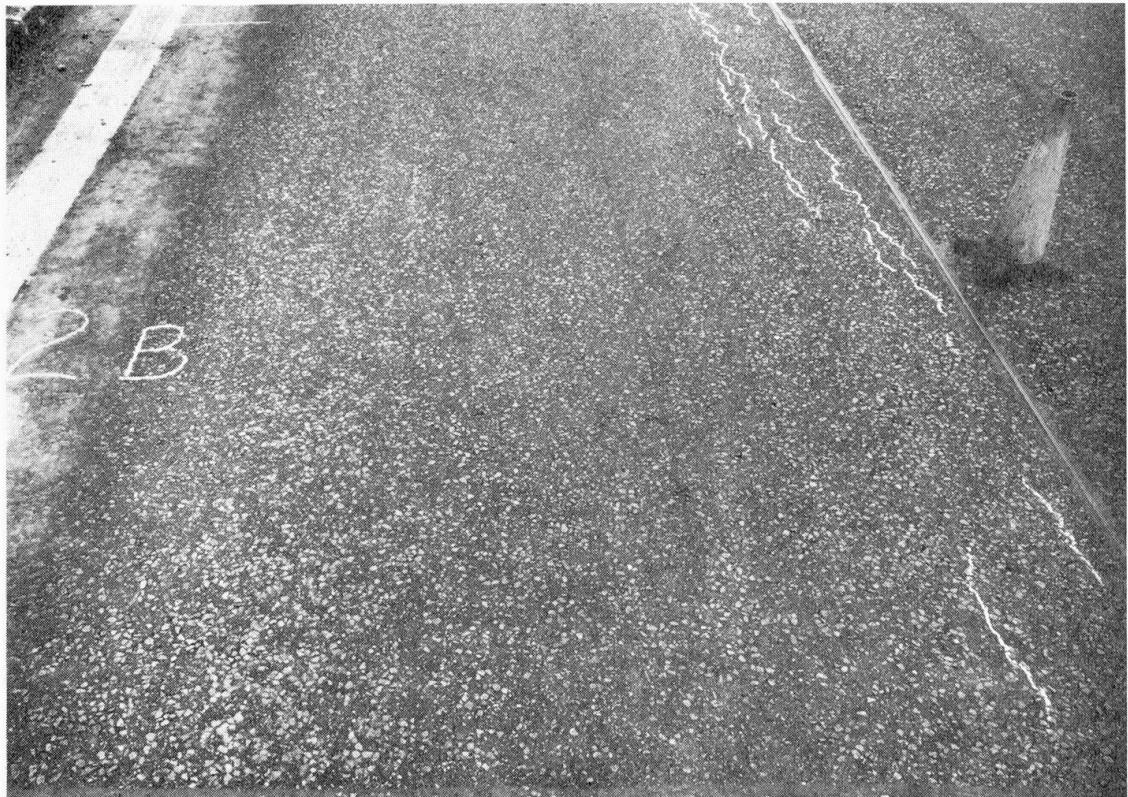
FIG. 6 CRACKING IN ROLLED ASPHALT ON FILLED RUBBER BITUMEN, NOVEMBER, 1967
