Artikel: Introductory report

INTRODUCTORY REPORT

H. THUL – F.K. REINITZHUBER
Germany

1. The Orthotropic Plate

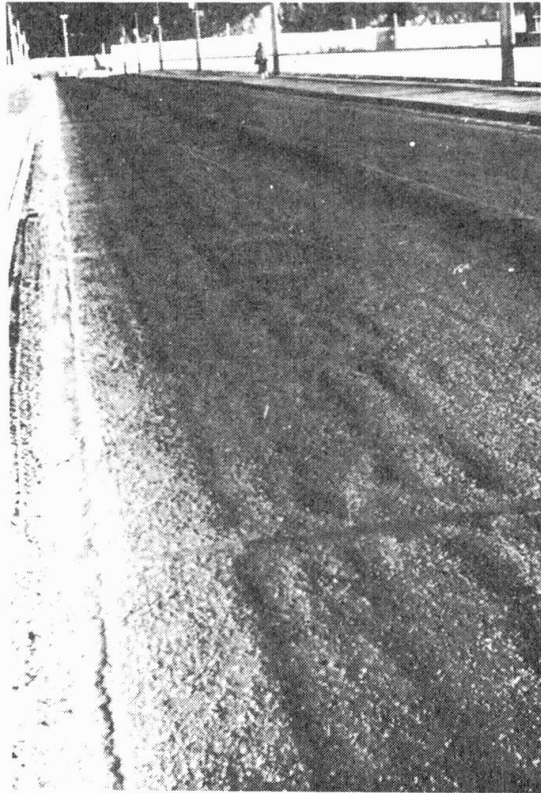
Rutting is a frequent problem, caused at high temperatures by a bitumen content either too rich or too soft. Ruts may be spaced regularly corresponding to the longitudinal stiffeners. See figure 6.

Figure 6: Rutting (transverse waving)

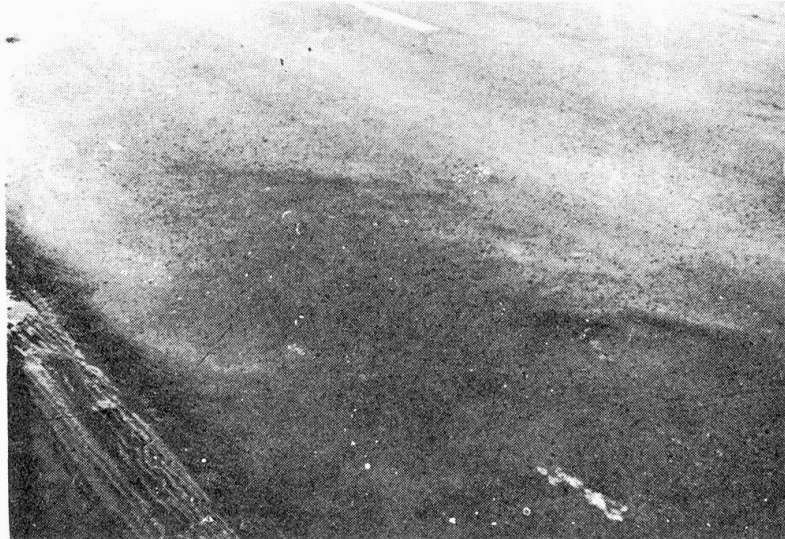
The surfacing may, however, have become so soft that, due to traffic, lateral shoving occurs over long distances forming wide ruts superimposed on the aforementioned undulations, spaced like the stiffeners. See figure 7.

Figure 7: Big-sized shoving,
up to 7 cm deep

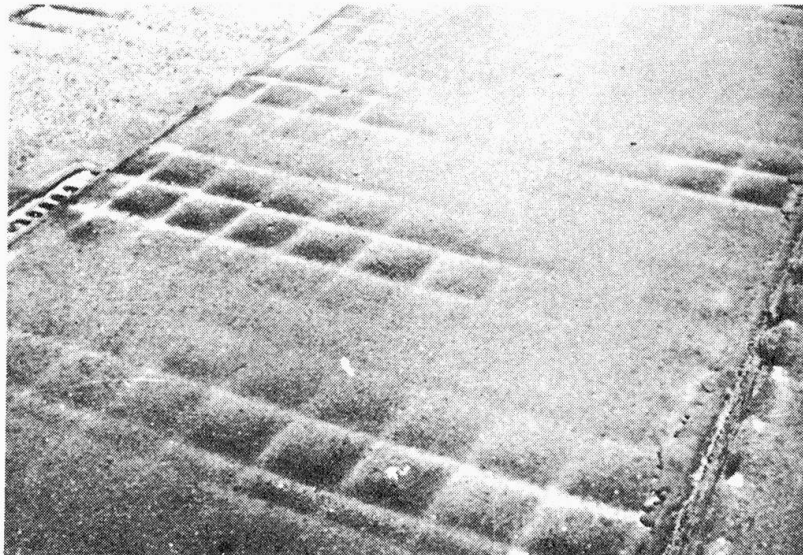
Any surfacing will be destroyed within short time due to insufficient shear strength or bond. It has been tried, therefore, to dowel the surfacing to the steel plates by mechanical means, e.g. by welding mesh reinforcing steel on studs to the plate. This method has not been successful. Due to different thermal expansions of steel and asphalt square targets in size of the mesh appeared on the top surface, presumably indicating insufficient bond. Small furrows up to 2,5 cm = 1" deep may develop atop of the mesh rods, causing cracks in harder types of asphalt and, eventually, destruction in total. See figure 13.

Figure 13: Steel mesh anchoring;
plasterlike top surface
