## INTRODUCTORY REPORT

H. THUL – F.K. REINITZHUBER  
Germany

### 1. The Orthotropic Plate

#### 4. Nature of Damage and its Causes

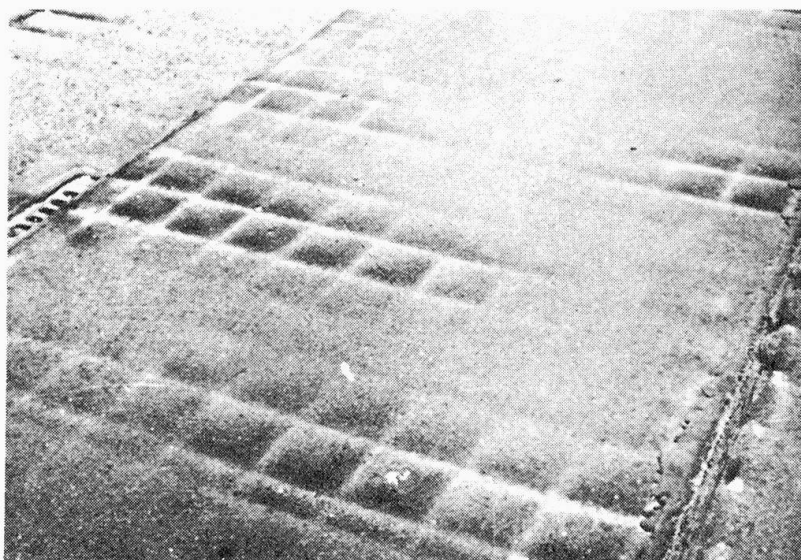
Any surfacing will be destroyed within short time due to insufficient shear strength or bond. It has been tried, therefore, to dowel the surfacing to the steel plates by mechanical means, e.g. by welding mesh reinforcing steel on studs to the plate. This method has not been successful. Due to different thermal expansions of steel and asphalt square targets in size of the mesh appeared on the top surface, presumably indicating insufficient bond. Small furrows up to 2,5 cm = 1" deep may develop atop of the mesh rods, causing cracks in harder types of asphalt and, eventually, destruction in total. See figure 13.

Figure 13: Steel mesh anchoring;  
plasterlike top surface
