IABSE AIPC IVBH SEMINAR on:

«CONCRETE STRUCTURES SUBJECTED TO TRIAXIAL STRESSES»
17th-19th MAY, 1974 - ISMES - BERGAMO (ITALY)

The Effects of Localised Steady and Cyclic Over-Heating in the Oldbury Concrete Pressure Vessels

I.W. HORNBY B. Sc. (Eng.), C. Eng., M.I.C.E. Central Electricity Research Laboratories, Leatherhead, U.K. G.D.T. CARMICHAEL B.Sc. PhD., C. Eng., M. I. Mech. E. Berkely Nuclear Laboratories, Berkeley, U.K. J. IRVING B. Sc. Generation Development and Construction Division, Cheltenham, U.K.

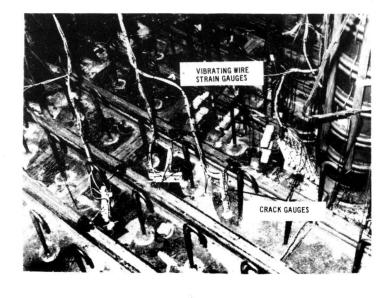
The model is shown diagrammatically in Fig. 3 and Fig. 4, shows the model before concreting. It consisted of a cylindrical disc of concrete 365.8 cm diameter and 152.4 cm thick, mounted with its central axis vertical. The bottom of the concrete was faced with a 12.7 mm thick steel liner, attached to the concrete with 38.1 cm long hook bolts at 30.5 cm equipitch. Fins 10.2 cm high were welded at right angles to the liner at 30.5 cm centres on which were mounted the pairs of cooling water pipes. These ran from north to south across the disc, except for the central pair which curved round the east side of the central penetration.

FIG. 4 VIEW OF MODEL DURING CONSTRUCTION, SHOWING INSTRUMENTATION

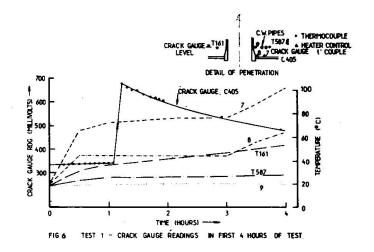
One pair of crack gauges showed a significant change in reading 65 minutes after the start of the first test. A plot of one of these gauge readings is shown in Fig. 6. The readings indicated the formation of a crack wider than 0.5 mm which decreased to zero as the test proceeded.

- Fig. 1 Oldbury vessel R1 Sections considered in preliminary calculations.
- Fig. 2 Oldbury vessel R1 Approximate stress histories at the inside face of the vessel at sections shown in Figure 1.
- Fig. 3 General arrangement of model.
- Fig. 4 View of model during construction showing instrumentation.
- Fig. 5 Vibrating wire strain and moisture gauge positions.
- Fig. 6 Test 1 Crack gauge reading in first 4 hours of test.

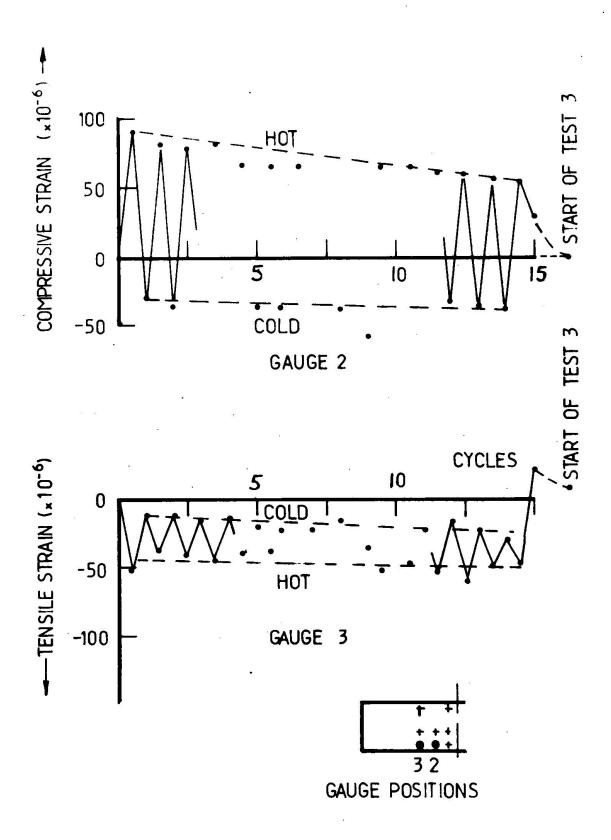
The strain variation at two gauge positions, at 24 hour intervals, during this test are shown in Fig. 9.

FIG.9 TEST 2 - RECORDED STRAINS AT GAUGES 2
AND 3 AT 24 HOUR INTERVALS

Very little strain change was recorded between the beginning and end of the test. Most gauges showed a trend in the tensile direction the maximum being 35 x 10⁻⁶ strain units. Results from two of the gauges in the zone of the crack (Nos 2 and 3) are shown in Fig. 9 and show no residual strain soon after the end of the test. These plots are again illustrated in Figs. 11 and 12. An interesting change occurred at the position of gauge 2. The thermal strain became compressive during the heating up part of the cycle whereas it was tensile during test 1 (Fig. 11). It is thought that this anomalous behaviour was due to the change of temperature distribution resulting from the absence of cooling water flow in the pipes mentioned above.

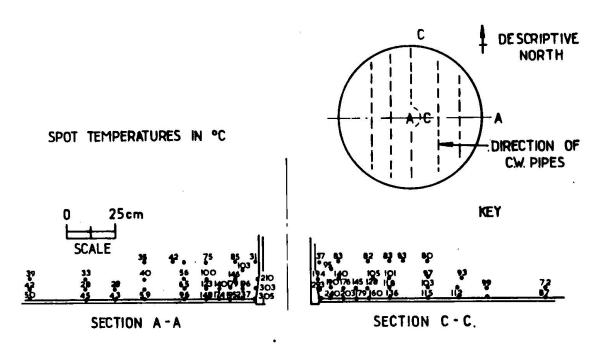
Steady state temperatures recorded by the thermocouples are shown in Fig. 10.

FIG. 10 TEST 3 TEMPERATURES IN THE MODEL AVERAGED FROM VALUES AT DAYS 21, 22, 24, AND 28.

During test 3 the maximum temperature applied to the model was 305°C at the junction of the main liner and penetration. As in test 2, because of the isolated central cooling pipes the high temperature zone extends more deeply into the concrete than would occur with full cooling capacity. This test, therefore, simulates not only the effect of a high temperature hot-spot but also failure of the cooling water supply local to the hot-spot.

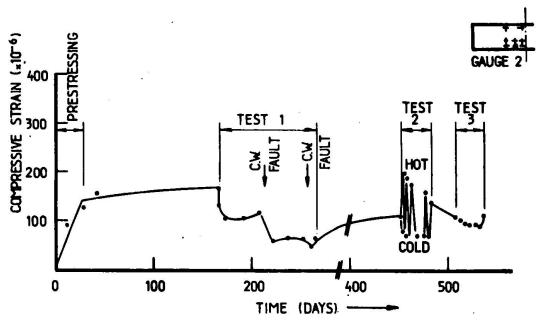
The strain changes occurring in the hoop gauges adjacent to the central penetration are shown in Figs. 11 and 12. These figures also show the total strain history of these two gauges during the three tests.

FIG.11 RECORDED STRAINS AT GAUGE 2 OVER COMPLETE HISTORY OF MODEL.

The strains which occurred in test 3 show little change during the heated period. It can be seen from Figs. 11 and 12 that there was little change in strain between the end of test 1 and the end of test 3. There was, therefore, little additional permanent deformation in the model caused by either thermal cycling or over-heating.

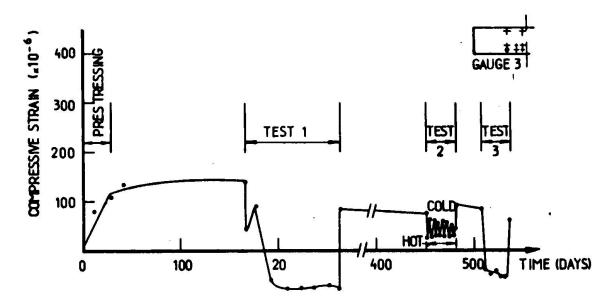
FIG 12 RECORDED STRAINS AT GAUGE 3 OVER COMPLETE HISTORY OF MODEL

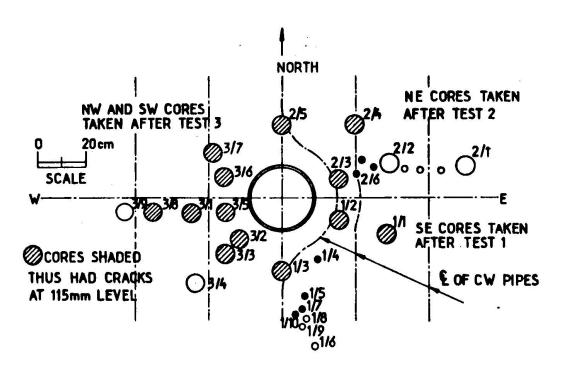
FIG.13 POSITIONS OF CORES TAKEN FROM MODEL

The cores taken during the first test included ones which penetrated the central pair of cooling pipes (see Fig. 13 and position of core 1/3). For the second test these pipes were isolated and consequently the concrete temperatures local to the central penetration were higher than normal. The conditions imposed on the concrete in this test were therefore more arduous than those experienced in the Oldbury vessel. (See Section AA of Fig. 7).

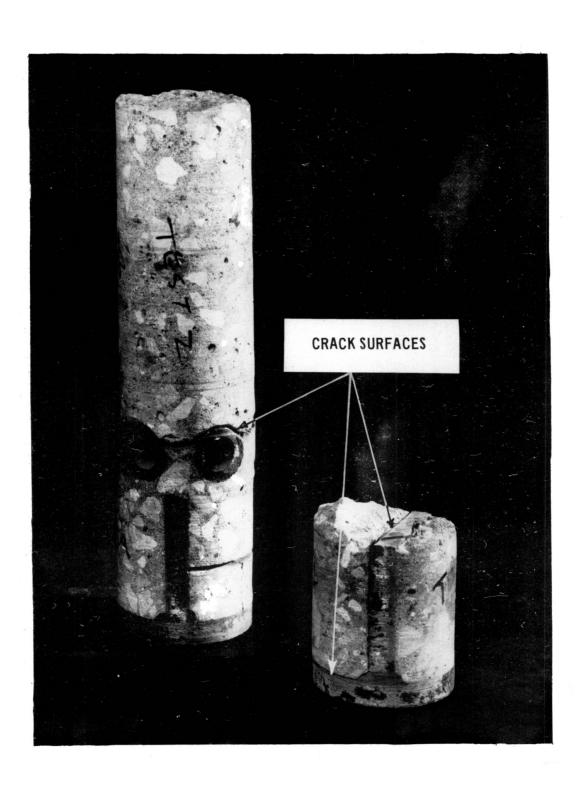
The cores taken after the test confirm the presence of the horizontal crack at a similar level to that found in test 1. This crack is clearly shown in Fig. 14. The extent of the crack in the NE quadrant after test 2 was similar to that in the SE quadrant in test 1. It is therefore considered that the original crack had not extended as a result of the thermal cycling. The presence of the hairline cracks in cores 2/3 and 2/5 is thought to be due to shrinkage induced by moisture movement.

FIG. 14 CORES 1/3 (RIGHT) AND 2/5 SHOWING CRACK SURFACES
