## The Effects of Localised Steady and Cyclic Over-Heating in the Oldbury Concrete Pressure Vessels

I.W. HORNBY B. Sc. (Eng.),  
C. Eng., M.I.C.E.  
Central Electricity Research  
Laboratories, Leatherhead, U.K.

During commissioning tests for Oldbury Nuclear Power Station it was found that 'hot-spots' with temperatures in excess of design values occurred in the concrete at a small number of positions immediately behind the concrete pressure vessel liner. An experimental investigation was conducted to ascertain the seriousness of damage, if any, to the liner and concrete which would result from these hot-spots.

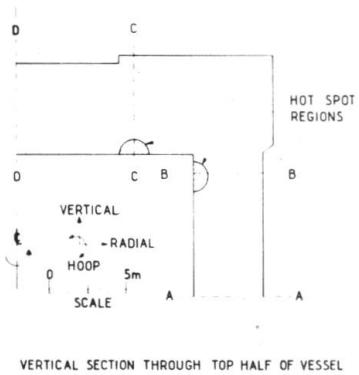
FIG. 1. OLDBURY VESSEL - SECTIONS CONSIDERED IN THE PRELIMINARY CALCULATIONS

A-A	MID-WALL
B-B	UPPER BOILER INSTRUMENT PENETRATION
C-C	CARBON SHIELD BLOCK
D-D	CENTRE OF TOP SLAB

Stresses in the vessel at the four positions shown in Fig. 1 were compared for the six loading conditions detailed below. At two of these positions there were several hot-spots whilst, for comparison, the other two positions were in areas operating under normal conditions.

- A Mid wall
- B Upper boiler instrument penetration (hot-spot of 180°C)
- C Carbon shield block (hot-spot of 90°C)
- D Centre of top slab
