## The Effects of Localised Steady and Cyclic Over-Heating in the Oldbury Concrete Pressure Vessels

I.W. HORNBY B. Sc. (Eng.),  
C. Eng., M.I.C.E.  
Central Electricity Research  
Laboratories, Leatherhead, U.K.

G.D.T. CARMICHAEL B.Sc.  
PhD., C. Eng., M.I. Mech. E.  
Berkely Nuclear Laboratories,  
Berkeley, U.K.

J. IRVING B. Sc.  
Generation Development  
and Construction Division,  
Cheltenham, U.K.

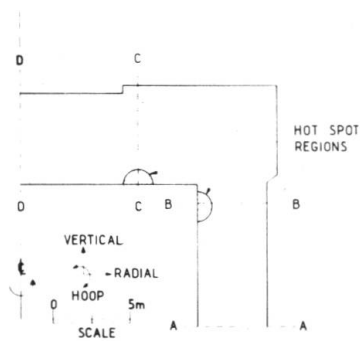
FIG. 1. OLBURY VESSEL - SECTIONS CONSIDERED IN THE PRELIMINARY CALCULATIONS

Stresses in the vessel at the four positions shown in Fig. 1 were compared for the six loading conditions detailed below. At two of these positions there were several hot-spots whilst, for comparison, the other two positions were in areas operating under normal conditions.

- A Mid wall
- B Upper boiler instrument penetration (hot-spot of 180°C)
- C Carbon shield block (hot-spot of 90°C)
- D Centre of top slab

VERTICAL SECTION THROUGH TOP HALF OF VESSEL

- A-A MID-WALL
- B-B UPPER BOILER INSTRUMENT PENETRATION
- C-C CARBON SHIELD BLOCK
- D-D CENTRE OF TOP SLAB

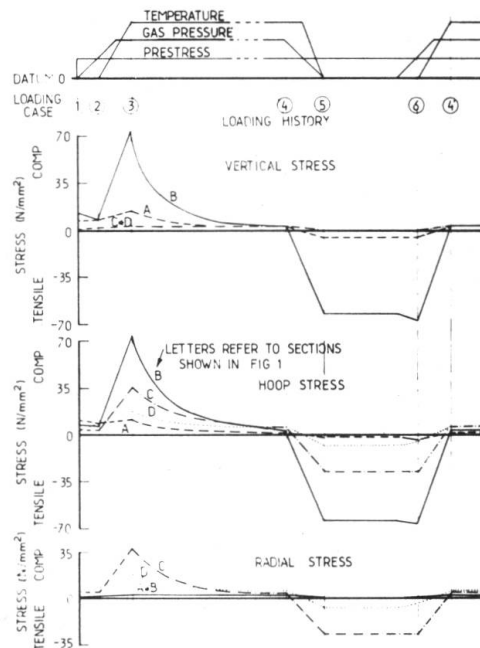
FIG. 2. OLBURY VESSEL - APPROXIMATE STRESS HISTORIES AT THE LINER FACE OF VESSEL SECTIONS A-A, B-B, C-C, AND D-D SHOWN IN FIG. 1

The computed radial, hoop and vertical stress histories at the four positions are shown in Fig. 2.

It is apparent from Fig. 2 that in general there are two unavoidable critical loading conditions:-

- (a) At initial start-up (loading case 3), when high compressive stresses occur.
- (b) During the shut-down cycle (loading cases 5 and 6), when high tensile stresses occur.

The worst tensions actually occur when repressurising after a shut-down (loading case 6). The results in Fig. 2 show that under all loading conditions the upper boiler instrument penetration (position B), sustains the highest stresses. For this reason the model was chosen to simulate this position with a hot-spot at approximately  $180^{\circ}\text{C}$ . This simulation would also show the effects of stress concentration due to the penetration. The analysis of the vessel showed that the highest stresses occur in the hoop and vertical directions, the maxima being very similar in these two directions. The choice of a model with equi-biaxial stresses approximately equal to these stresses was therefore justifiable.

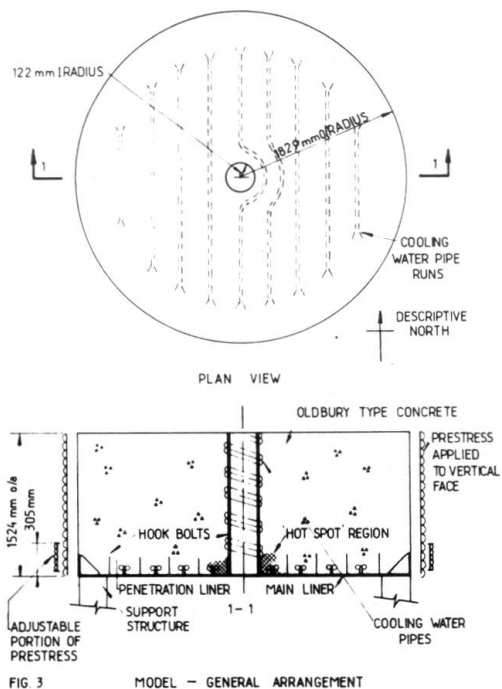
FIG. 3. MODEL - GENERAL ARRANGEMENT

The model is shown diagrammatically in Fig. 3 and Fig. 4, shows the model before concreting. It consisted of a cylindrical disc of concrete 365.8 cm diameter and 152.4 cm thick, mounted with its central axis vertical. The bottom of the concrete was faced with a 12.7 mm thick steel liner, attached to the concrete with 38.1 cm long hook bolts at 30.5 cm equipitch. Fins 10.2 cm high were welded at right angles to the liner at 30.5 cm centres on which were mounted the pairs of cooling water pipes. These ran from north to south across the disc, except for the central pair which curved round the east side of the central penetration.

The boiler instrument penetration was 'sleeve' reinforced with 27.3 cm O.D. steel tube, 14.3 mm thick, thickened locally where it was welded to the liner. The tube was water cooled by two spirally wound pipes welded to its outer surface.

The actual model chosen is illustrated diagrammatically in Fig. 3 and is described later in the paper. In order to verify further that the model was representative a separate stress analysis was undertaken. The resulting stress profiles at the simulated penetration were compared with those computed for the vessel during a typical reactor start-up/shut-down cycle. The calculations showed that a steep stress gradient behind the liner is caused by the temperature gradient between the liner and the cooling water pipes which are positioned 100 mm into the concrete. The tensile stresses predicted under loading case 6 greatly exceed the tensile strength of the concrete and cracking would be expected. The results obtained from this preliminary comparison showed that reproduction of the appropriate prestress and temperature pattern in the model would produce a similar stress and strain situation to that in the vessel.

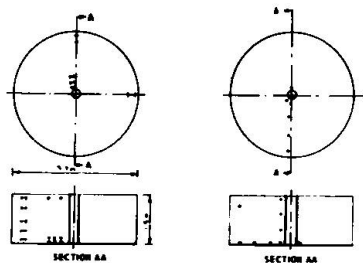
FIG. 5 VIBRATING WIRE STRAIN GAUGE (LEFT) AND MOISTURE GAUGE POSITIONS

Eighteen 'Perivale' type 641 vibrating wire strain gauges were positioned as shown in Fig. 5. The gauges were used to measure the strains occurring in the concrete during the tests.

Twelve C.E.R.L. moisture gauges, positioned as shown in Fig. 5 were used to determine the moisture gradients in the concrete during the tests.

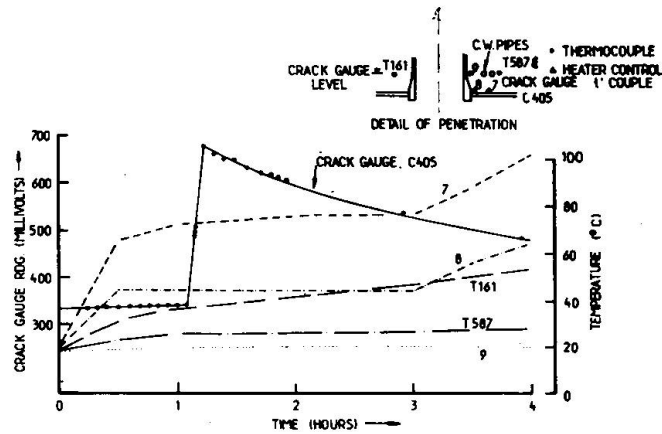
FIG. 6 TEST 1 - CRACK GAUGE READINGS IN FIRST 4 HOURS OF TEST

One pair of crack gauges showed a significant change in reading 65 minutes after the start of the first test. A plot of one of these gauge readings is shown in Fig. 6. The readings indicated the formation of a crack wider than 0.5 mm which decreased to zero as the test proceeded.

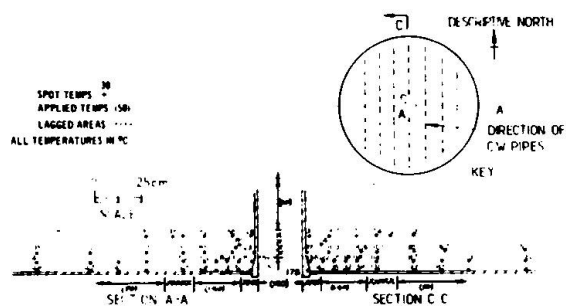
FIG. 7 TEST 2 - RECORDED TEMPERATURES AT 24 HOURS AFTER START OF TEST

The temperature distribution applied to the liner is shown in Fig. 7, which also shows the maximum temperatures recorded during the first cycle. The temperature variation at two positions in the model during one 48 hours cycle is shown in Fig. 8.

The cores taken during the first test included ones which penetrated the central pair of cooling pipes (see Fig. 13 and position of core 1/3). For the second test these pipes were isolated and consequently the concrete temperatures local to the central penetration were higher than normal. The conditions imposed on the concrete in this test were therefore more arduous than those experienced in the Oldbury vessel. (See Section AA of Fig. 7).

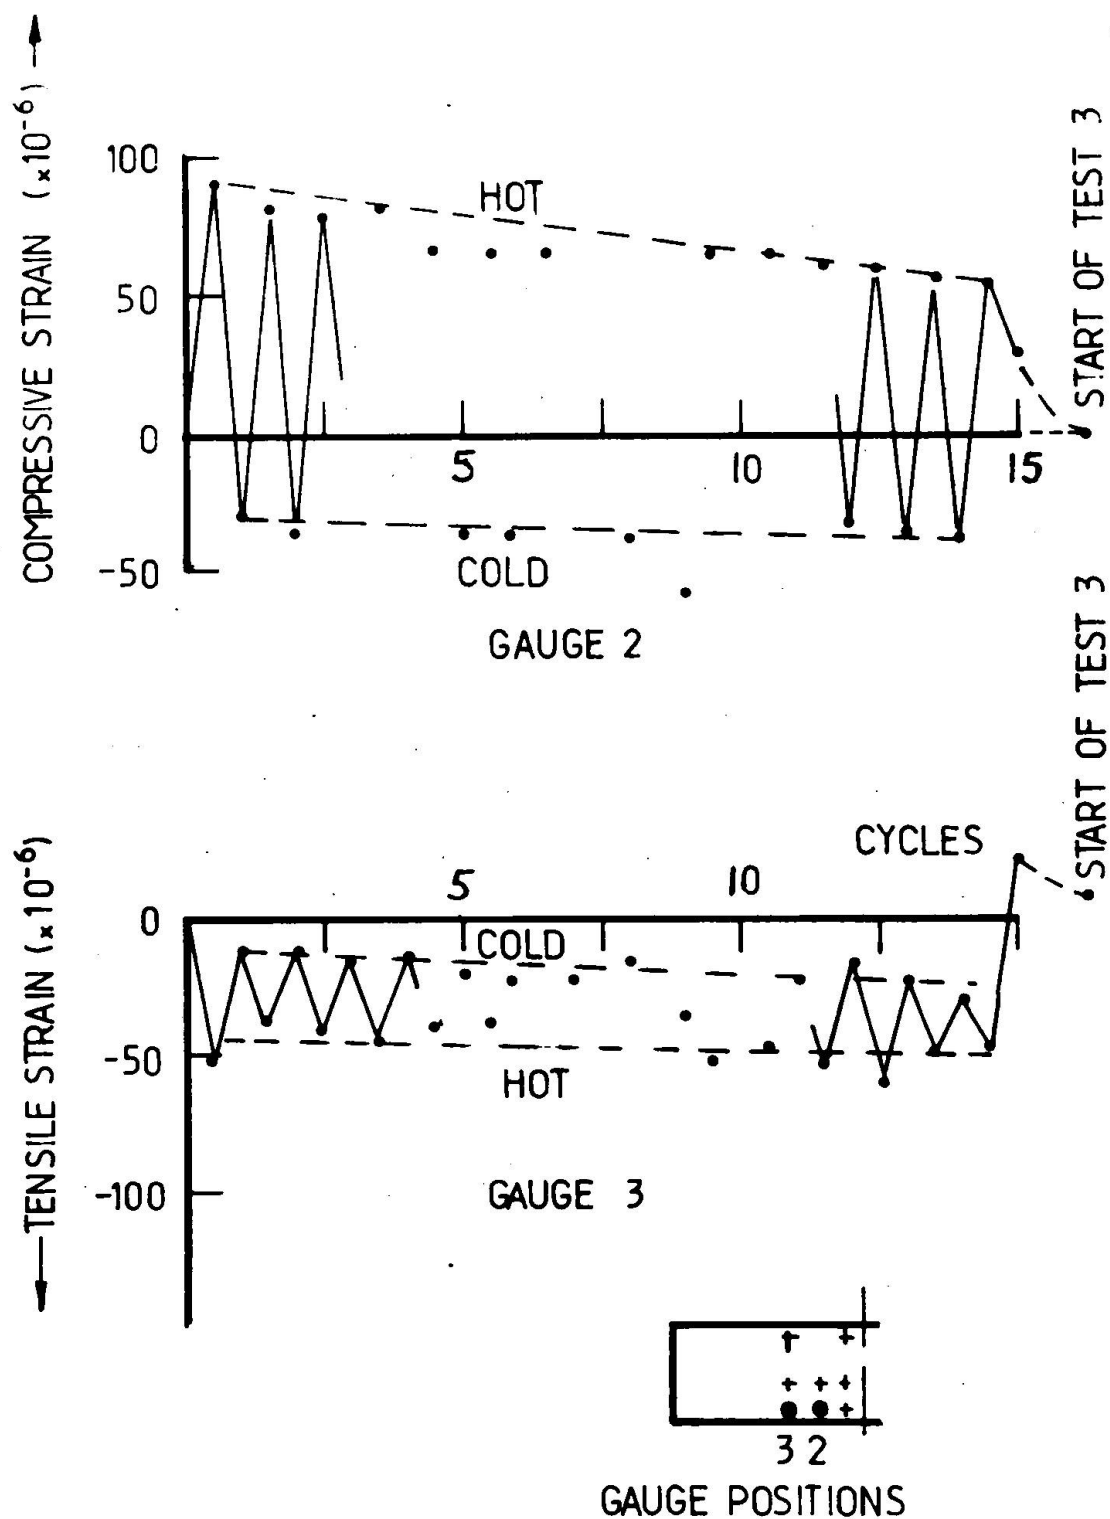
FIG. 9 TEST 2 - RECORDED STRAINS AT GAUGES 2 AND 3 AT 24 HOUR INTERVALS

The strain variation at two gauge positions, at 24 hour intervals, during this test are shown in Fig. 9.

Very little strain change was recorded between the beginning and end of the test. Most gauges showed a trend in the tensile direction the maximum being  $35 \times 10^{-6}$  strain units. Results from two of the gauges in the zone of the crack (Nos 2 and 3) are shown in Fig. 9 and show no residual strain soon after the end of the test. These plots are again illustrated in Figs. 11 and 12. An interesting change occurred at the position of gauge 2. The thermal strain became compressive during the heating up part of the cycle whereas it was tensile during test 1 (Fig. 11). It is thought that this anomalous behaviour was due to the change of temperature distribution resulting from the absence of cooling water flow in the pipes mentioned above.

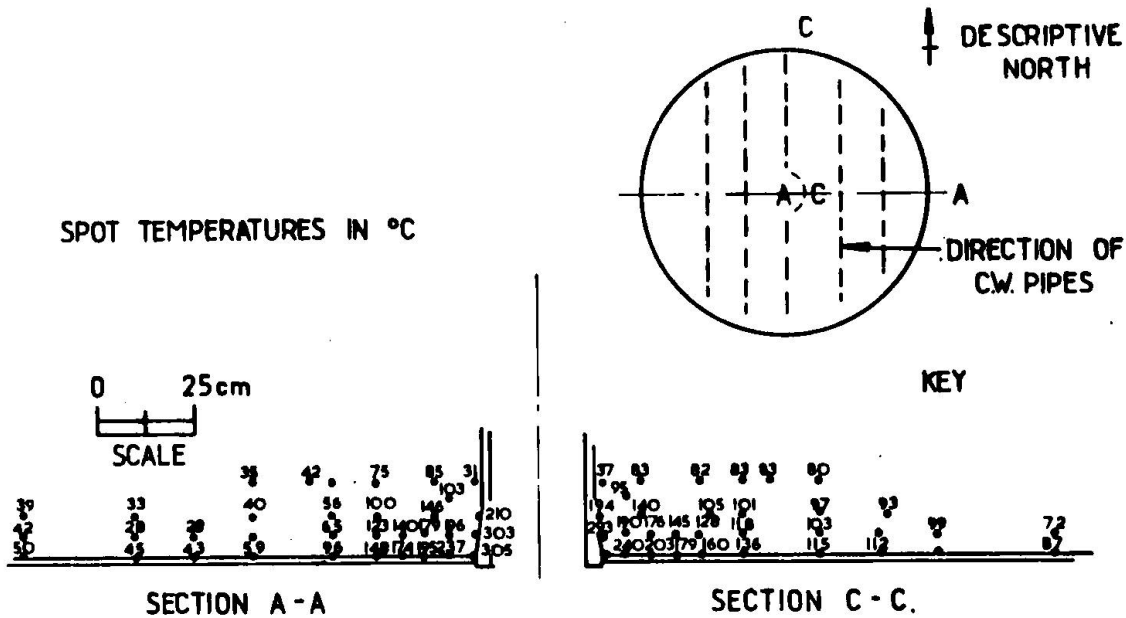
FIG. 10 TEST 3 TEMPERATURES IN THE MODEL AVERAGED FROM VALUES AT DAYS 21, 22, 24, AND 28.

Steady state temperatures recorded by the thermocouples are shown in Fig. 10.

During test 3 the maximum temperature applied to the model was  $305^{\circ}\text{C}$  at the junction of the main liner and penetration. As in test 2, because of the isolated central cooling pipes the high temperature zone extends more deeply into the concrete than would occur with full cooling capacity. This test, therefore, simulates not only the effect of a high temperature hot-spot but also failure of the cooling water supply local to the hot-spot.

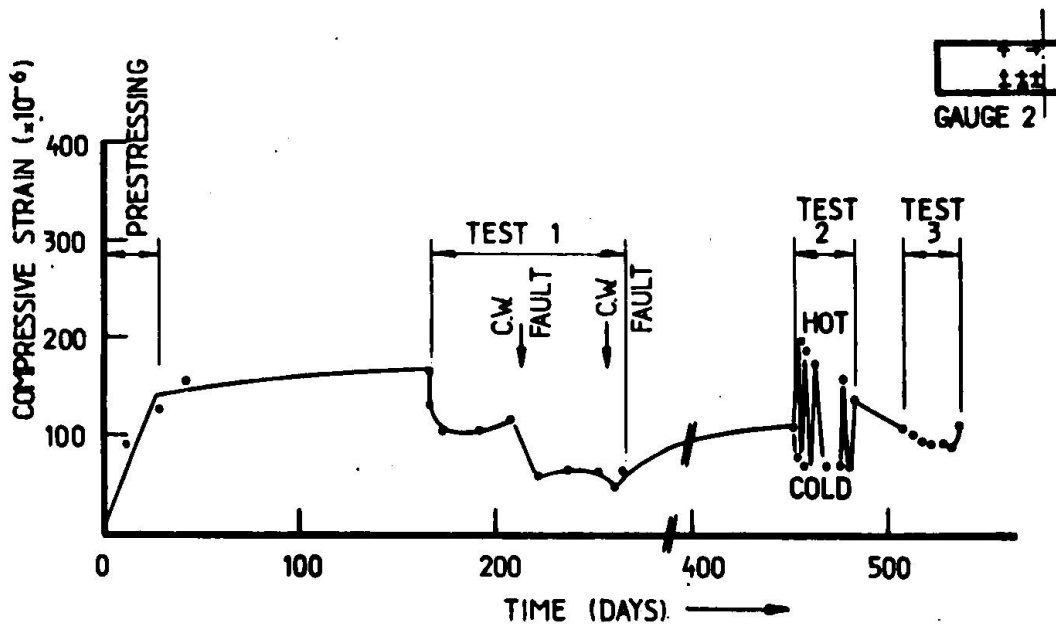
FIG. 11 RECORDED STRAINS AT GAUGE 2 OVER COMPLETE HISTORY OF MODEL.

The strain changes occurring in the hoop gauges adjacent to the central penetration are shown in Figs. 11 and 12. These figures also show the total strain history of these two gauges during the three tests.

The strains which occurred in test 3 show little change during the heated period. It can be seen from Figs. 11 and 12 that there was little change in strain between the end of test 1 and the end of test 3. There was, therefore, little additional permanent deformation in the model caused by either thermal cycling or over-heating.

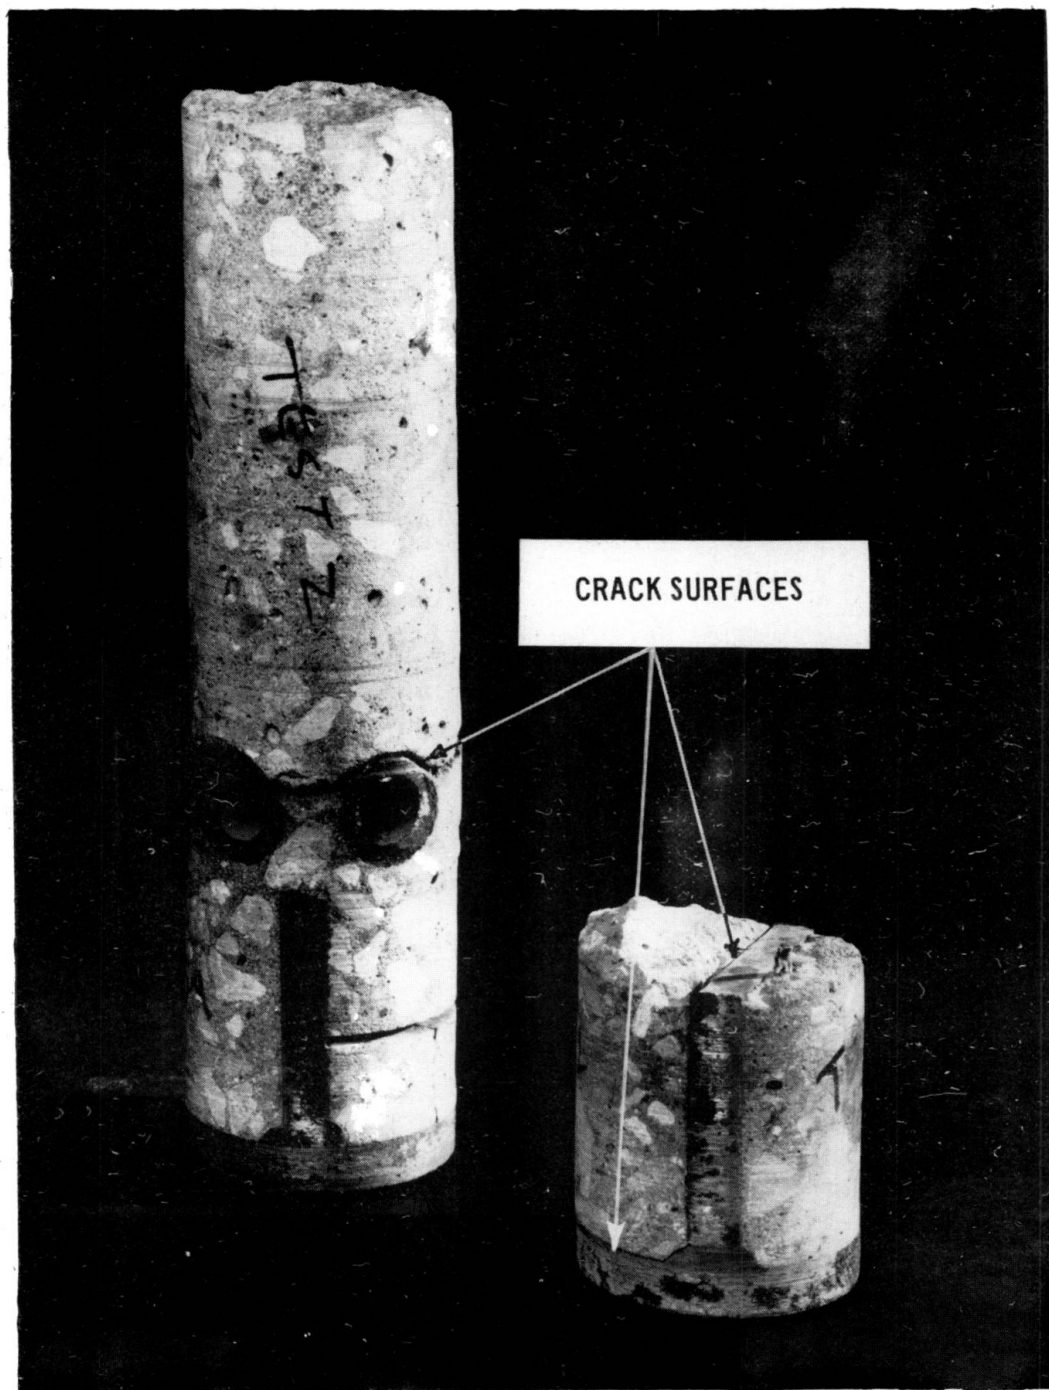
FIG. 14 CORES 1/3 (RIGHT) AND 2/5 SHOWING CRACK SURFACES

The cores taken after the test confirm the presence of the horizontal crack at a similar level to that found in test 1. This crack is clearly shown in Fig. 14. The extent of the crack in the NE quadrant after test 2 was similar to that in the SE quadrant in test 1. It is therefore considered that the original crack had not extended as a result of the thermal cycling. The presence of the hairline cracks in cores 2/3 and 2/5 is thought to be due to shrinkage induced by moisture movement.
