SOME FUNDAMENTAL ASPECTS OF EARTHQUAKE ENGINEERING

by MIHAIL IFRIM, Professor, Ph.D., Civ.Eng.,
Head of Department of Theoretical and Applied Mechanics
Faculty of Civil Engineering
Bucharest, Romania

The work includes a series of observations on the effects of recent strong earthquakes and on some measures which become essential in earthquake engineering, and includes aspects related to: concept and design, seismic code of regulations, soil influence, numerical analysis, construction, research and professional education.

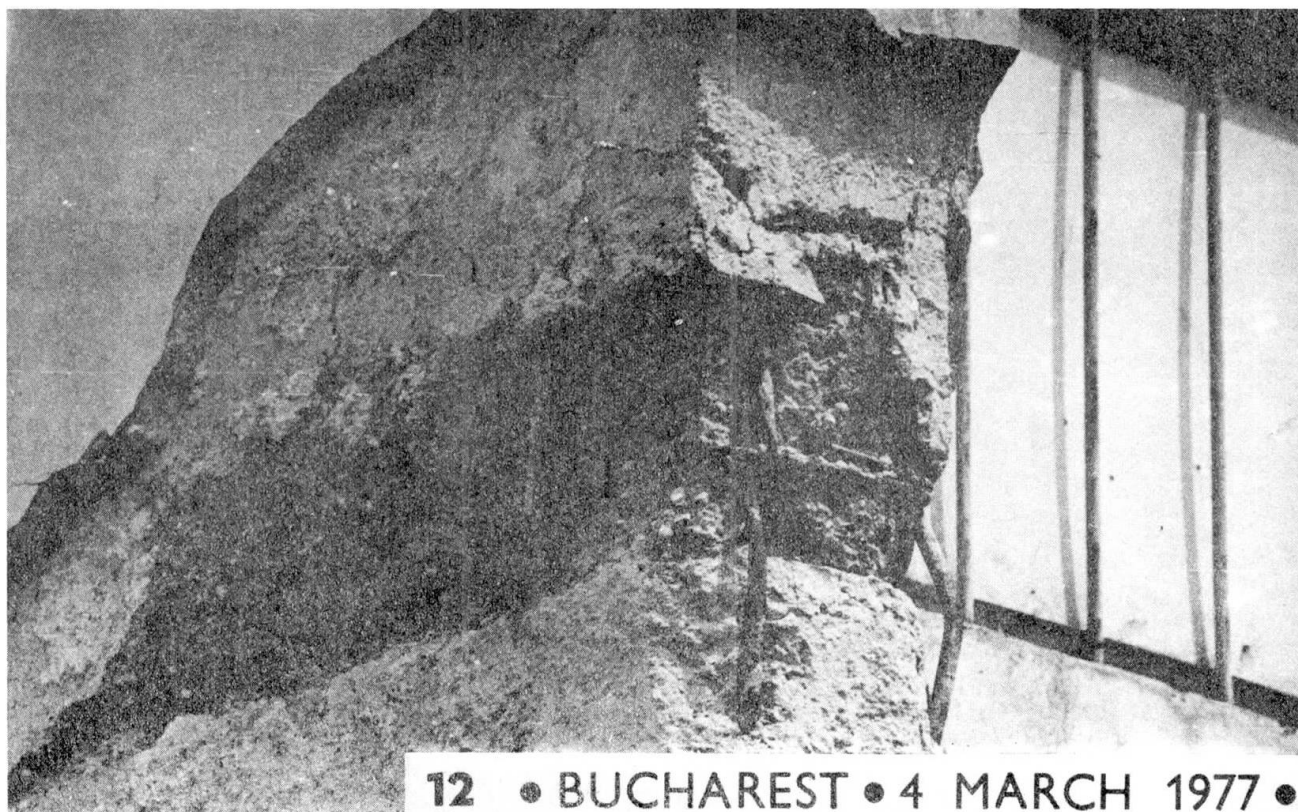
12

- Photo 12,13 - Local damage at the extremity of a shear wall due to strong compression
- Photo 14,15 - Partial collapse of nonseismic designed buildings (built in the '30's)

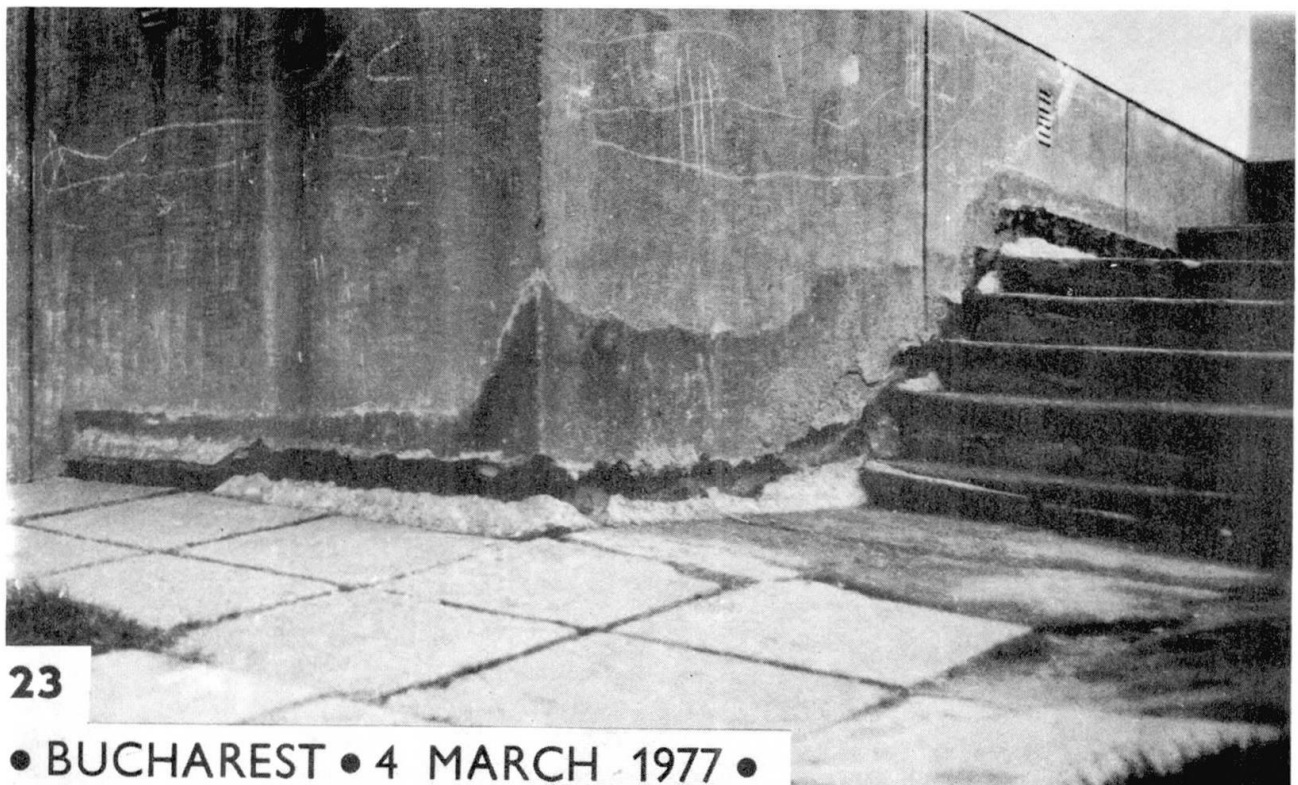
- Photo 23 - Rocking effect due to soil-structure interaction.
