SOME FUNDAMENTAL ASPECTS OF EARTHQUAKE ENGINEERING

by MIHAIL IFRIM, Professor, Ph.D., Civ.Eng.,
Head of Department of Theoretical and Applied Mechanics
Faculty of Civil Engineering
Bucharest, Romania

The work includes a series of observations on the effects of recent strong earthquakes and on some measures which become essential in earthquake engineering, and includes aspects related to: concept and design, seismic code of regulations, soil influence, numerical analysis, construction, research and professional education.

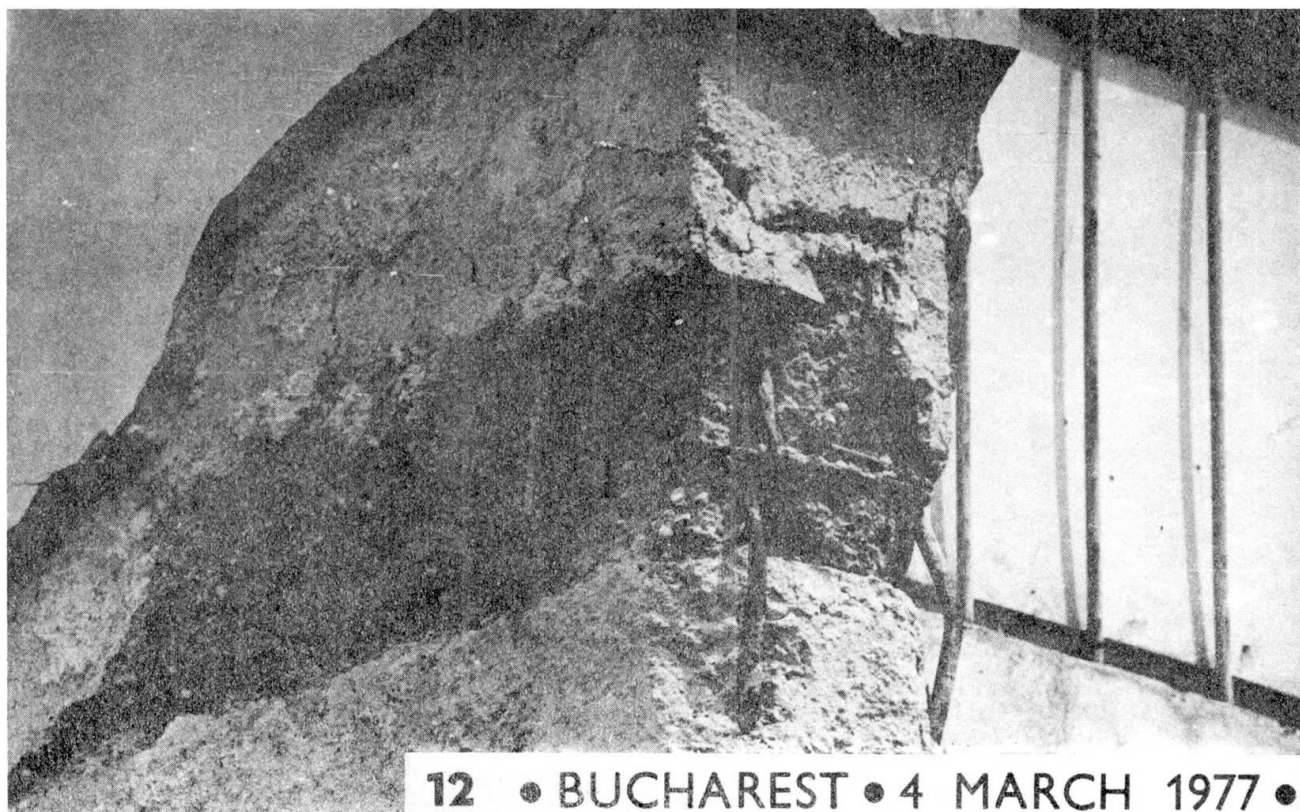
12

- Photo 12,13 - Local damage at the extremity of a shear wall due to strong compression
- Photo 14,15 - Partial collapse of nonseismic designed buildings (built in the '30's)

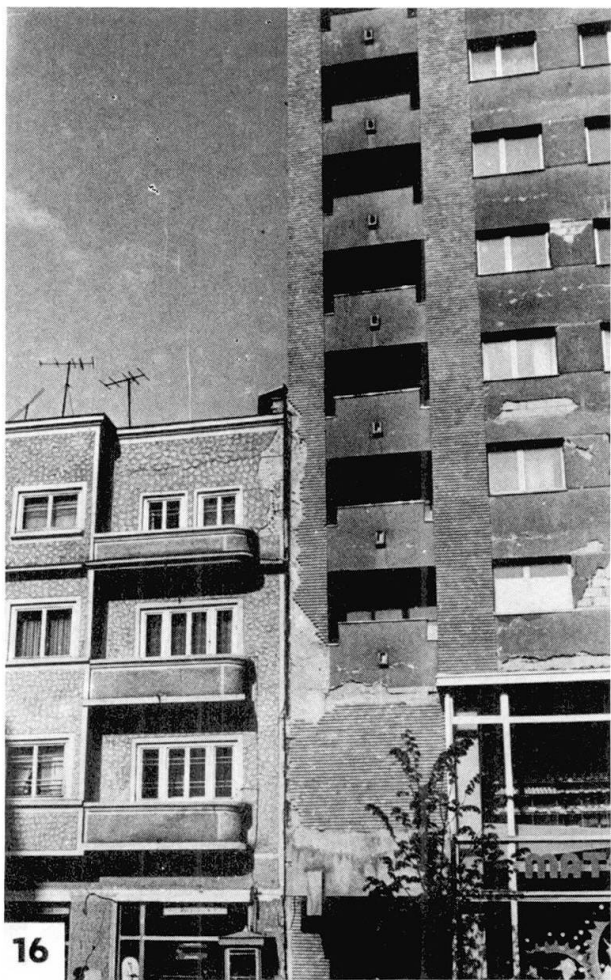
16

- Photo 16,17 - Span of separation between buildings after the earthquake
- Photo 18,19 - Dislocation of frontispiece with great inertial effect in a monumental building

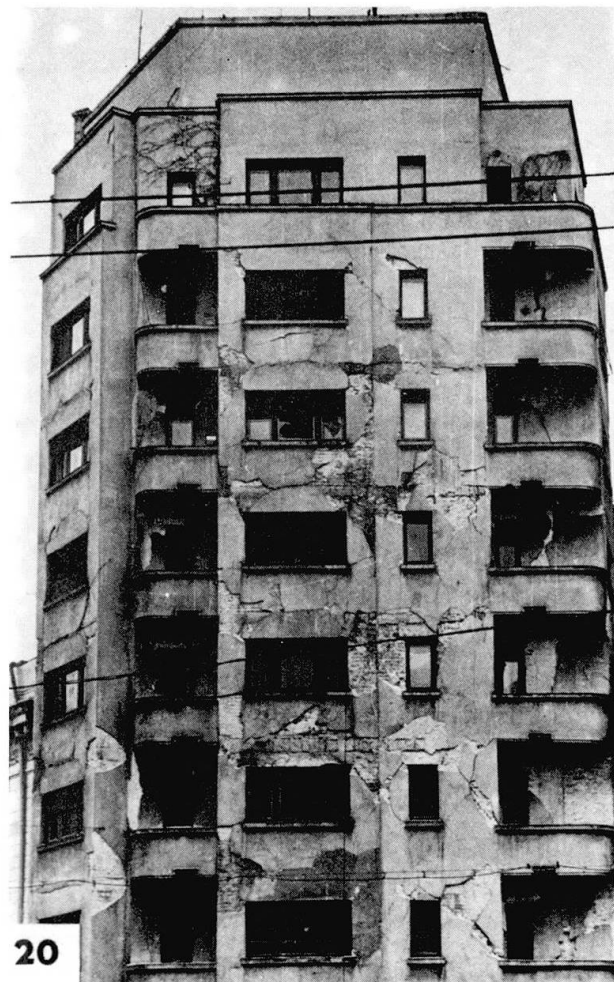
- Photo 20 - Damage in masonry walls of a structure in concrete frames (built in the '30's)
- Photo 21,22 - Typical crack in bearing walls (built in the '30's)

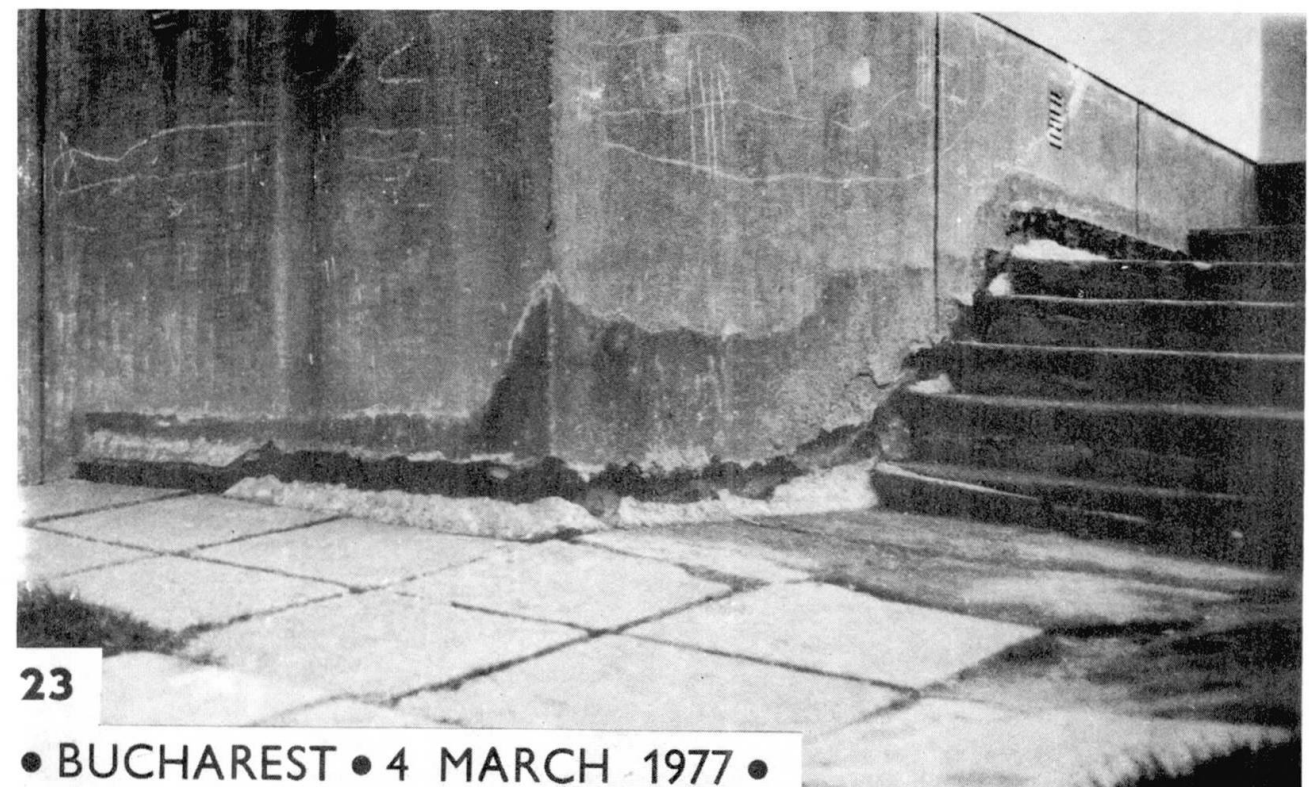
- Photo 23 - Rocking effect due to soil-structure interaction.
