**Zeitschrift:** IABSE reports of the working commissions = Rapports des

**Rubrik:** Session III: Effects of recent earthquakes in Italy and other countries

# **Effects of Recent Earthquakes** in Italy and Other Countries

STRUCTURAL BEHAVIOUR OF THE DAMAGED BUILDING DURING THE FRIULI EARTHQUAKES BETWEEN MAY 6 AND SEPTEMBER 15, 1976

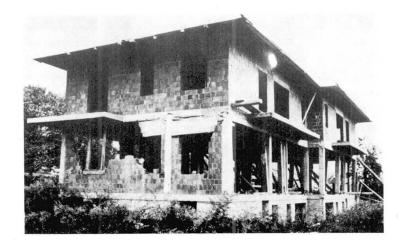
Figure 1: (after May 6th): Uncompleted building in Gemona with groundfloor open on three sides and living floor above. The supporting framework of the groundfloor consists of reinforced concrete columns, partitioned on one of the narrow sides by brick walls. The upper floor is exclusively brick. Due to the ear hquake load, the building rotated around the partitioned transverse wall in the groundfloor. The fixing points of the columns were badly damaged in the cellar and groundfloor ceilings. The brick walls on the transverse side on the groundfloor were slighthly cracked: the upper floor remained undamaged.

The buildings which were undamaged or which suffered only minor plaster cracks, showed no further damage or, at the most, single wall cracks. Their supporting structure withstood this earthquake load and can be considered sufficiently earthquake-proof against similar earthquakes. The building with severely cracked brick walls suffered in most cases even more masonry damage, due to their weakened condition (Figures 1 and 2).

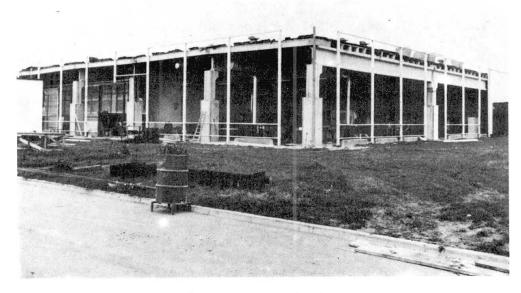
Figure 11: (after May 6th): Factory building near Artegna. Severe displacement of the prefabricated reinforced concrete framework together with distortion of the foundation and tilting of a corner column. A large number of the only lightly secured reinforced concrete façade elements were thrown off.

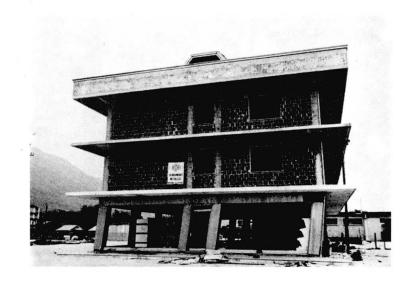
Figure 12: (after September 15th): Factory building near Artegna, after repair, without further earthquake damage. In order to increase the carrying capacity, the concrete columns were surrounded with a 15 cm strong concrete sheath. The earthquake load was reduced by replacing the heavy concrete façade elements by a Tight metal façade.

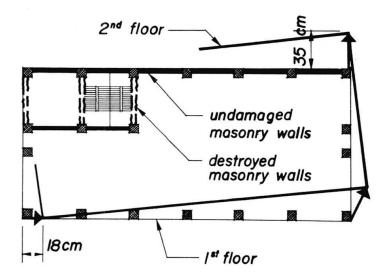
The ground plan of the dwelling house with the open ground floor shown before. Twisting of the building around the staircase stiffened with masonry walls.

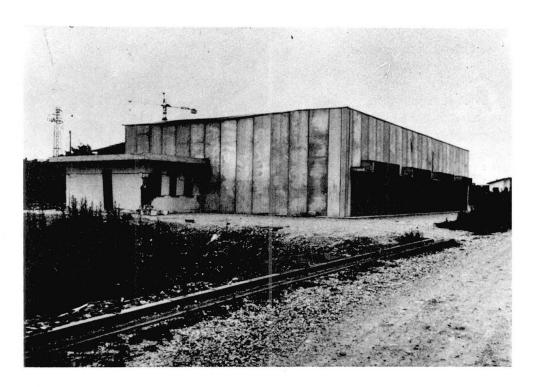
Figure 16: Prefabricated storage shed with brick annex in Gemona. Side wall panels slightly caved in by impact with rigid annex. Upper part of the annex shorn off and pushed over by the impact force due to insufficiently wide joints.

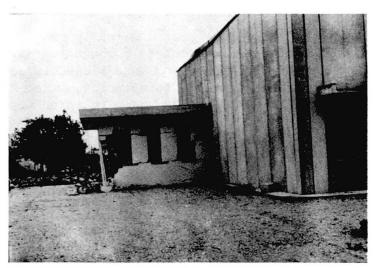
Figure 18: Prefabricated storage shed in Gemona as shown before. The supporting frames and the wall panels generally not damaged because of energy absorption in the material of the joints between the single panels.

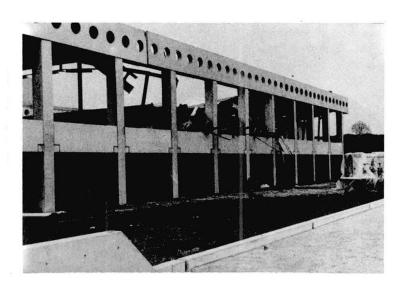
Figure 19: Heavily damaged prefabricated factory shed near Osoppo with roof girders fallen down. Friction joints insufficient to provide structural stability.

If prefabricated structures are designed only in accordance with the Standards laid down for earthquake forces or these forces are overlooked altoghether, then the result is greatly underdimensioned connections of the structure elements Load bearing connexions should be properly designed against the expected dynamic forces. Purely friction-type joints are no longer sufficient to transfer the forces that arise, even from only weak earthquake loads (Figure 19).

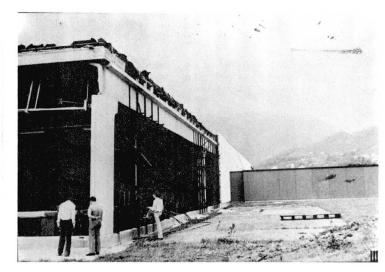
Figure 20: Prefabricated factory shed near Artegna. Wall panels fallen out during the earthquake because of insufficient fixation.

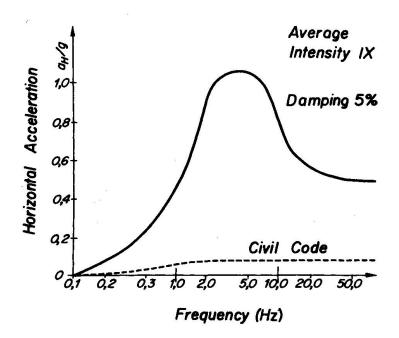
Figure 21: Horizontal ground acceleration for earthquakes of intensity IX (MSK) (U.S. Atomic Energy Commission, WASH 1255). The dashed line gives the disign ground acceleration according to the conventional aseimic building code.

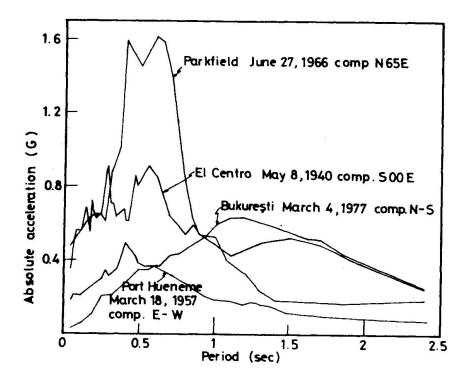
Fig. 2 Absolute acceleration response spectra for damping 5% of critical

In Bucharest, a ground surface acceleration of 0.20 g(component N-S) was recorded by SMAC instrument, while at a distance of about 700 km in Nis, Yugoslavia, a ground acceleration of 0.04 g, E-W component was recorded by SMA-1 instrument. Interesting to be mentioned here is the frequency content of this earthquake if it is compared to some other earthquakes (Fig. 2).

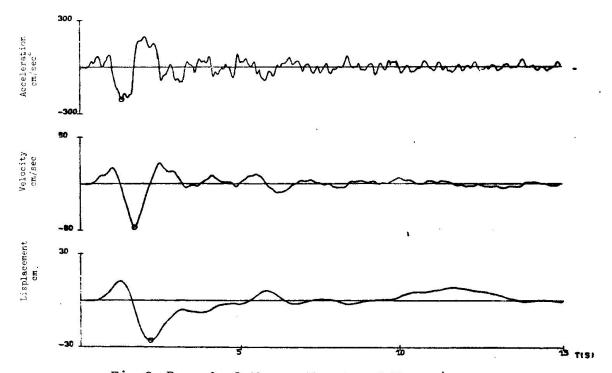
Fig. 2 Record of the earthquake of March 4,1977 - INCERC

- the maximum values of the ground motion for the N-S direction were:  $a_m = 208.2$  cm/sec<sup>2</sup> (0.21 g),  $v_m = 74.9$  cm/sec and  $d_m = 25.4$  cm/sec.
- the mode shape of the predominant pulses has a period larger than 1.0 sec.
- the response acceleration spectra has an upper ceiling with periods of 0.5 to 2.0 and a lower ceiling with periods larger than 3.0 sec. These three characteristics made the conditions of the structures rather unfavourable with periods larger than 0.5-0.6 sec (semi-rigid and flexible structures). The Magurele building has an initial period of vibration of 0.7 sec, according to the design, but during the earthquake the period increased due to the decrease of rigidity and put the structure in an unfavourable condition regarding the periods.

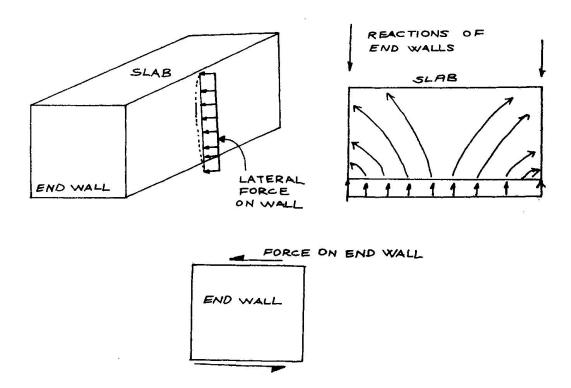
Figure-1 State of Loading on Brick Walls Due to Lateral Forces

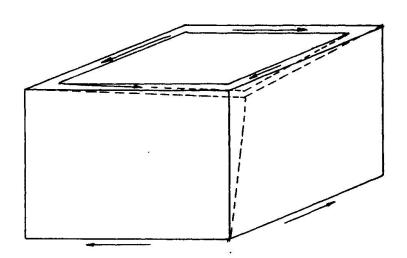
Figure=2 Corner Behaviour of Masonry Buildings.

Since the earthquake forces will act in the two principal directions of the building, the corners of the building will be very critical. Figure-2

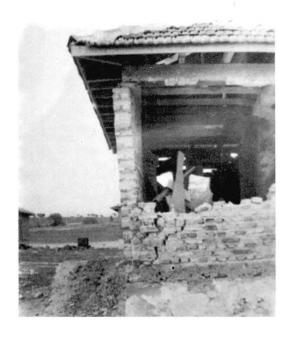
Figure-3 Corner Damage due to Earthquake

In fact such kinds of corner failures have been observed many times in Turkey. Figure-3. In case when there are no slabs of reinforced concrete or the roof truss is not rigid enough to hold the two cross walls together this form of damage should be expected.

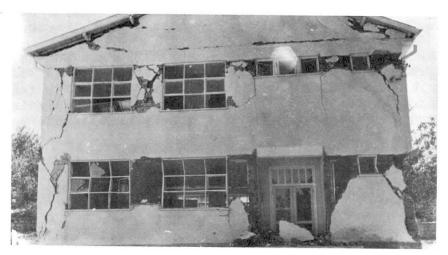
Figure-5 Typical Failure of Brick Masonry

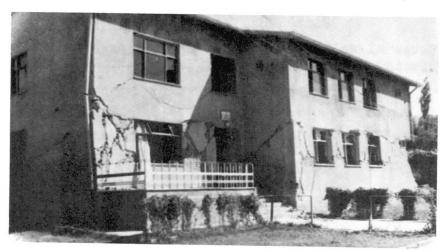
Figure-6 Typical Failure of Brick Masonry

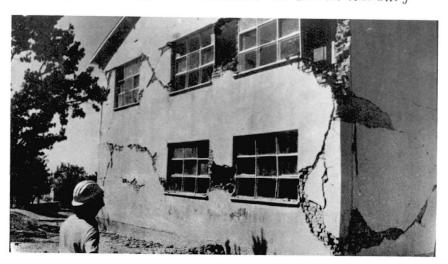
Figure-7 Typical Failure of Brick Masonry

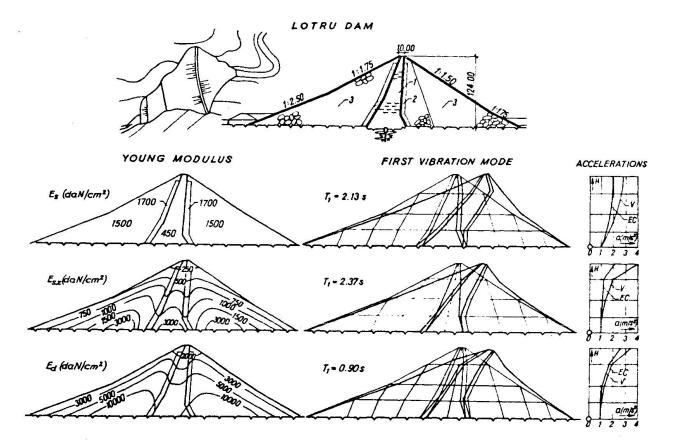
Fig. 3 Earthquake response of the Lotru dam: 1-clay core, 2-tranzition zone; 3-rockfill.

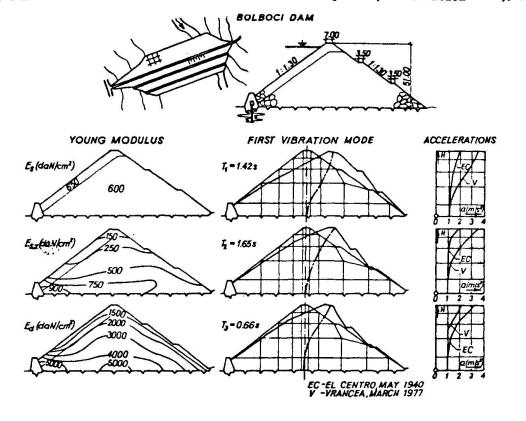
Fig. 4 Earthquake response of the Bolboci dam.

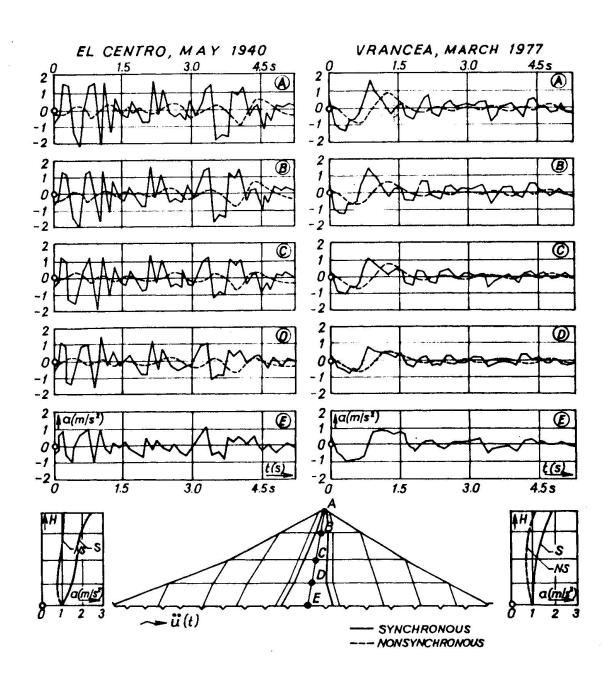
Fig. 6 The influence of the nonsynchronous character of the excitation on the earthquake response of Lotru dam.

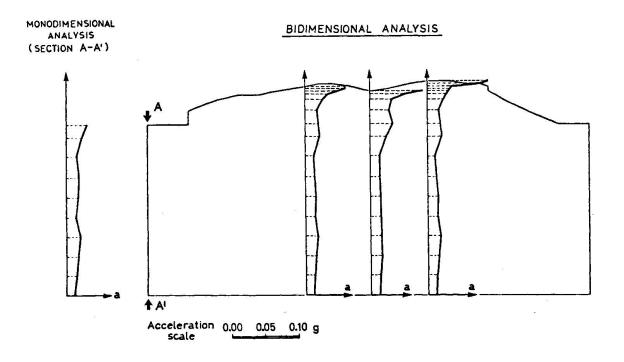
Fig. 2 - Buia hill. Comparison of accelerations obtained with monodimensional analysis

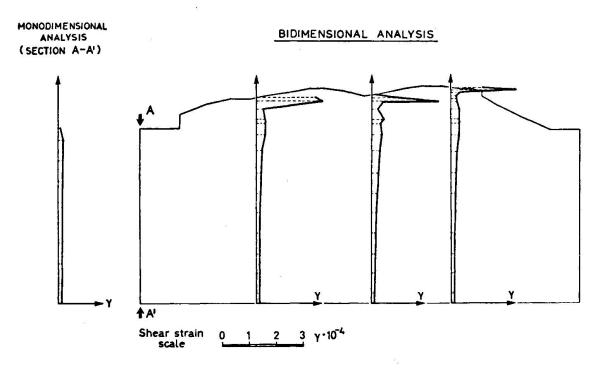
Fig. 3 - Buia hill. Comparison of shear strains obtained with monodimensional and bidimensional analysis

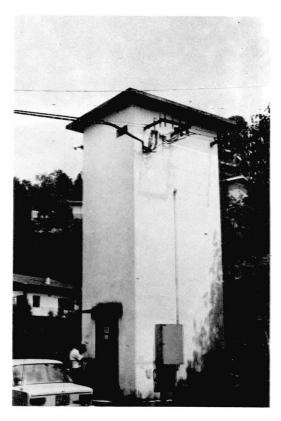
Fig 2. Distribution cabin at Bilerio.

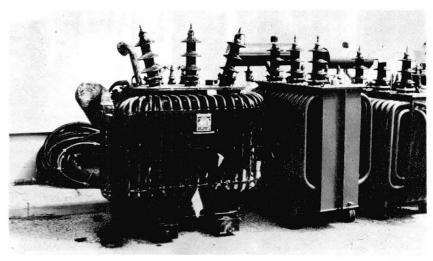
Fig 1. Damaged and new distribution transformers.

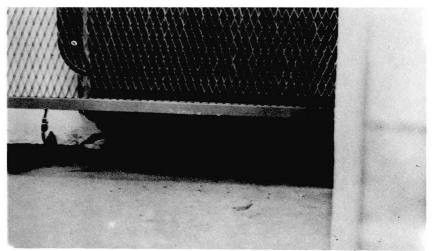
Fig 3. The transformer inside the cabin has moved during the earthquake; one of the back wheels fell into the oil drainage well.

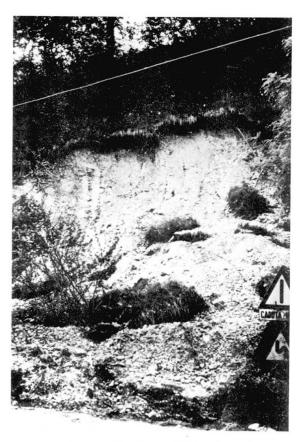
Fig 5. Small landslide by the road at Cornino.

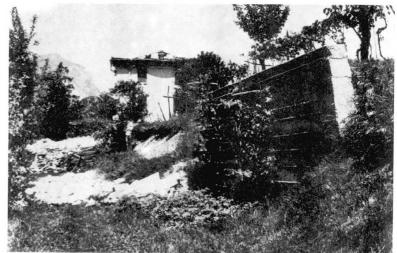
Fig. 7. Duomo Gemona; Failure of the retaining wall.

large as in the valley. The slip vectors, however, were large enough to cause the failure of retaining walls. Figure 6 was taken from Gemona. The low strength masonry wall could not resist the slip vector as did the concrete wall sitting next to it.

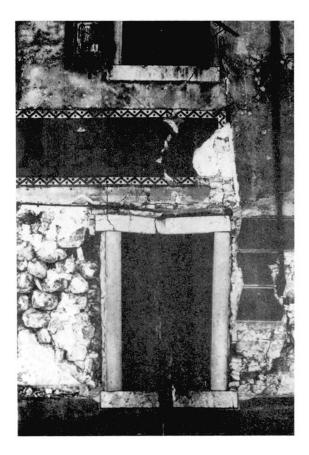
Fig. 8 Collapse mechanism of masonry wall at Gemona.

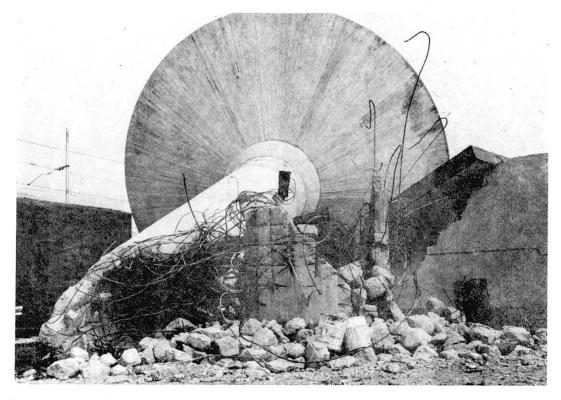
Figure 1: Destroyed watertower at Gemona railway station

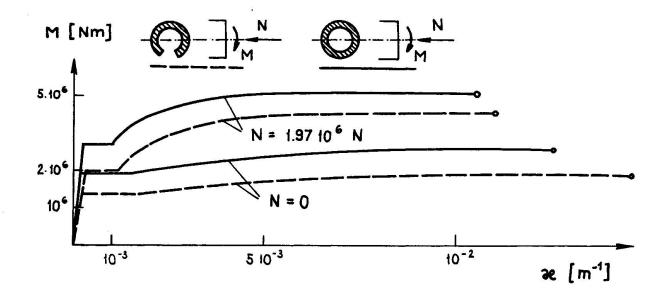
Figure 5: Momentum-curvature-relationship for the reinforced concrete column. The normal force  $N = 1.97 \cdot 10^6 \ N$  is the result of water and structure weight.
