Zeitschrift: IABSE reports of the working commissions = Rapports des commissions de travail AIPC = IVBH Berichte der Arbeitskommissionen

Band: 30 (1978)

FRIULI EARTHQUAKES: 1976
STRONG MOTION ACCELEROGRAPH RECORDS

STRUCTURAL BEHAVIOUR OF THE DAMAGED BUILDING DURING THE
FRIULI EARTHQUAKES BETWEEN MAY 6 AND SEPTEMBER 15, 1976

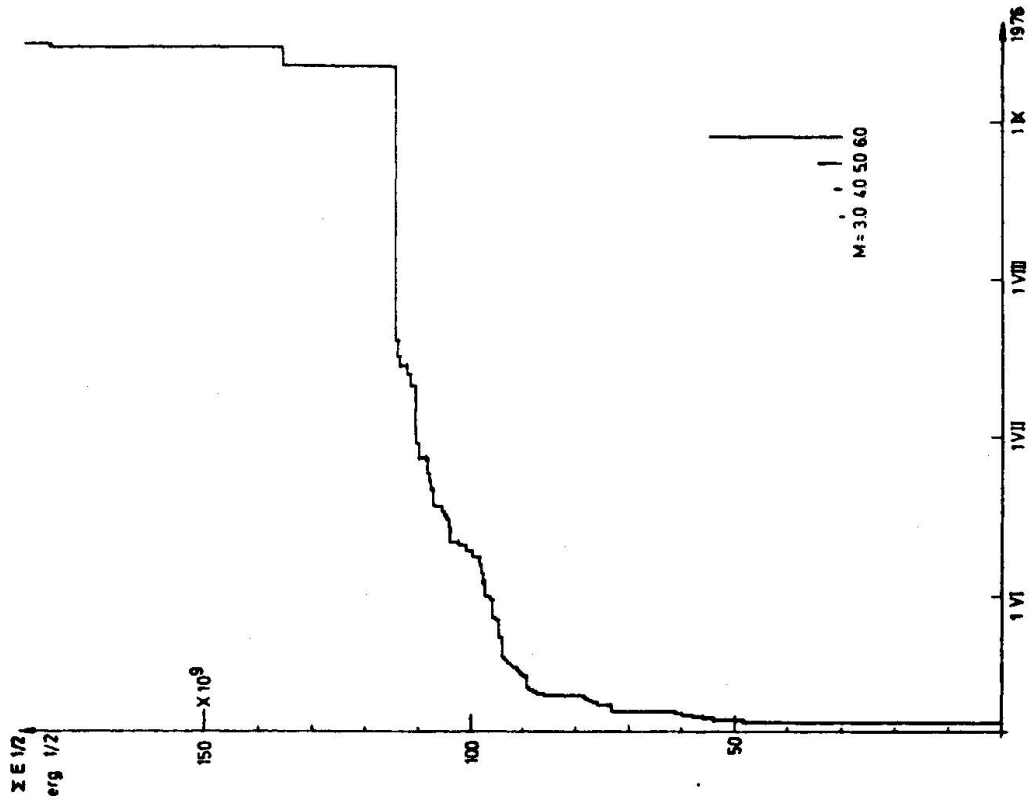
Fig. 4 STRAIN RELEASE CURVE (May 1st to Sept. 15, 1976)
(After I. Cvijanovic)

To the east, in Yugoslavia, typical seismogene zones in continuation with the west-east directed faults of the Friuli Pre-Alps and Julian Pre-Alps are found in the region of Tolmin, whereas southwards this direction changes into north-west-southwest (Dinaride direction). Zones of Ljubljana, Idrija, Ilirska Bistrica-Klana and Rijeka are typical earthquake origin areas with possible magnitudes over 6,5 but however with a small possibility of occurrence. As evident from the time distribution of strong shocks in the region, calm periods exist, however they are lately followed by strong seismic motions (Fig. 3). After the series of 1959 events, no stronger earthquakes were recorded in the period from 1963 to 1975. Finally, the energy release culminated in the May 6, 1976 earthquake and the subsequent earthquakes of the fall 1976 and spring 1977 (Fig. 4).

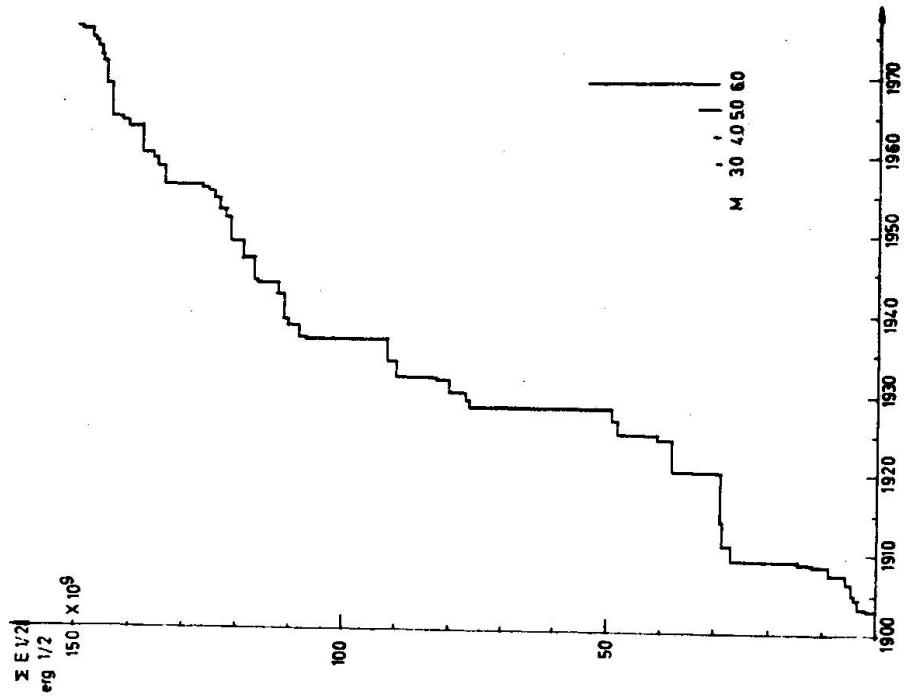
Fig. 3 STRAIN RELEASE CURVE (1900 - 1976)
(After D. Cvijanovic)

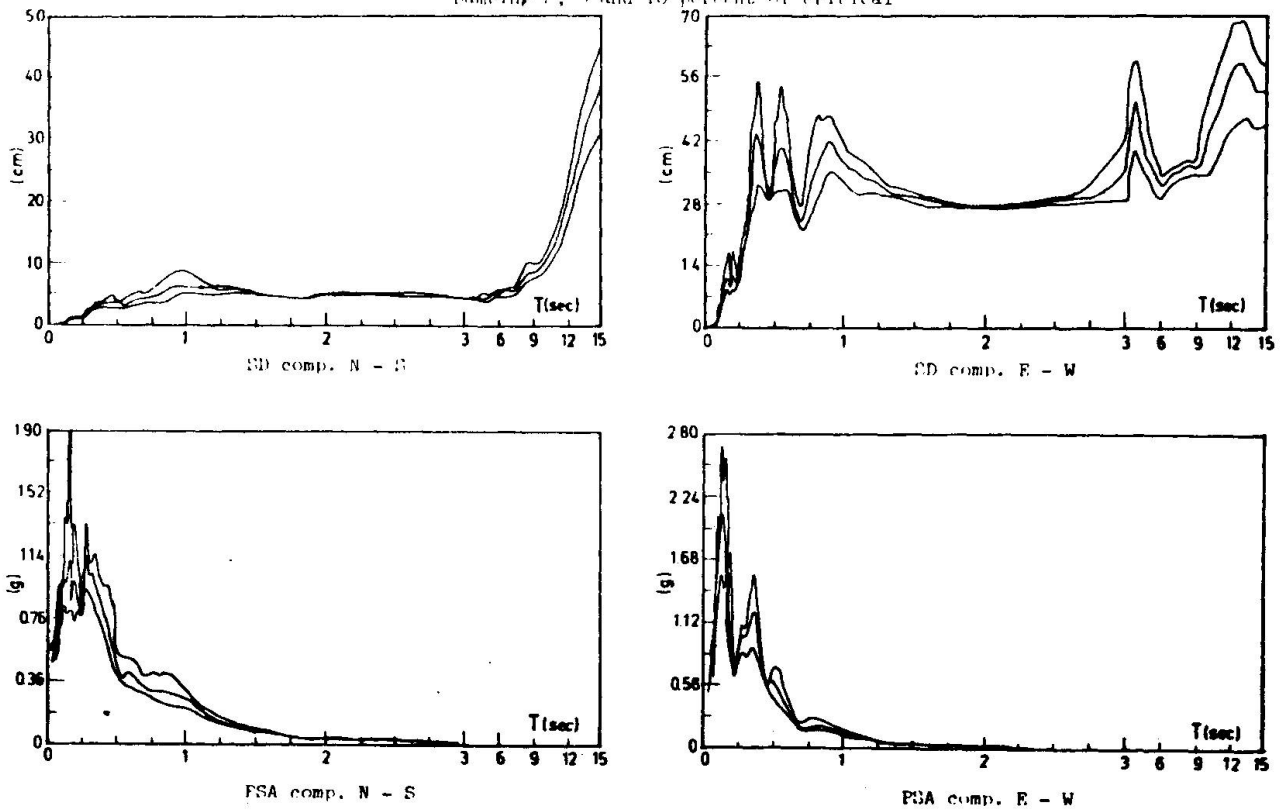
Fig. 10

FRIULI EARTHQUAKE, ITALY, SEPT. 15, 1976, 03h 15m, RECORDED IN BREGINI - YUGOSLAVIA
 RELATIVE DISPLACEMENT AND PSEUDO ACCELERATION RESPONSE SPECTRA
 Damping 2, 5 and 10 percent of critical

As it can be seen from the above table, the instrument at Breginj recorded two very important records (Figs. 8 and 9) with maximum acceleration of 0.525 g i.e. 0.419 g, which is of special interest for the earthquake engineers. Furthermore, because the instrument is located at a distance of cca 25-30 km from the epicenter in a structure which did not suffer significant structural damage due to these earthquakes, while all other structures in Breginj were completely destroyed. At the same time, at Kobarid and Robic, which are at almost the same distance from the epicenter, acceleration of 0.126 g and 0.109 g, i.e. 0.105 g and 0.088 g was recorded.

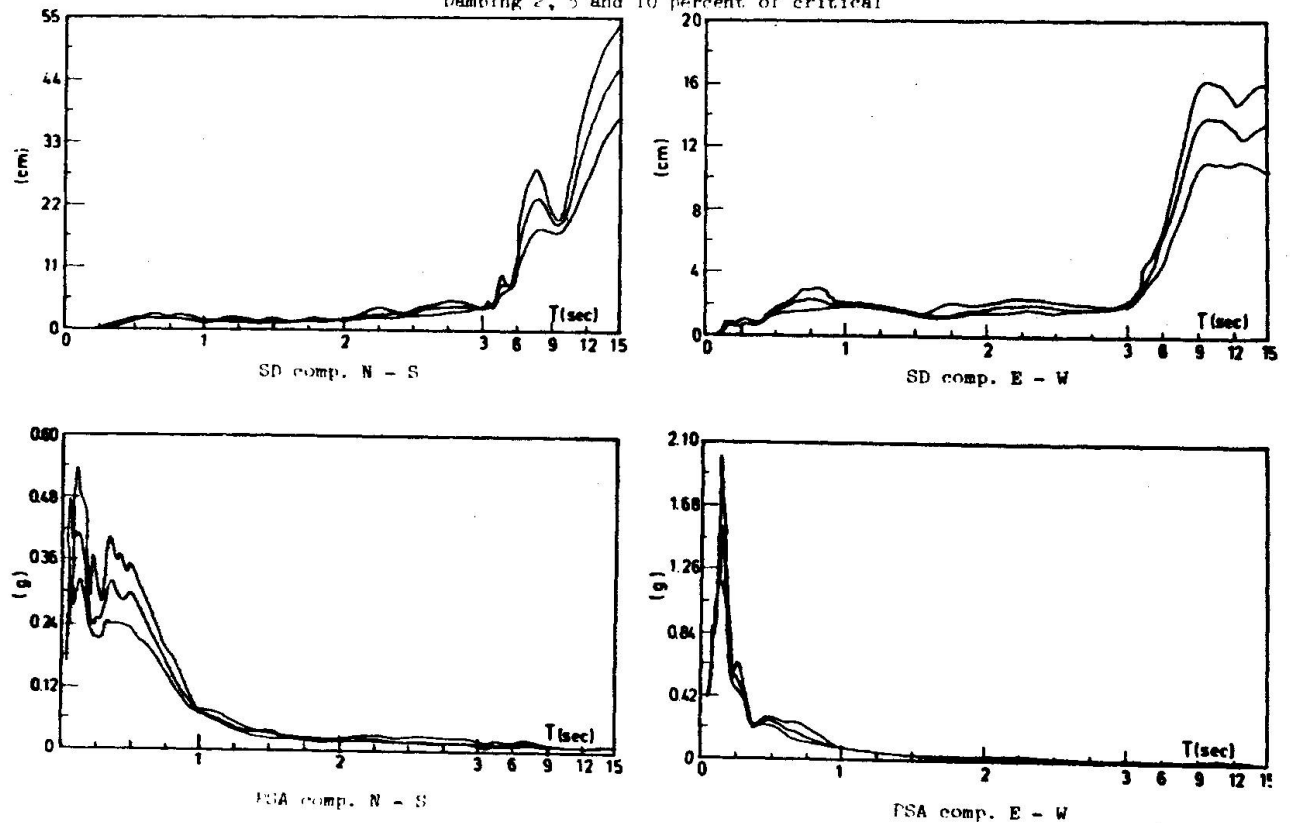
Fig. 11

FRIULI EARTHQUAKE, ITALY, SEPT. 15, 1976, 09h 21m, RECORDED IN BREGINJ - YUGOSLAVIA
 RELATIVE DISPLACEMENT AND PSEUDO ACCELERATION RESPONSE SPECTRA
 Damping 2, 5 and 10 percent of critical

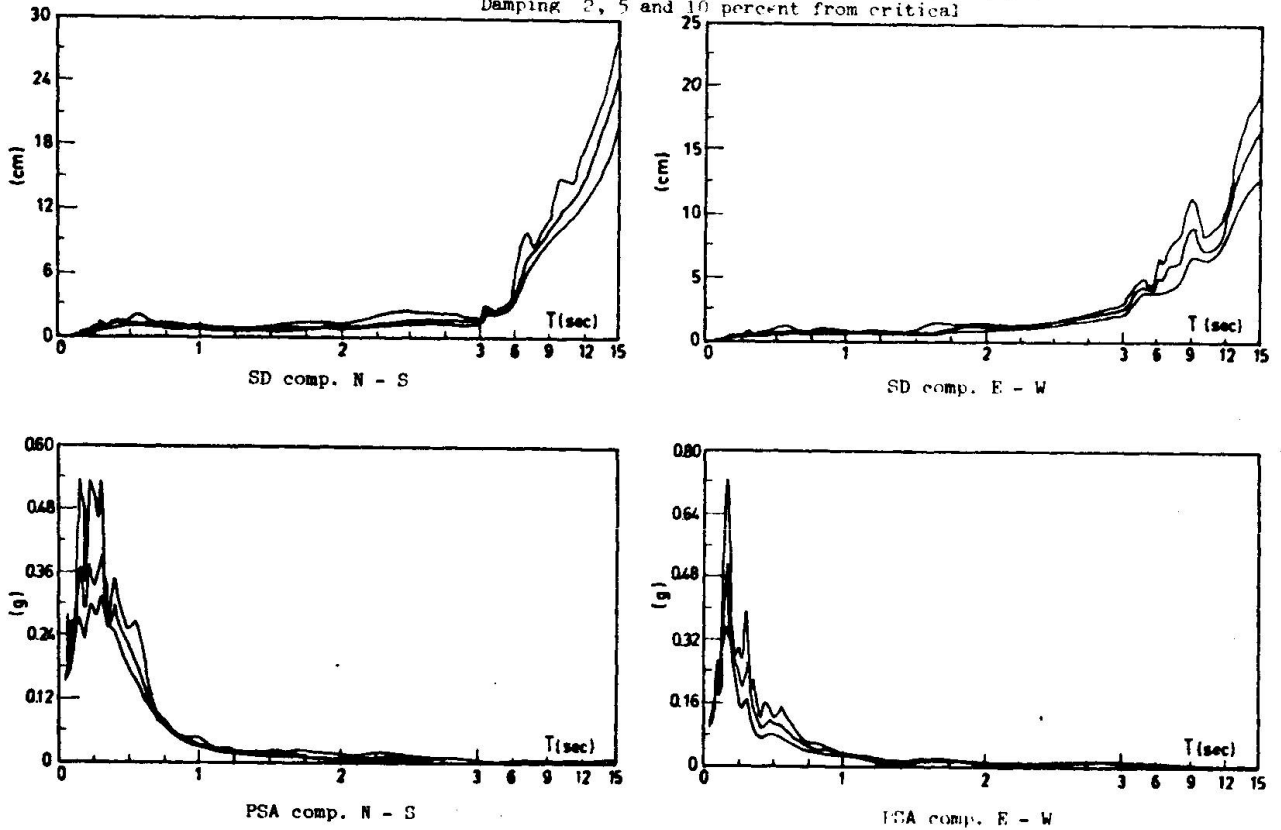
Fig. 12

FRIULI EARTHQUAKE, ITALY, SEPT. 15, 1976, 09h 21m, RECORDED IN KOBARID - YUGOSLAVIA
 RELATIVE DISPLACEMENT AND PSEUDO ACCELERATION RESPONSE SPECTRA
 Damping 2, 5 and 10 percent from critical

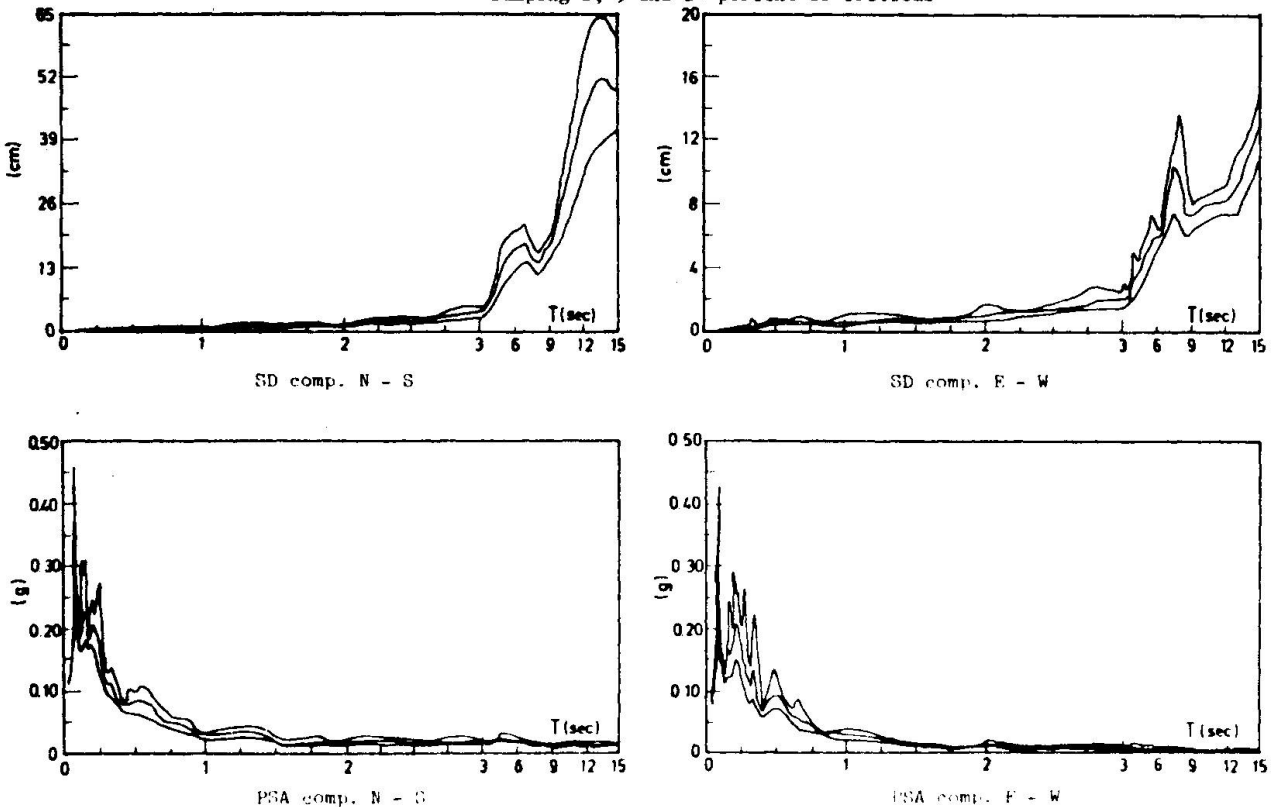
Fig. 13

FRIULI EARTHQUAKE, ITALY, SEPT. 15, 1976, 03 h 15m, RECORDED IN ROBIC - YUGOSLAVIA
 RELATIVE DISPLACEMENT AND PSEUDO ACCELERATION RESPONSE SPECTRA
 Damping 2, 5 and 10 percent of critical

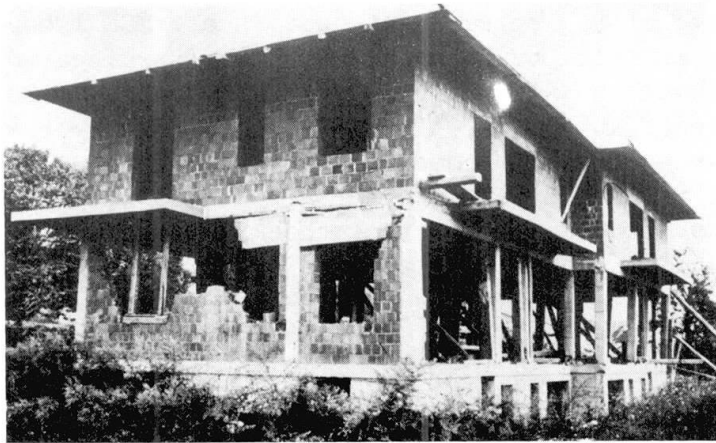
Figure 2: (after September 15th): Uncompleted building in Gemona after renewed earthquake stress. The reinforced concrete columns in the groundfloor were completely destroyed at their fixing points, connection being maintained by the reinforcement only. The massive wooden struts in the groundfloor saved the building from collapse during the second strong earthquake. The already damaged brick wall in the groundfloor was additionally strained due to the strenghtening effect of the wooden struts in the open groundfloor area. The wide brick window jamb was broken out and the reinforced concrete window supports shaken from their rests.

The buildings which were undamaged or which suffered only minor plaster cracks, showed no further damage or, at the most, single wall cracks. Their supporting structure withstood this earthquake load and can be considered sufficiently earthquake-proof against similar earthquakes. The building with severely cracked brick walls suffered in most cases even more masonry damage, due to their weakened condition (Figures 1 and 2).

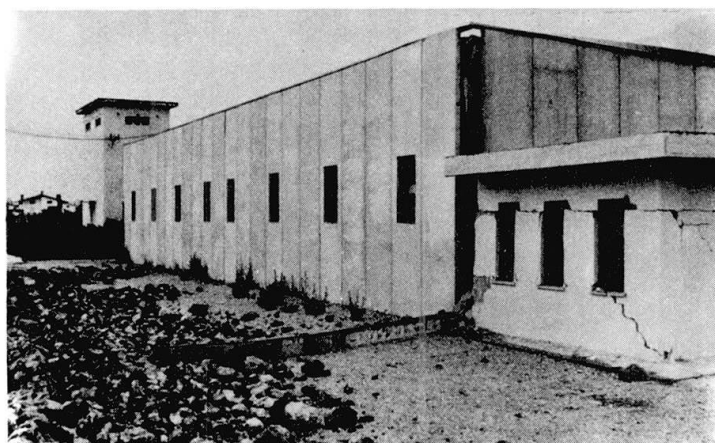
Figure 3: (after May 6th): Prefabricated shed with brick annex in Gemona. The supporting framework of the shed is undamaged. The concrete elements of the side wall, on the other hand, were slightly caved in by the impact of the rigid annex. The plastic material of the wall joints was torn by the large deformation. The roof of the annex was shorn off and pushed over at window level by the impulse load of the impact due to insufficiently wide joints.

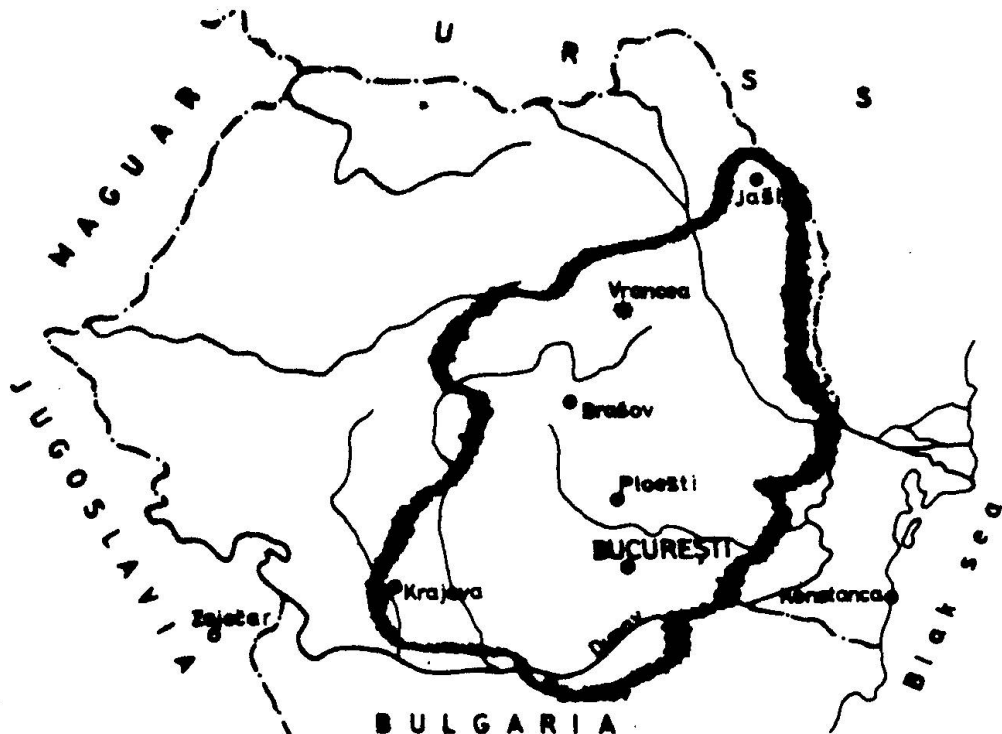
Fig. 1 Map of the Romania showing the region affected by the March 4, 1977 earthquake

The failures and damage due to the earthquake effect were experienced on an area of 80.000 km² which is 1/3 of the whole Romanian territory. Also, some distruction is evident in Bulgaria along the River Danube. The earthquake was felt in Yugoslavia, too, with different intensities (fig.1).

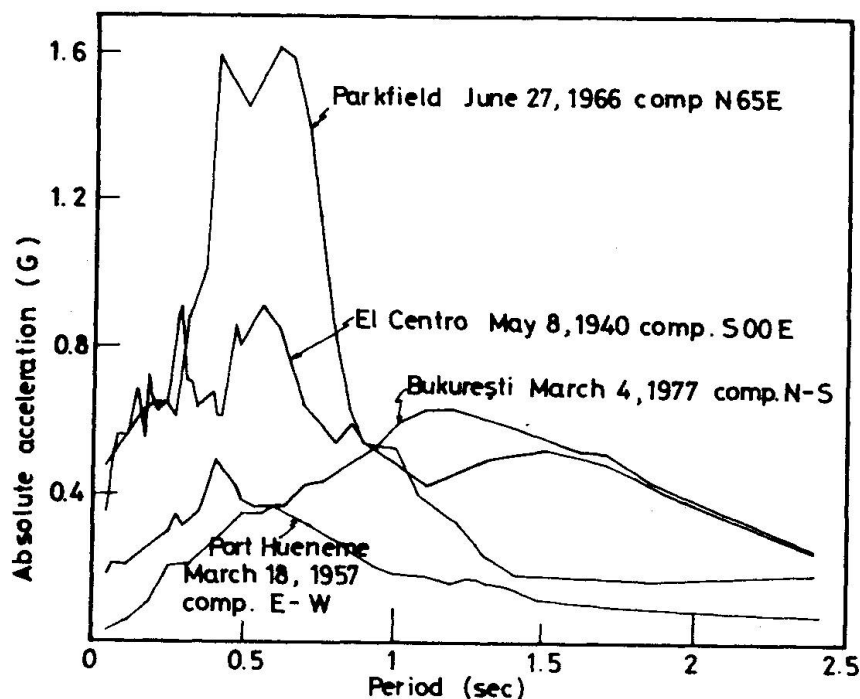
Fig. 2 Absolute acceleration response spectra for damping 5% of critical

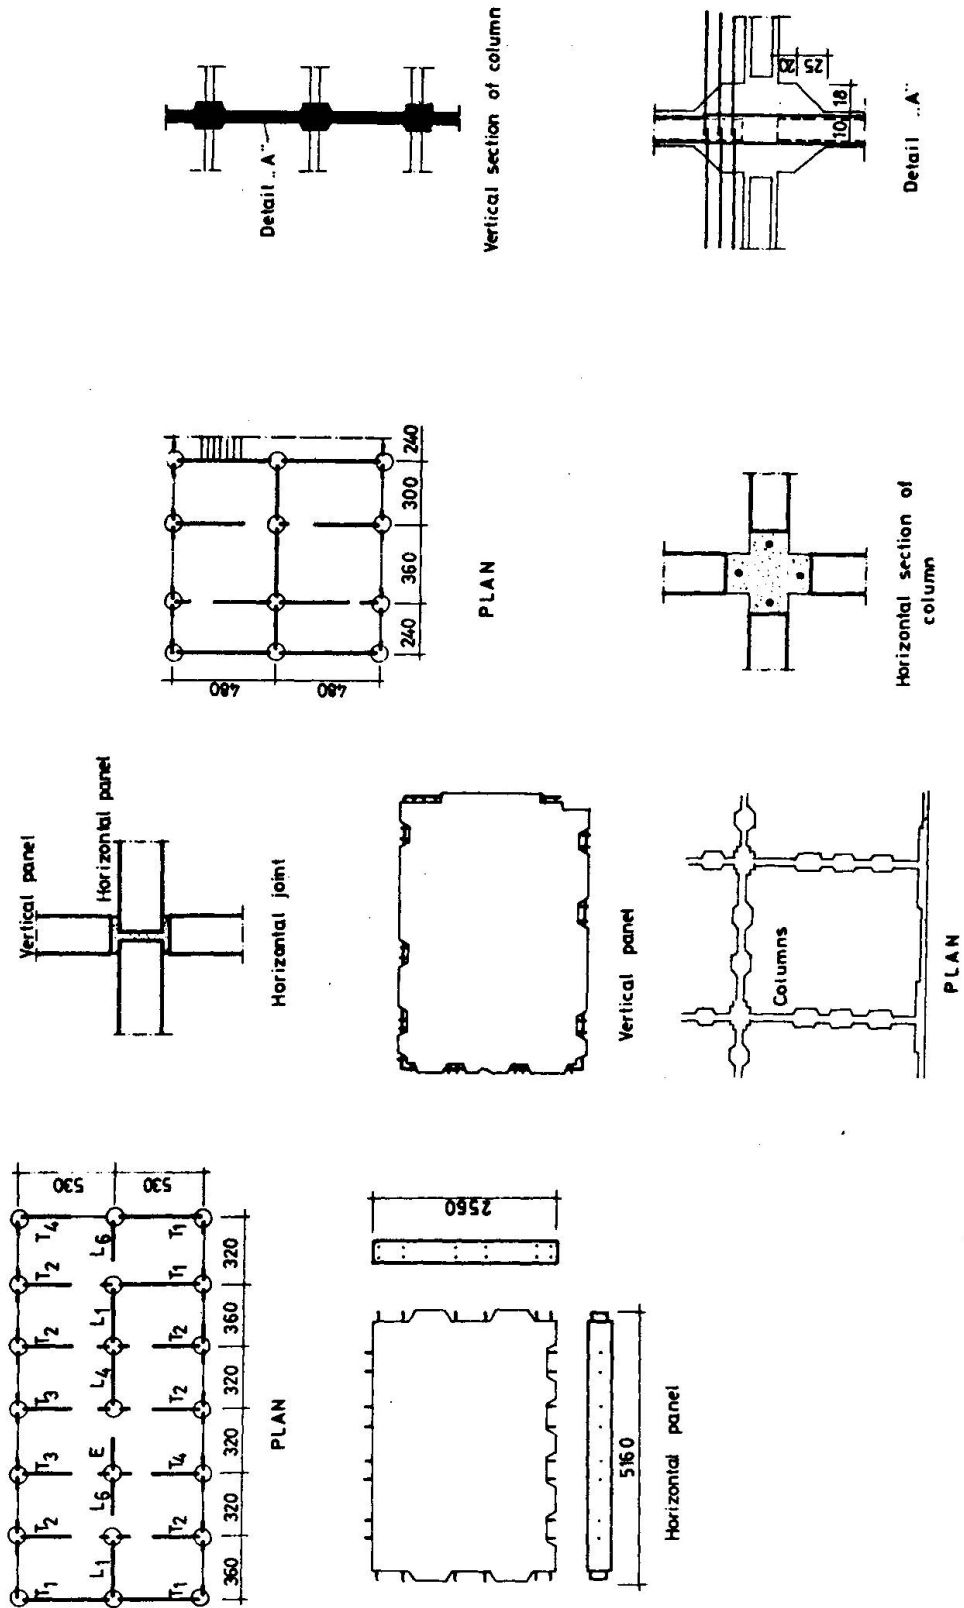
Fig. 5

3. Many structures in Bucharest have 5 storeys and monolythic basement. Fig. 5. gives details of some members and connections of this system. It should be mentioned here that all panel systems in Bucharest have shear base coefficient of 7-9%, up to ultimate state.

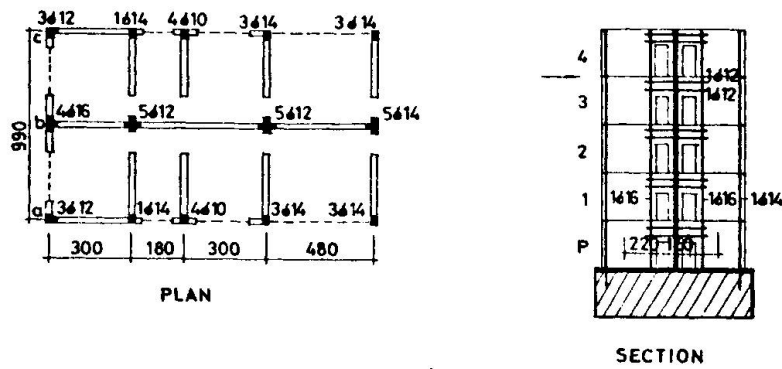
Fig. 7

In Kraiova, buildings with same design, same number of storeys and similar solutions are constructed. The plan of reinforcement distribution is given in Fig. 7. These structures have a shear base coefficient of 10-12% up to the yield point in bending of the reinforcement.

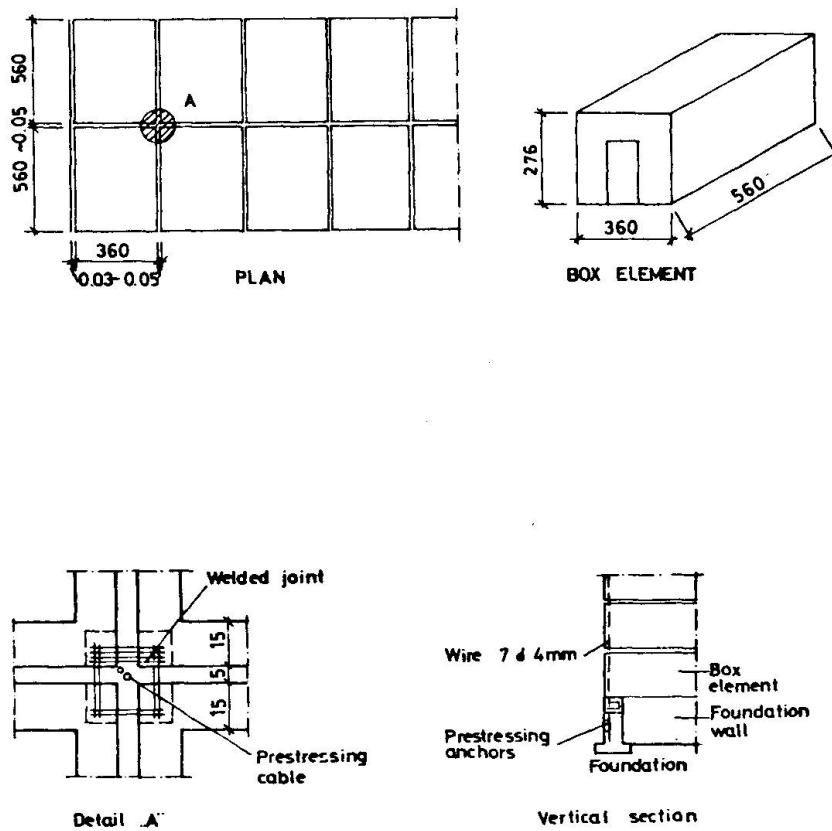
5. In Kraiova a large panel system is both prefabricated and constructed. It is a 5 storey system of box type, i.e. complete room. Each apartment consists of 3,5 boxes monolithically connected in situ along the edges by welding and placed concrete. Each corner is then prestressed by vertical cables of 12 t (wire of $7\phi 4$ mm.) along the height of the building. The prestressed cables are then anchored to the monolithic basement walls which were constructed in situ together with the foundation. Fig. 8

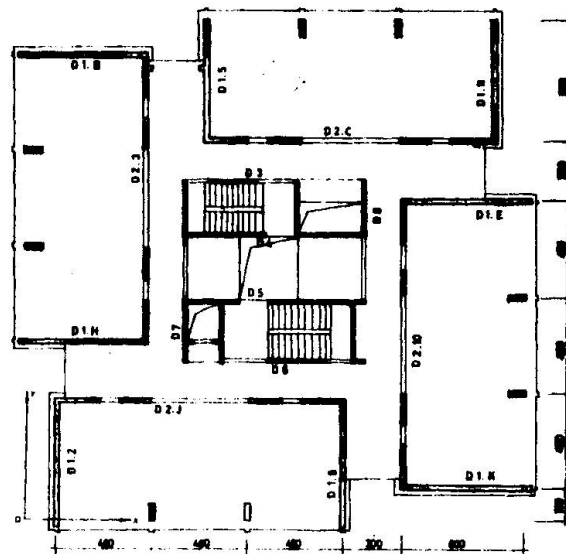
Fig. 1 Typical floor plan

The Office building within the Nuclear Physics Institute at Magurele is a reinforced concrete building, square in plan of 26 m side and 44 m height, with basement, ground floor and 10 stories (Fig. 1). The main structural system consists of reinforced concrete walls, with and without openings, and floor slabs of pre-cast parts and cast in place parts. Most of the walls have thickness of 25 cm. The main reinforcement is placed at the ends of the sections of walls and ranged from 0.46% to 0.90%. The horizontal reinforcement consists of two layers of bars 10 mm at 20 cm. The yield stress of reinforcement used was 3600 kp/cm², and the specified strength of concrete 200 kp/cm².

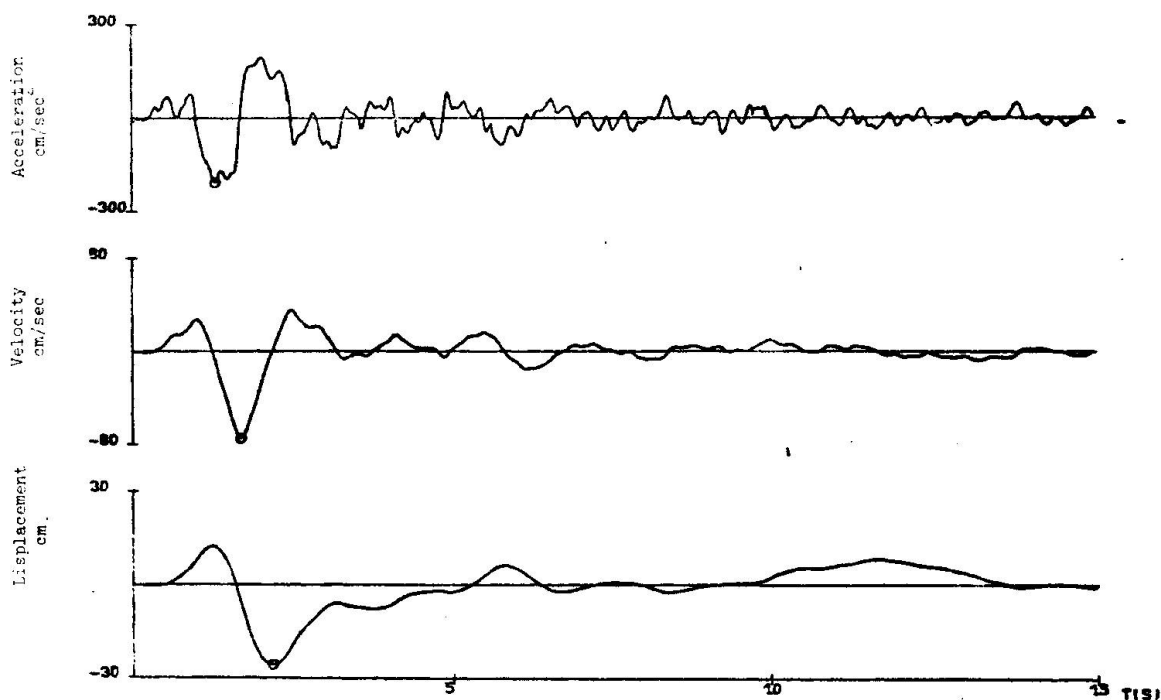
Fig. 2 Record of the earthquake of March 4, 1977 - INCERC

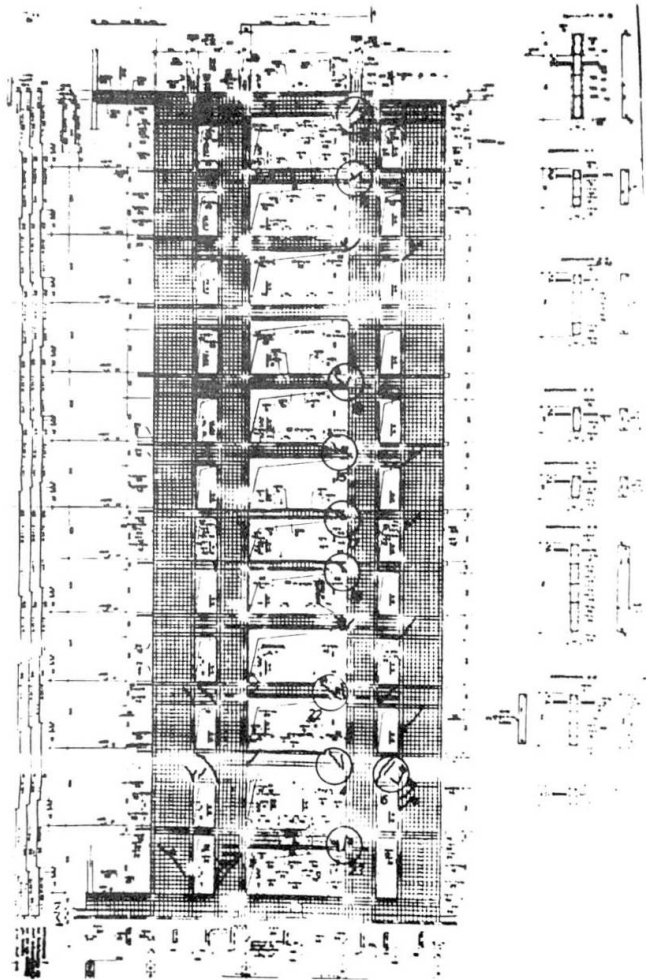
Fig.4 Elevation of wall D₂₋₃

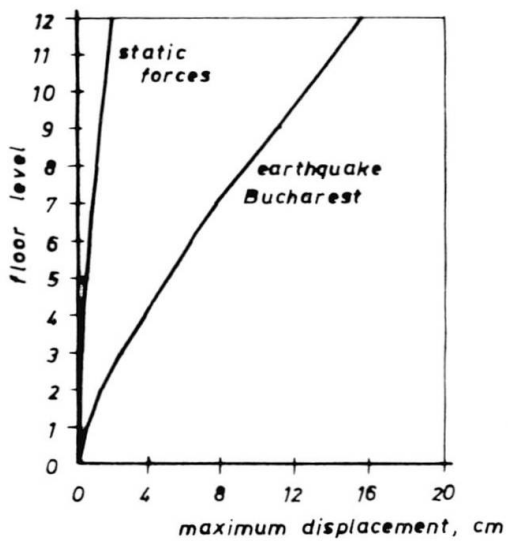
Fig.5 Envelopes of maximum elastic floor displacements

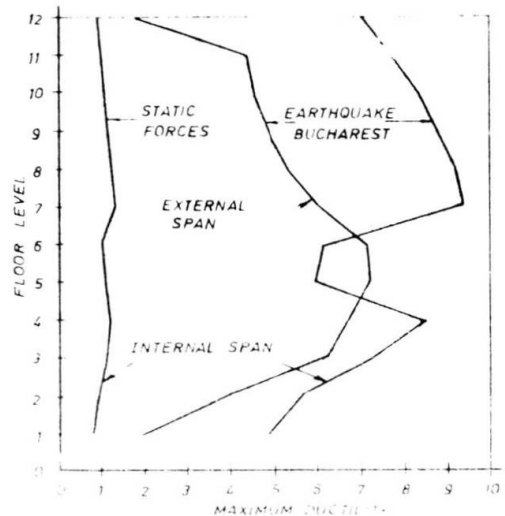
Fig.6 Envelopes of maximum beam ductilities, D₂₋₃

During investigation of the ability of the building to withstand the March 4, 1977 earthquake, the ratio between "the maximum moment at a section from the gravity and seismic loading, divided by the ultimate moment capacity of the section" was required [4]. These relations are shown in Fig.6 as "ductilities" for the beams of the wall D_{2-3} . The maximum moments from the earthquake are

considerably larger than the flexural capacity of the sections, which results in the very high "ductilities".

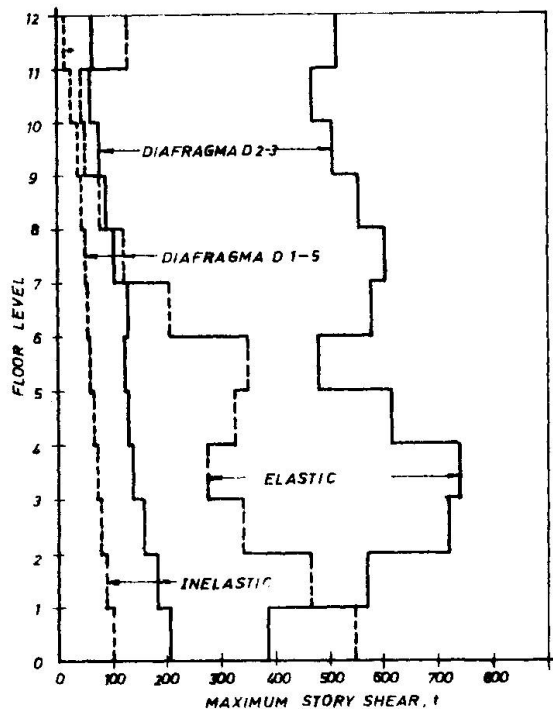
Fig.7 Envelopes of maximum storey shears

The fig.7 illustrates the maximum storey shears obtained from elastic and inelastic analysis. Although direct comparison is not possible, due to the separate treatment of the walls in the inelastic analysis, it could be stated that the shear forces obtained by the elastic analysis are too high.

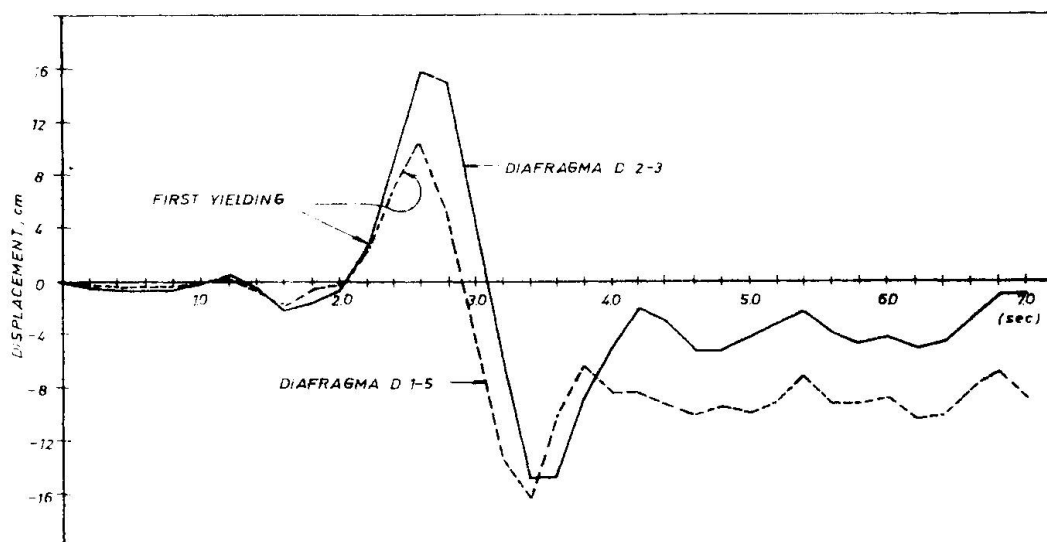
Fig.8 Time history of horizontal displacements at the top of the structure

The time history of the displacement at the top of the walls D_{1-5} and D_{2-3} is shown in Fig.8. It could be said that the maximum elastic and inelastic displacements were similar.

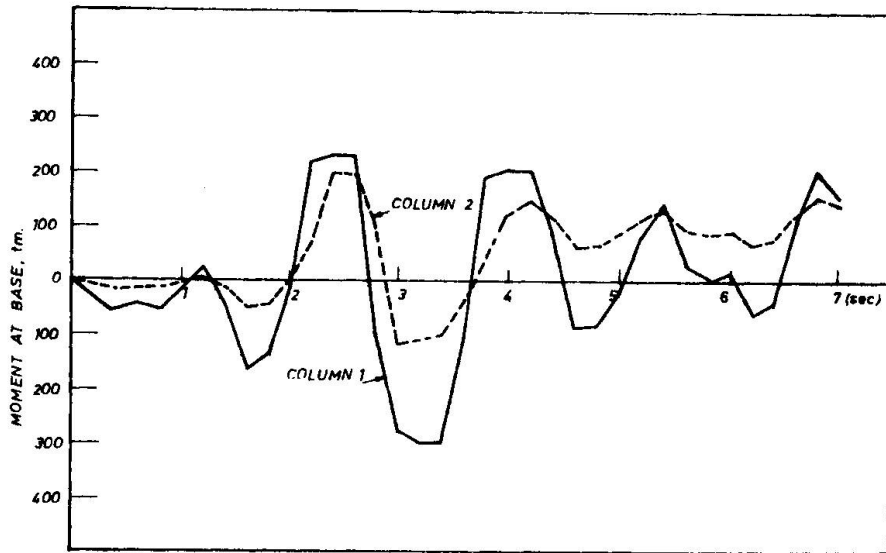
Fig.10 Time history of bending moment at base of D₂₋₃

The Figs. 10 and 11 show the change of the moments and the axial forces at the base of the columns in D_{2-3} and sometimes the axial forces are larger than those corresponding to the balance point.

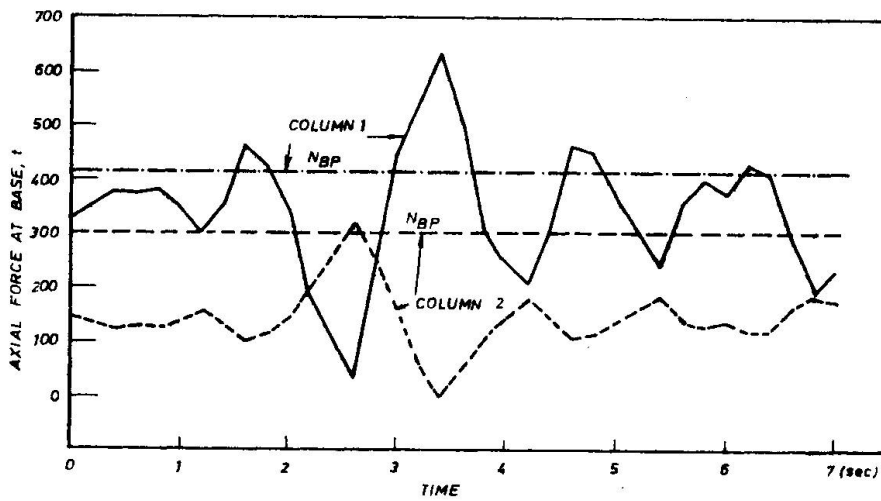
Fig.11 Time history of axial forces at base of D₂₋₃

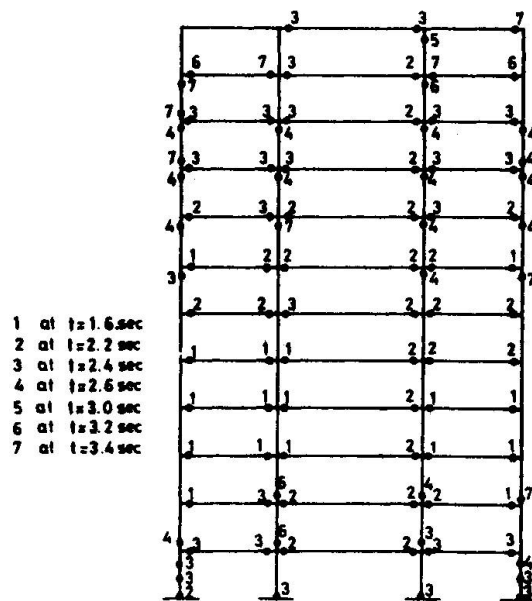
Fig.12 Sequence and location of plastic hinges, D₂₋₃

Fig 12 illustrates the location and the sequence of forming of plastic hinges in the wall D_{2-3} . The plastic hinges indicated did not occur simultaneously, but generally in groups concentrated at a floor level.

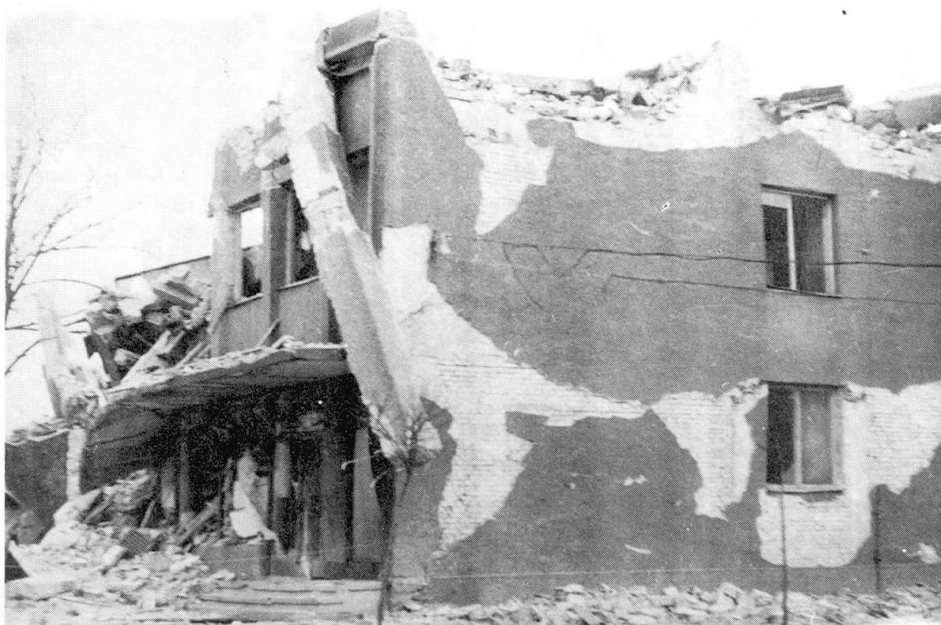
fig. 11

The fifth storey office building (fig. 10) is typical building with flexible first storey. The existing of shear walls at the stairs only develop additional rotational effects and reserve partly only first two storeys at the stairs (fig. 11). The cylindrical columns of the building are well designed (fig. 12) but connections between girders and columns did not forme space resisting frame for horizontal exitation. The small length of down girders steel bars into columns (fig. 10 b) was not capable to bear suficient bending moments from the earthquake. Similar construction had the sixt storeys public residential building wich was colapsed on the same way (fig. 13).

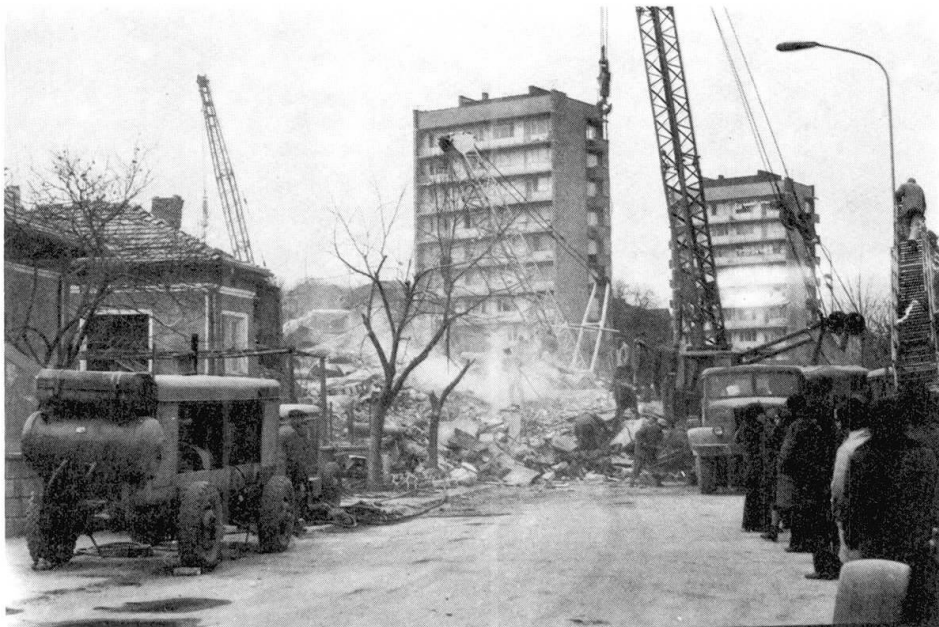
fig. 14

The nine storeys apartment building with shops (without shear walls) into first storey was colapsed as previous two buildings (fig. 14). Another two nine storeys buildings with the same construction but with masonry shear walls in first storey have resisted very well to the earthquake (fig. 15).

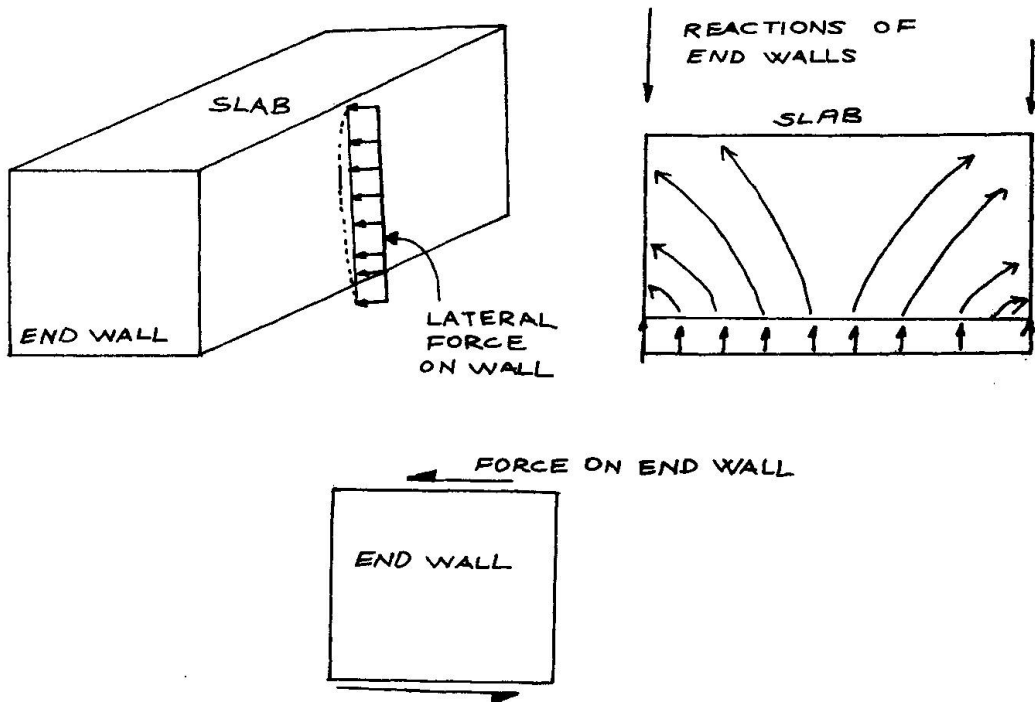
Figure-1 State of Loading on Brick Walls Due to Lateral Forces

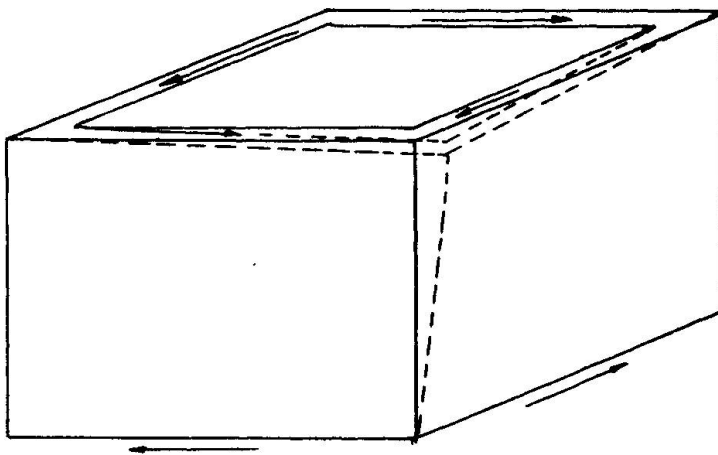
Figure-2 Corner Behaviour of Masonry Buildings.

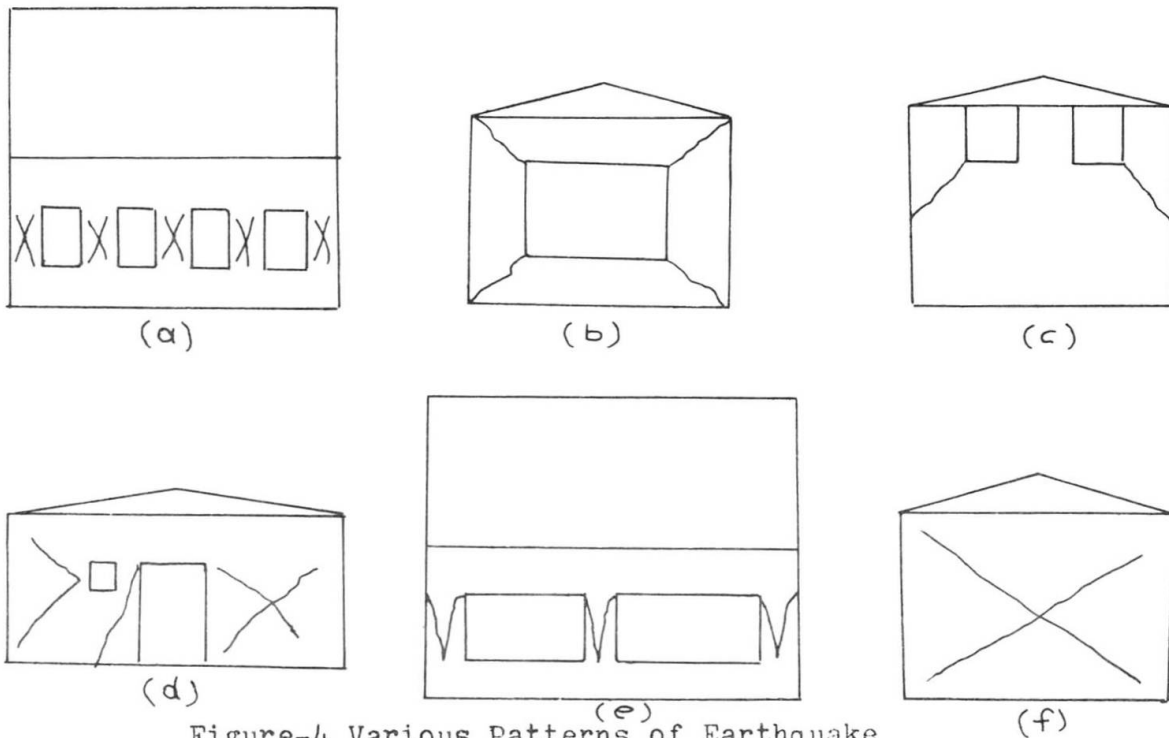
Figure-4 Various Patterns of Earthquake Cracking in Masonry Buildings

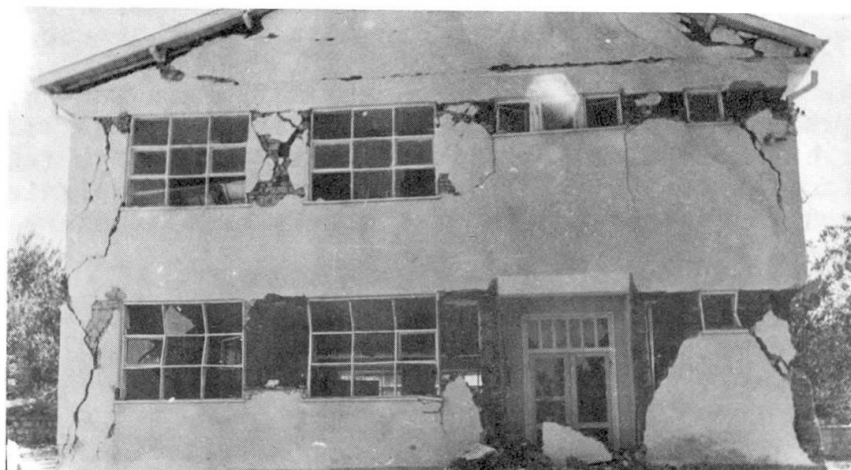
Figure-5 Typical Failure of Brick Masonry

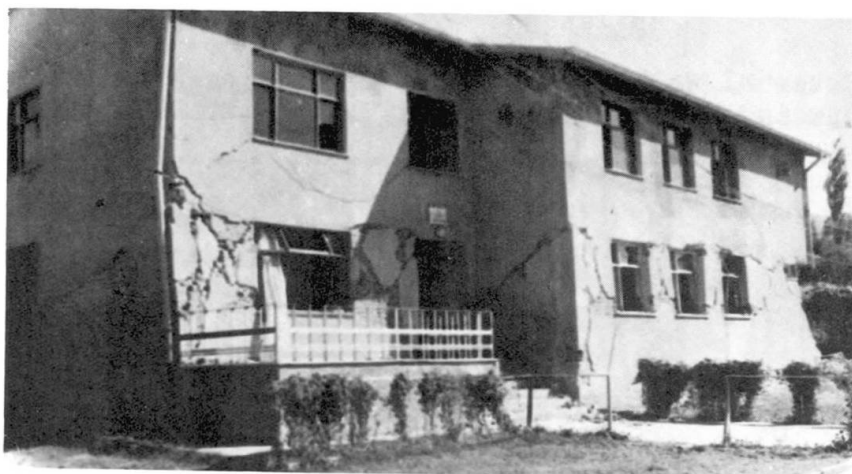
Figure-6 Typical Failure of Brick Masonry

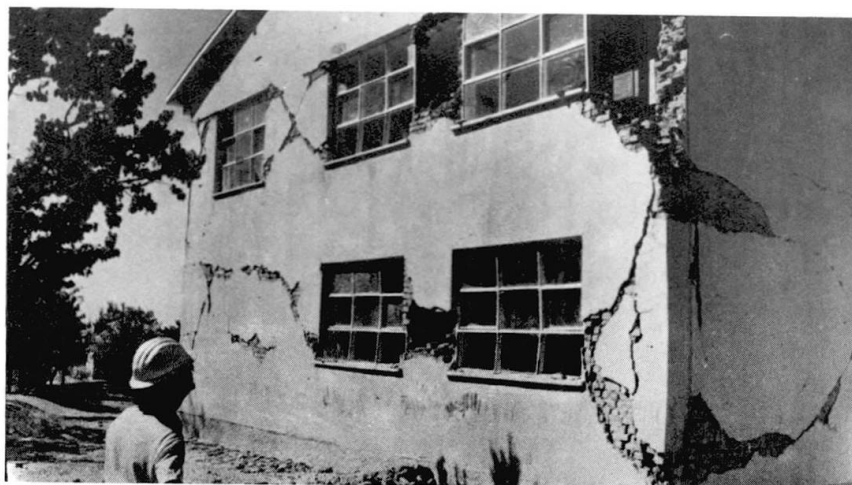
Figure-7 Typical Failure of Brick Masonry

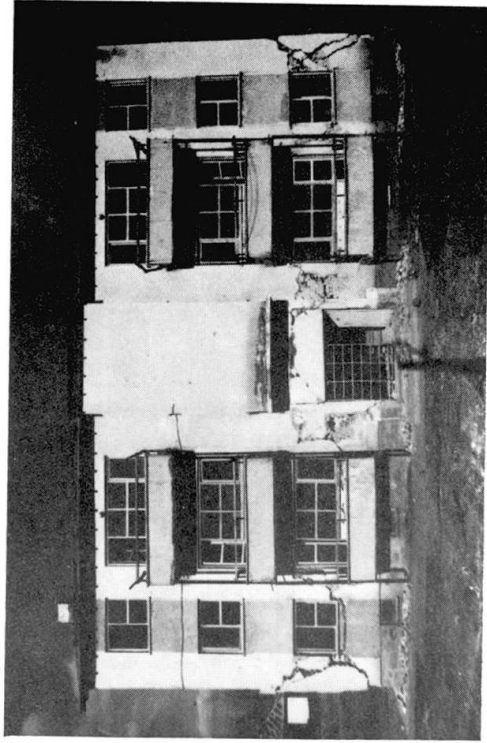
Figure-9 Muradiye Staff Housing

Building	External Wall Opening Ratio %	Wall/Floor Area Ratio cm/m ²	Damage	Remarks
Çaldıran Staff Housing				
x-axis	41-37	26	No damage	I = IX
y-axis	0	31	No damage	(Figure-8)
Muradiye Staff Housing				
x-axis	54-59	17	Heavy damage	I = VII
y-axis	0	26	No damage	(Figure-9)
Muradiye Junior High School				
x-axis	15	20	Slight damage	I = VII
y-axis	53-37	12	Heavy damage	(Figure-10)
Palu Monopoly Office				
x-axis	42-35	21	Damage	
y-axis	0-16	24	No damage	I = VI
Palu Local Administration Building				
x-axis	55	25	Heavy Damage	I = VI
y-axis	29	30	No damage	(Figure-11)

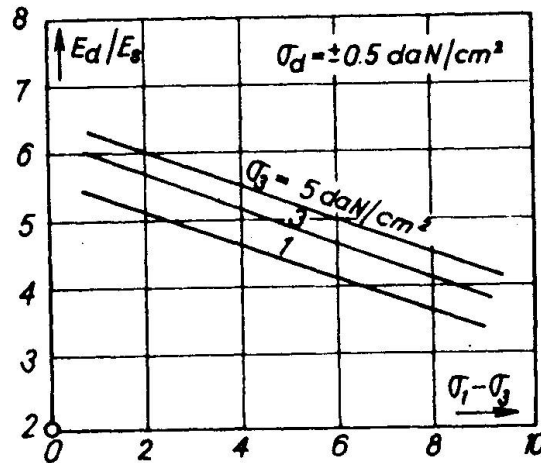
Fig. 1 The correlation between E_d/E_s ratio and the principal stresses in the dam body (after Hayashi, Fuziwara and Komeda).

Fig.1 shows the dependency of the dynamic and static moduli ratio (E_d/E_s) with the principal stresses in the dam body as it came out from the experiments carried out by HAYASHI, FUZIWARA and KOMEDA[3].

linear. Thus, at the end of the analysis the displacements, stresses and deformation moduli in the dam body have been obtained. The dynamic moduli have been determined with approximation in accordance with the static moduli previously determined, using the diagrams shown in Fig.1. The contours of the deformation moduli in dams cross sections for the three hypothesis considered may be followed in figures 3 and 4.
