Zeitschrift: IABSE reports of the working commissions = Rapports des commissions de travail AIPC = IVBH Berichte der Arbeitskommissionen

Band: 30 (1978)

FRIULI EARTHQUAKES: 1976
STRONG MOTION ACCELEROGRAPH RECORDS

STRUCTURAL BEHAVIOUR OF THE DAMAGED BUILDING DURING THE
FRIULI EARTHQUAKES BETWEEN MAY 6 AND SEPTEMBER 15, 1976

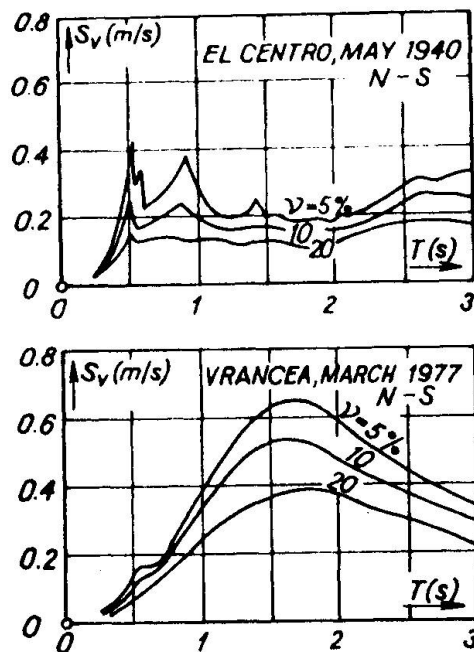
Fig. 2 The velocity spectra of the earthquakes El Centro and Vrancea, scaled to 0,1 g.

The earthquake behaviour has been determined by response spectrum analyses, for two earthquakes considered to be characteristics : EL CENTRO, May 1940 and Vrancea, March, 1977. The corresponding velocity spectra, scaled at the maximum acceleration of 0,1 g are presented in figure 2. One should notice that while the El Centro earthquake spectrum shows peaks within the range of quasirigid structures (with the first vibration periods of 0.3...0.5s), the Vrancea earthquake, that has recently occurred in Romania, shows peaks within the period range of 1.5s.

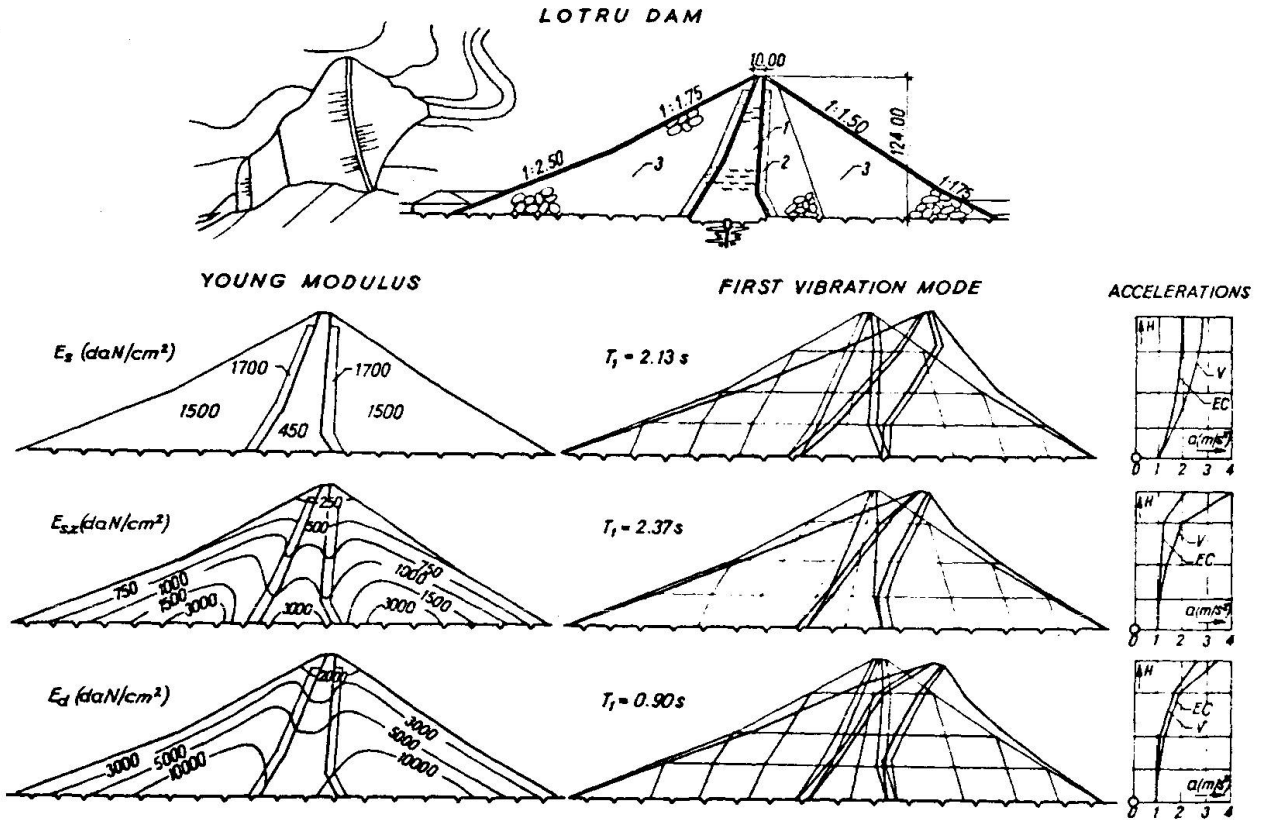
Fig. 3 Earthquake response of the Lotru dam:1-clay core,2-tranzition zone;3-rockfill.

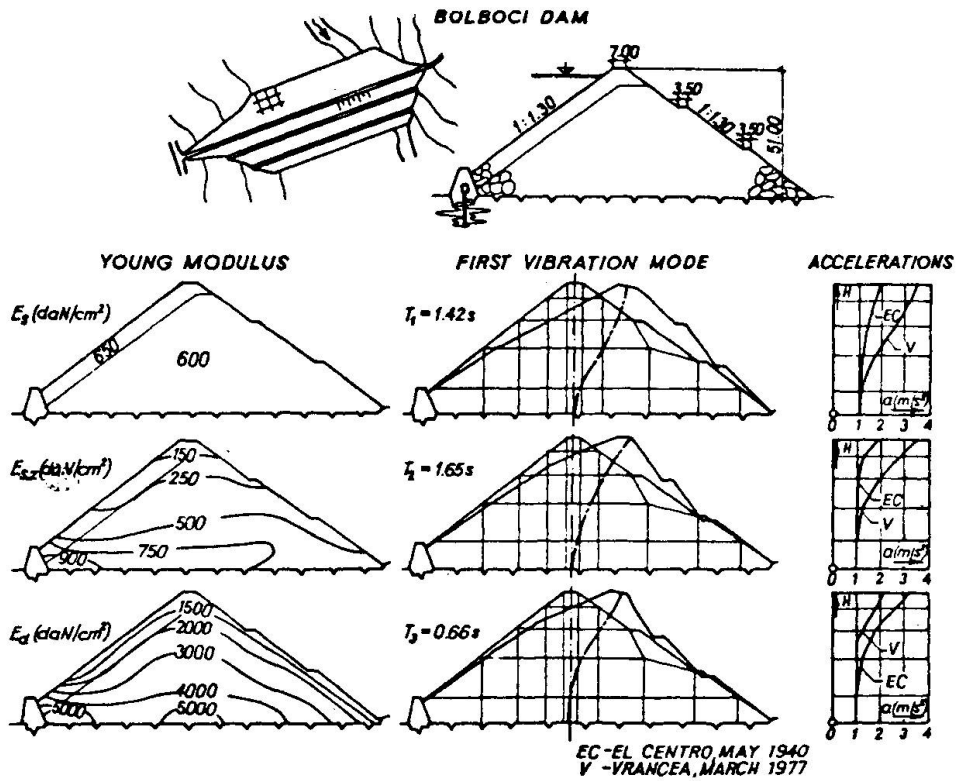
Fig. 4 Earthquake response of the Bolboci dam.

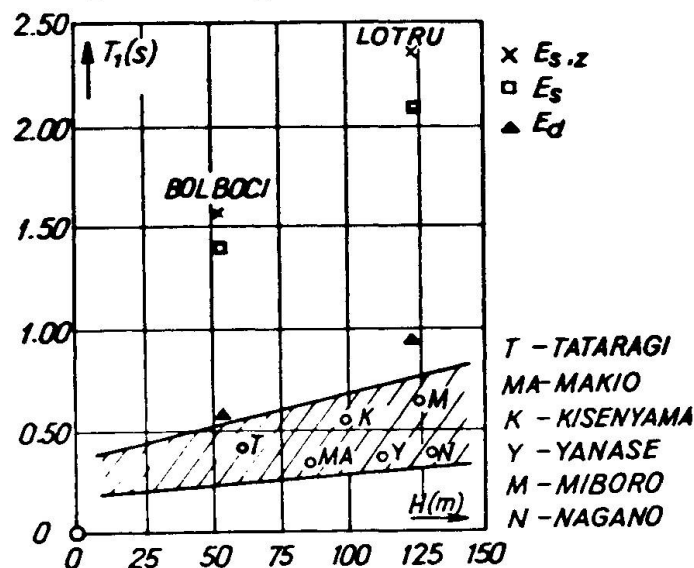
Fig. 5 The first vibration periods determined for Lotru and Bolboci dams comparatively with those measured for several Japanese rockfill dams (after Okamoto).

The analysis results are shown in figures 3 and 4. For both dams not only an important change of the vibration fundamental period is obvious but also the shape of the first vibration mode according to the deformation modulus used. In the case of dynamic moduli the fundamental period is about 2.5 times less and the displacements corresponding to the first mode shape are more reduced in the lower half of the dam height, presenting increases towards the crest. As a result, the distributions of the induced accelerations into the dam body by the two considered earthquakes, for a damping of 10% of the critical one, is different in its turn. While in the case of static moduli, the Vrancea earthquake, a slower one, leads to higher values of the response accelerations, in the case of the dynamic moduli the situation is reverse. At the same time in the case of dynamic moduli, the distribution over the dam height shows important increases in the upper third of the dam only, as it has been noticed according to the field records of the earthquake response of some rockfill dams [6].

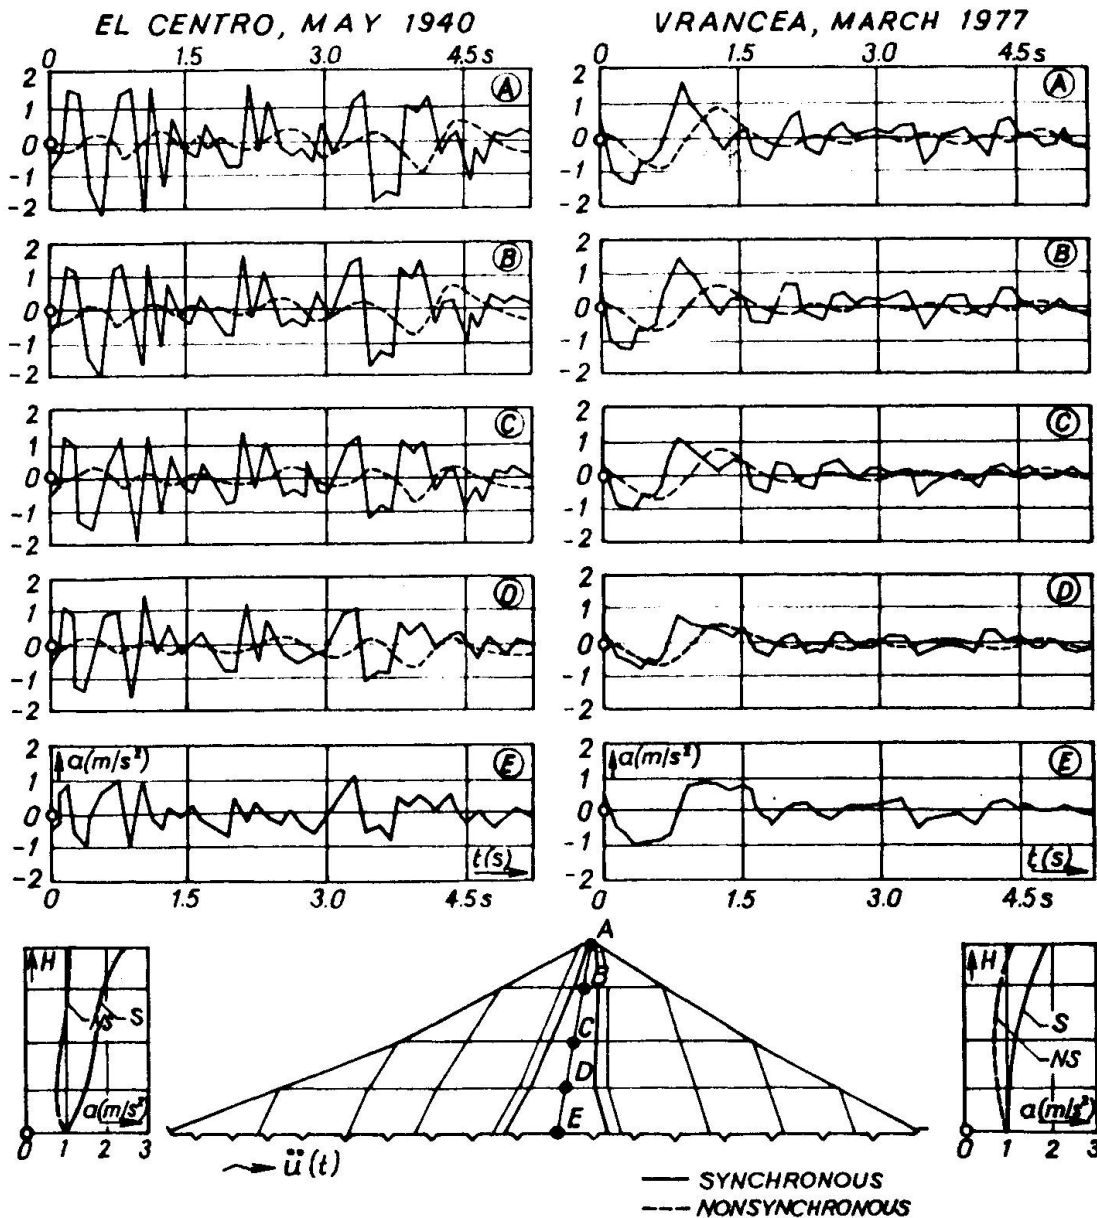
Fig. 6 The influence of the nonsynchronous character of the excitation on the earthquake response of Lotru dam.

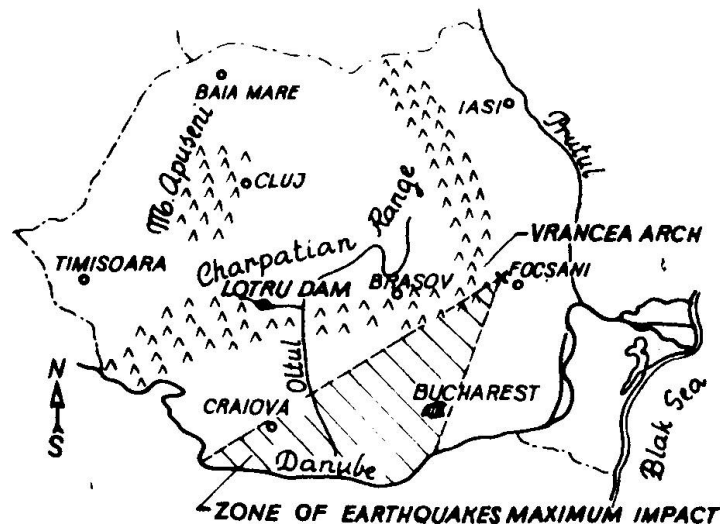
Fig. 7 The Lotru dam location as to the maximum impact zone of the Vrancea earthquake, March 1977.

The magnitude of 7.2 places the Vrancea earthquake, March 4-th 1977, among the strongest earthquakes to have occurred in Europe in the last few decades. The earthquake focus was located at about 100 km depth in Vrancea region, an area with a well known high earthquake activity. From the point of view of the dam shaking it is interesting to point out that on March 4-th 1977 as well as in the previous earthquakes the maximum intensities were felt towards South-South West of the epicenter. In Fig.7 a sketch of the most affected zone within the Romanian territory is presented; it also shows that Lotru dam, located at about 200 km away from the epicenter, was outside the impact zone (the earthquake intensity at the site was estimated to be VI on the MM scale).

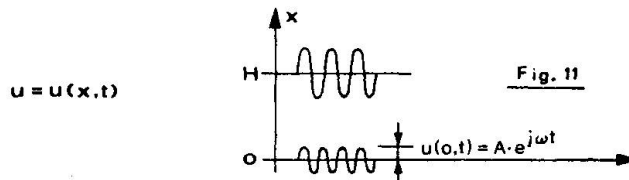
Vertical propagation of harmonic shear waves through the system shown in fig. 11 will cause only horizontal displacements

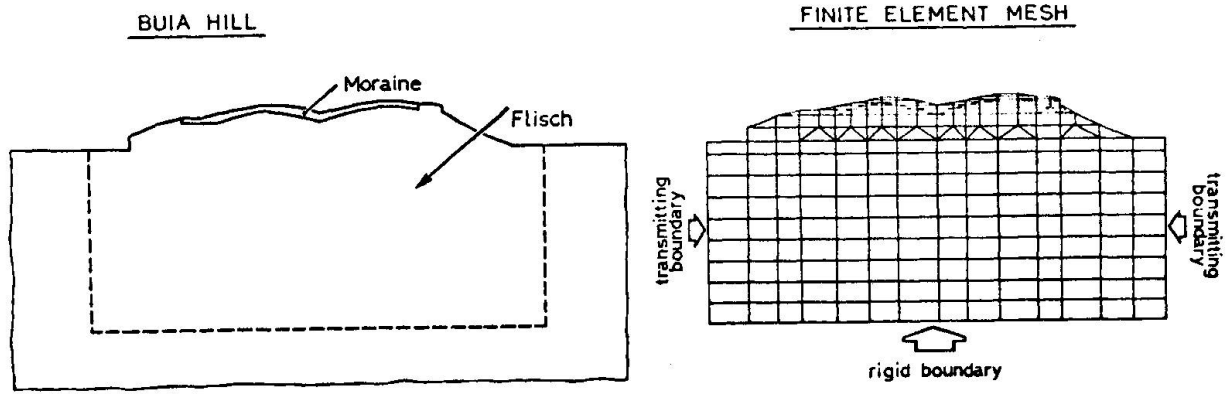
FIG. 1 - Buia hill. Geometry and finite element mesh

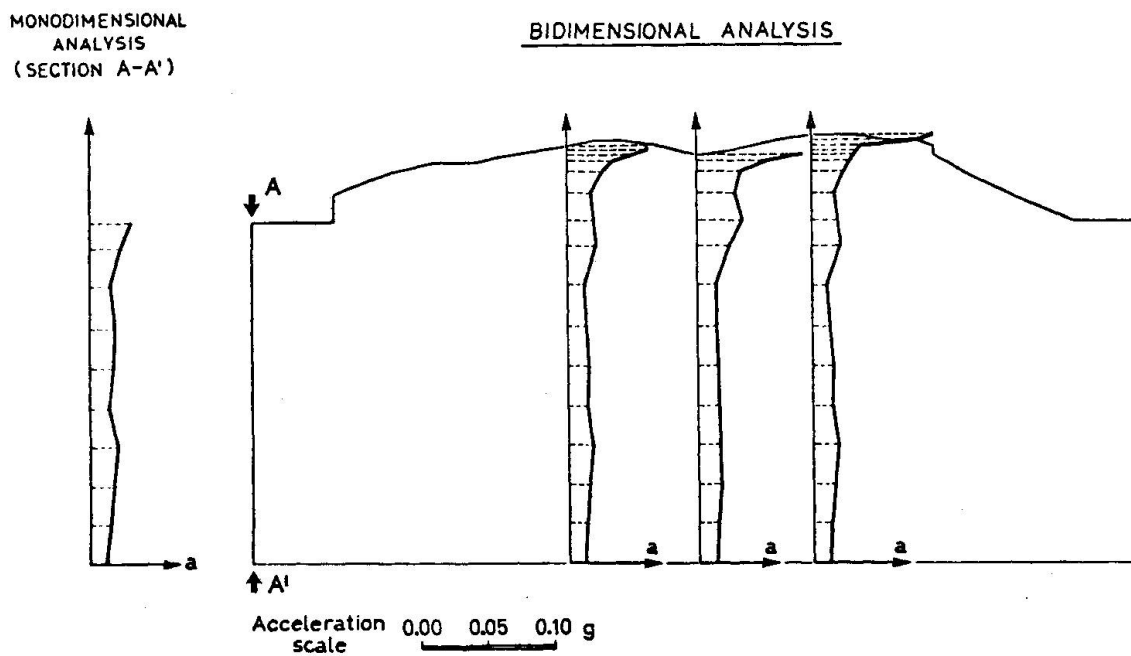
Fig. 2 - Buia hill. Comparison of accelerations obtained with monodimensional and bidimensional analysis

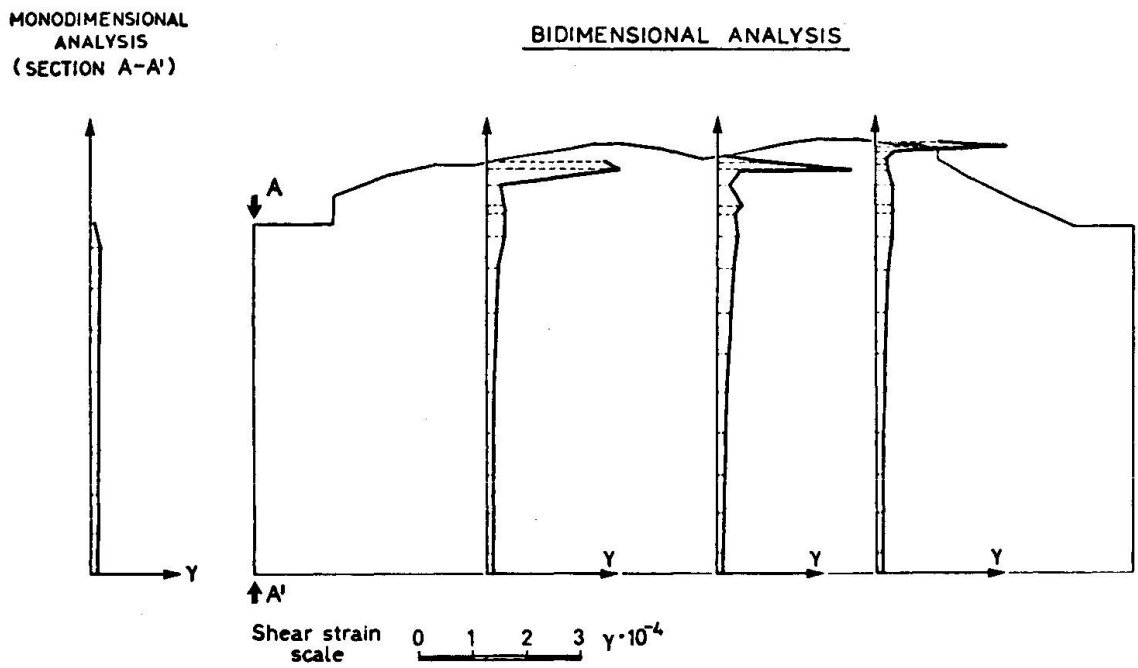
Fig.3 - Buia hill. Comparison of shear strains obtained with monodimensional and bidimensional analysis

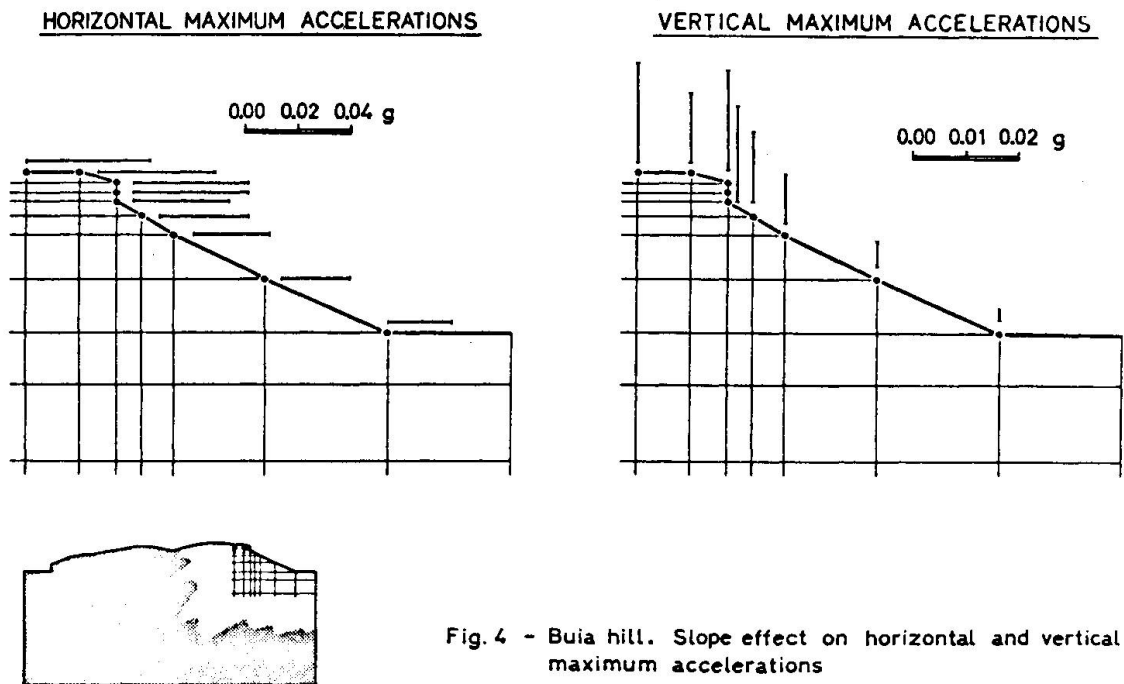
Fig.4 - Buia hill. Slope effect on horizontal and vertical maximum accelerations

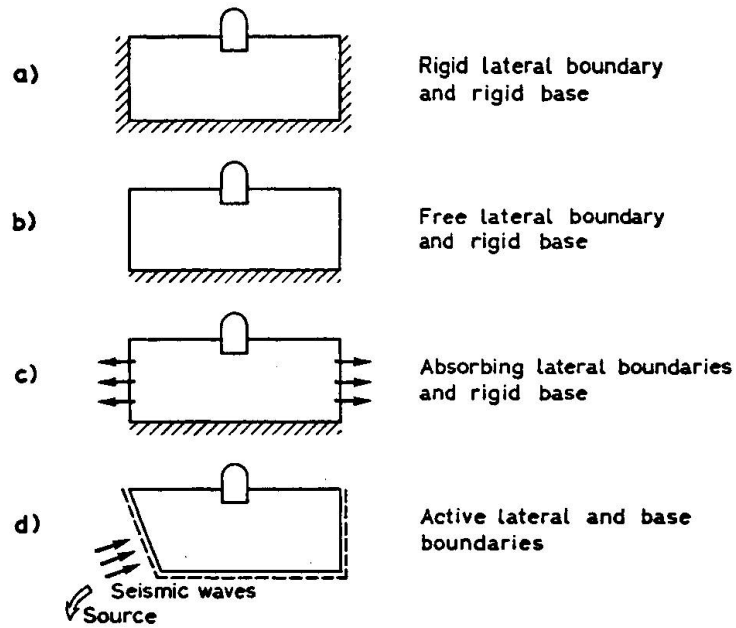
Fig. 5 - Different analytical model for earthquake response of soil deposits

The past years have seen a considerable development of finite element techniques to solve dynamic problems both for soil deposit and for soil-structure interaction analysis, taking advantage of the flexibility and ease with which the finite element method can be adapted to different geometries, which are usually met in soil mechanic problems [13]. But, the use of finite elements to simulate an infinite space calls for suitable boundary conditions to avoid spurious reflections from the model contour [7]. Three techniques, of increasing sophistication, have been proposed up to now - see Fig. 5.

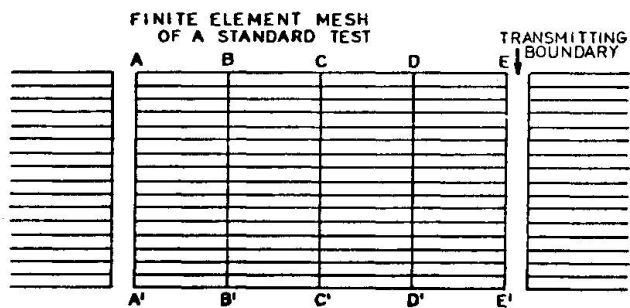
Fig. 6 - Flush technique. Comparison between monodimensional and bidimensional analysis

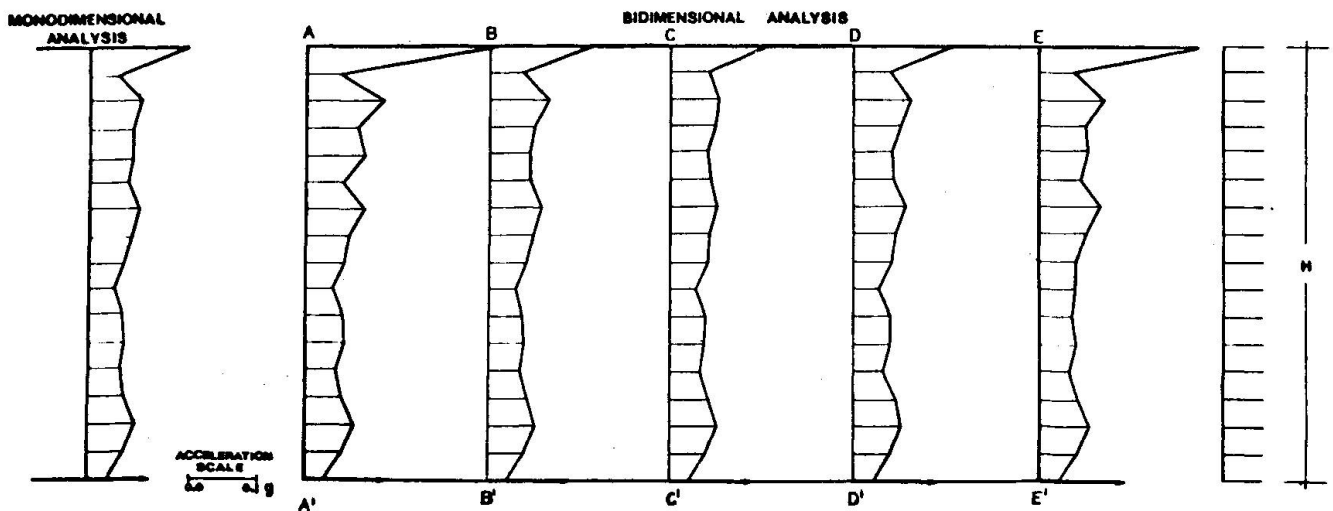
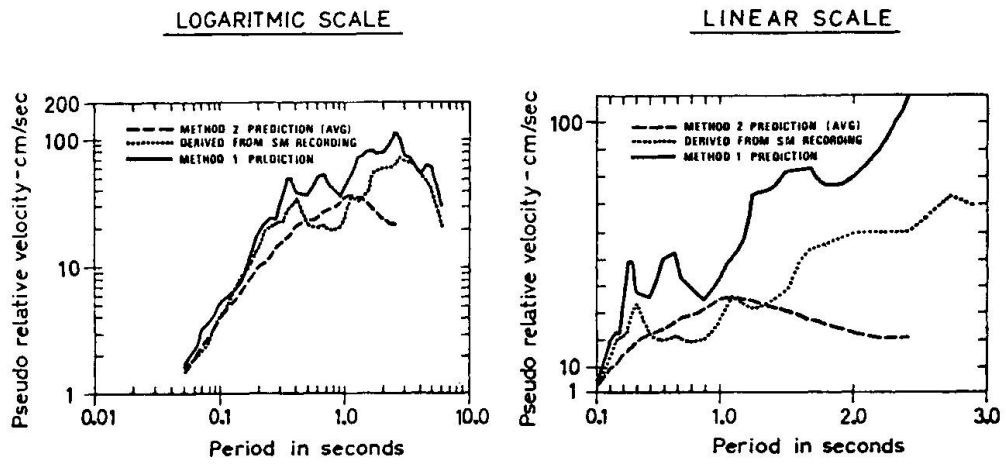
Fig.7 - Calculated relative site transfer function and comparison of spectral prediction methods - Hays et al. results [11]

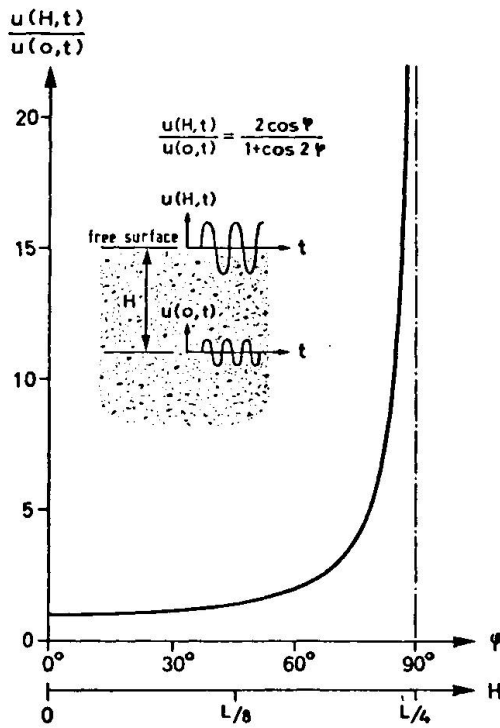
Fig. 8 - Frequency transfer function

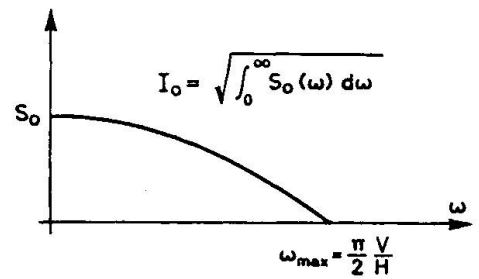
Fig. 9 - Assumption for power spectral density of seismic acceleration at some depth

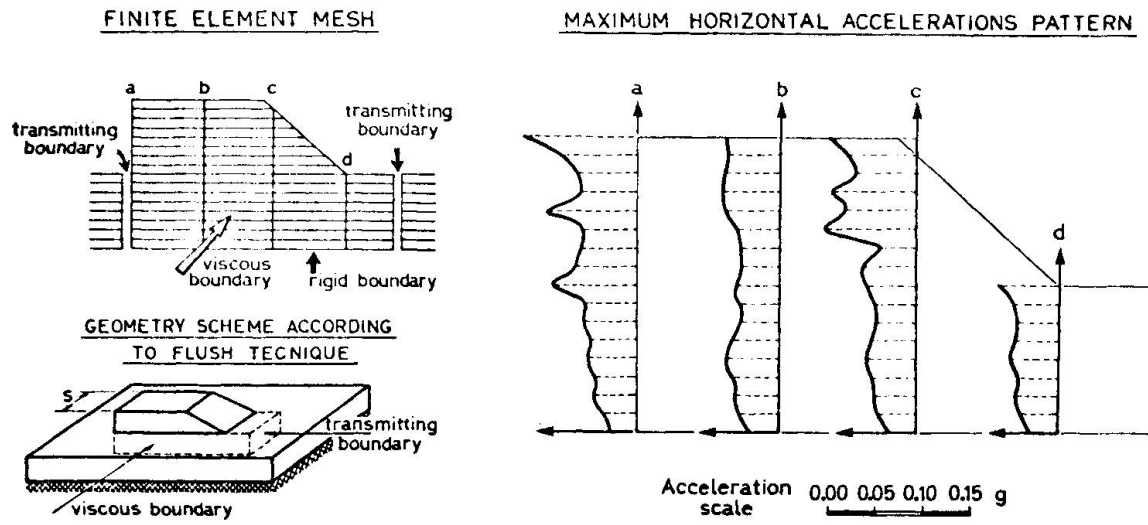
Fig.10 - Hilly site. Geometric effect on accelerations

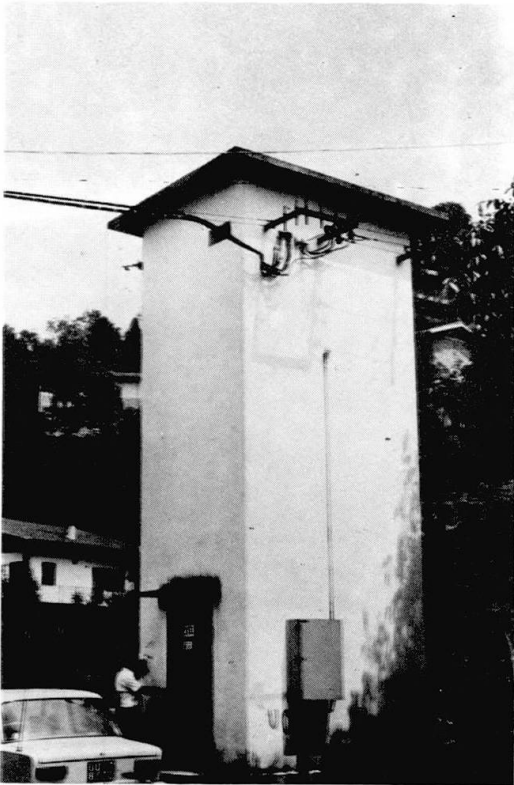
Fig 2. Distribution cabin at Bilerio.

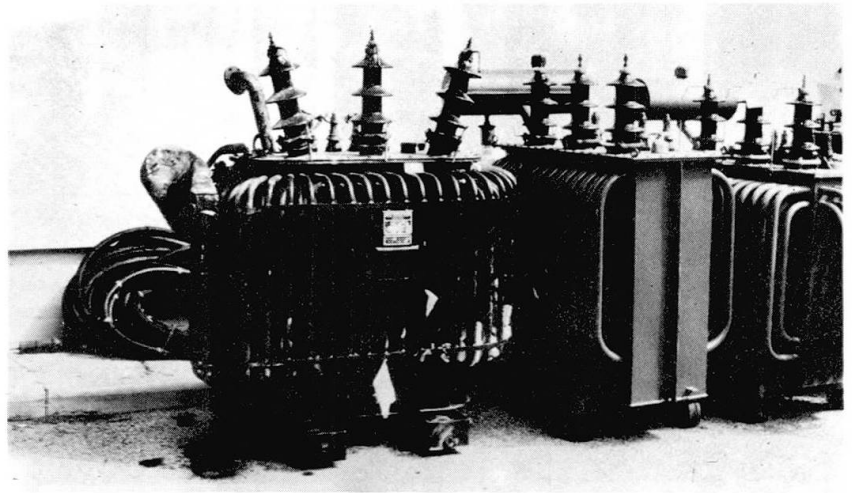
Fig 1. Damaged and new distribution transformers.

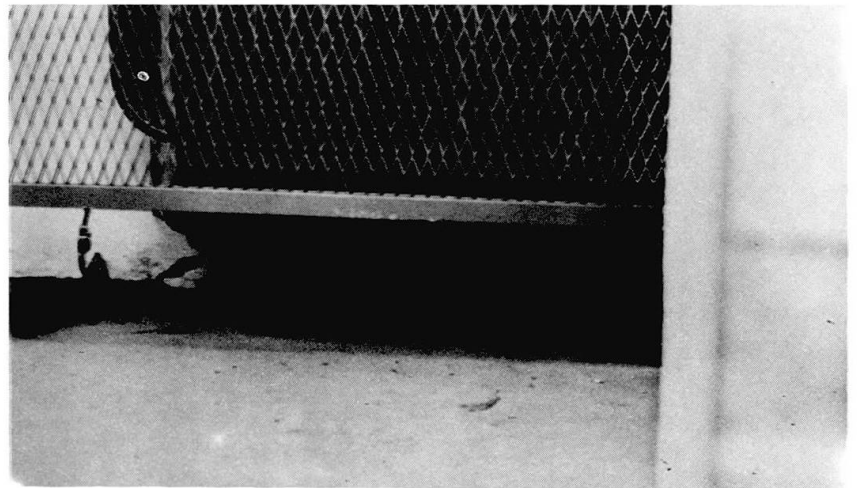
Fig 3. The transformer inside the cabin has moved during the earthquake; one of the back wheels fell into the oil drainage well.

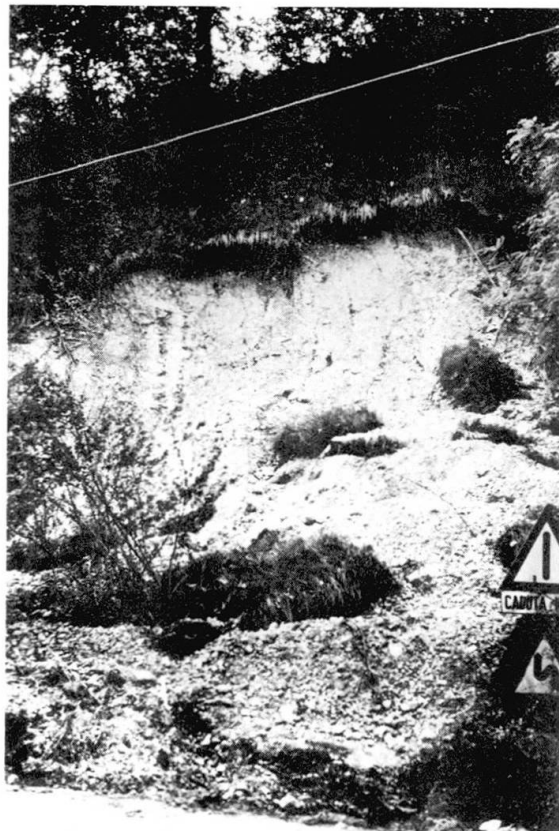
Fig 5. Small landslide by the road at Cornino.

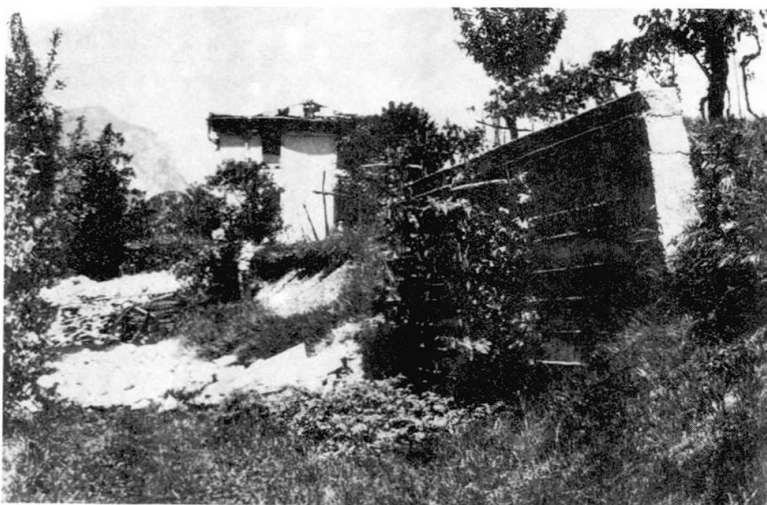
Fig. 7. Duomo Gemona; Failure of the retaining wall.

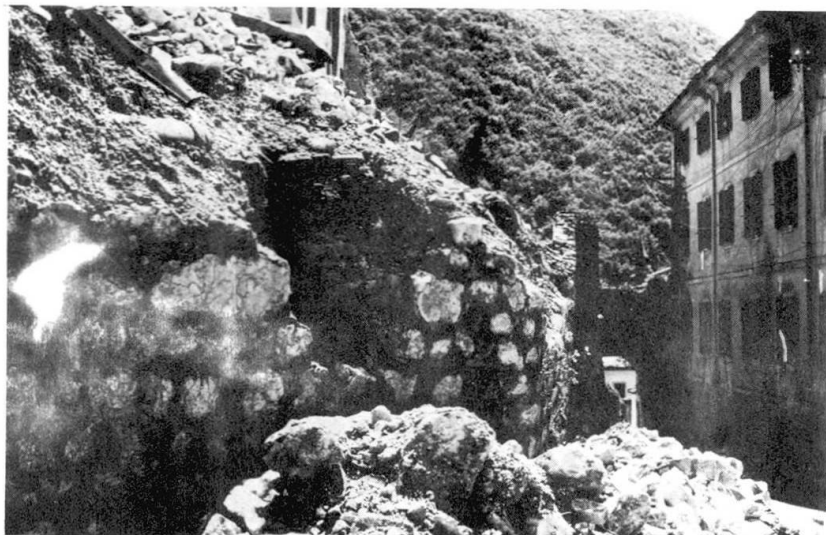
large as in the valley. The slip vectors, however, were large enough to cause the failure of retaining walls. Figure 6 was taken from Gemona. The low strength masonry wall could not resist the slip vector as did the concrete wall sitting next to it.

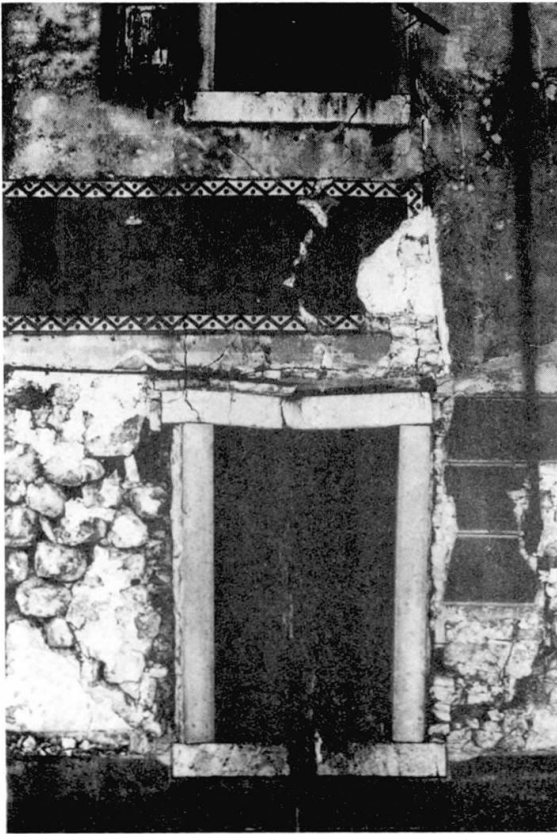
Fig. 8 Collapse mechanism of masonry wall at Gemona.

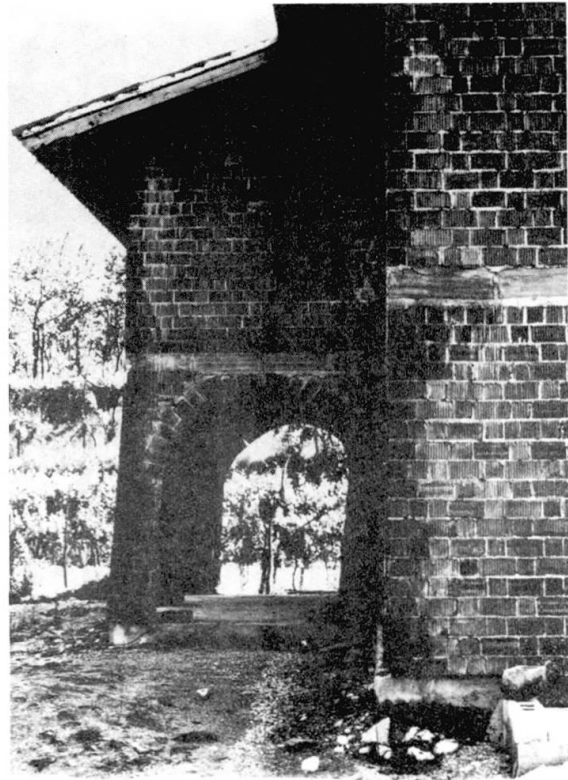
Fig. 9 Gemona; the building moved back and forth on the concrete base.

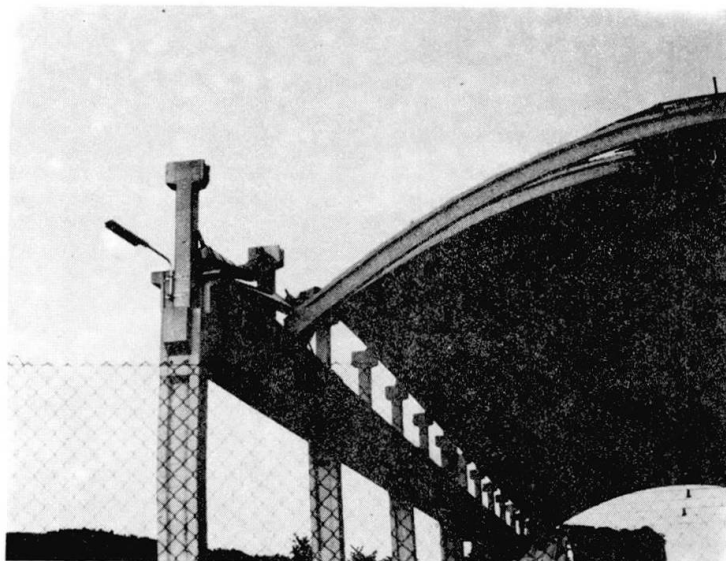
Fig. 10 (above) Industrial hangar at Magnano;
collapse mechanism.

Figure 10 shows the mode of collapse of an industrial hangar. In this case the relatively small slip vector measured on the ground was amplified by the elastic deformation of the column.

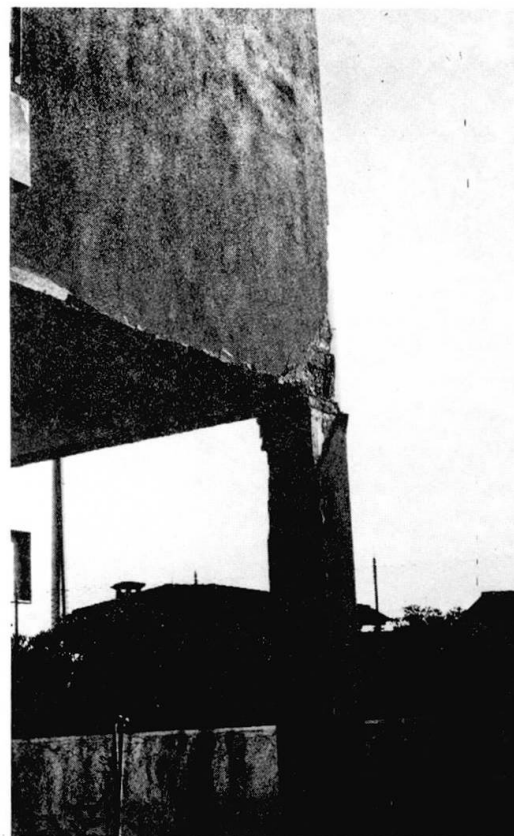
Fig. 11 (right) Slip at the joint of a prefabricated building at Majano.

Dislocations along joints in prefabricated buildings may be critical in their earthquake performance as shown on Figure 11. The building is in Majano across the road from another building that collapsed. A variation of the joint strength in one direction could have set up the collapse mechanism.

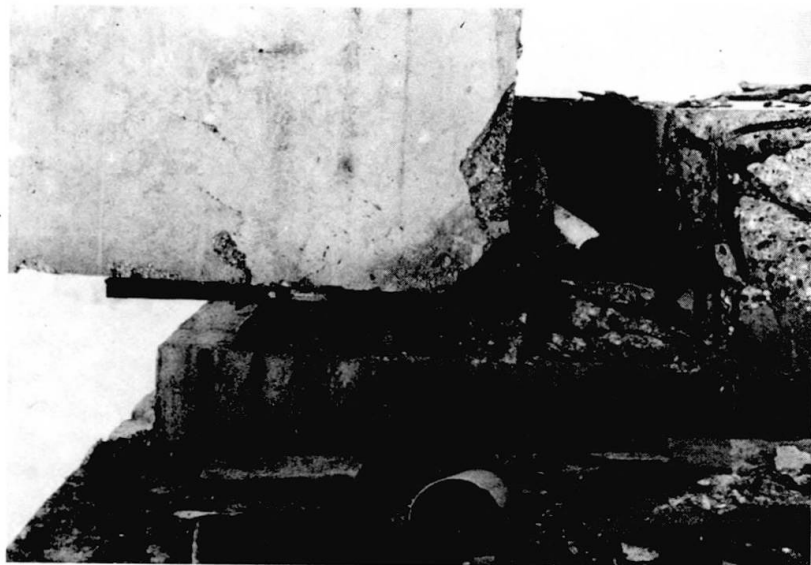
Fig. 12 Prestressed bridge over the Tagliamento River;
slip of the supports.

On the recent alluvium the transformers showed large displacements. The same large dislocations could be seen along the supports of the prestressed bridge across the Tagliamento River (Figure 12).

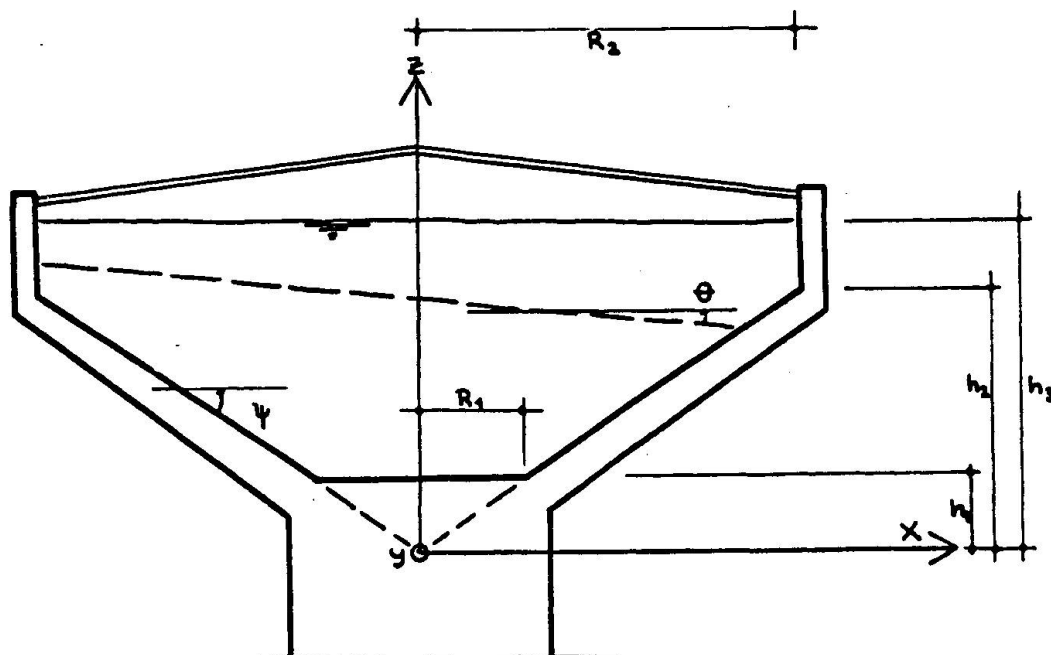
$$\begin{aligned} h_1 &= 0.74 \text{ m} \\ h_2 &= 2.54 \text{ m} \\ h_3 &= 2.89 \text{ m} \end{aligned}$$

$$\begin{aligned} R_1 &= 1.30 \text{ m} \\ R_2 &= 4.55 \text{ m} \\ \tan \psi &= 0.558 \end{aligned}$$

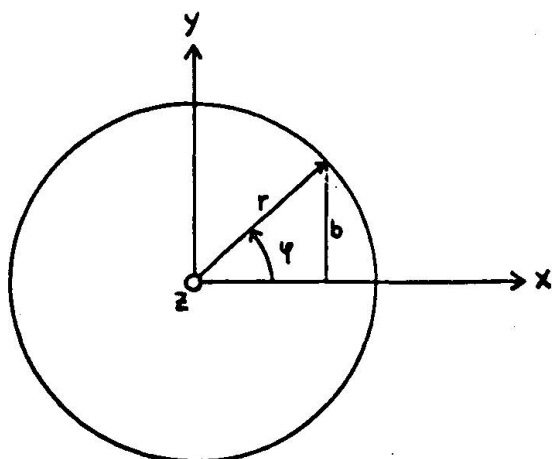
Figure 3: Plan view of the container ($z = \text{const.}$)

where r , b , x , y , and θ are defined in figures 2 and 3, $a = \operatorname{tg} \psi$, a dot means differentiation with respect to time and $(\)_{,z} = \frac{\partial (\)}{\partial z}$. u , v , w are the components of the velocity \underline{v} . The equations (1) differ from the equations (2) only in the component u , where in (1) the second summand is due to the conical shape of the container.

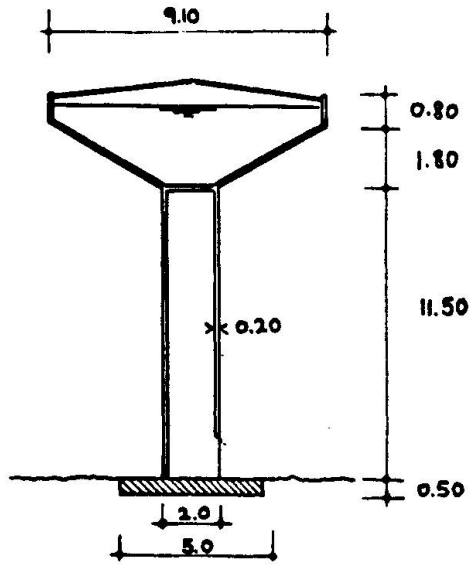
Figure 4: Watertower at Gemona railway station

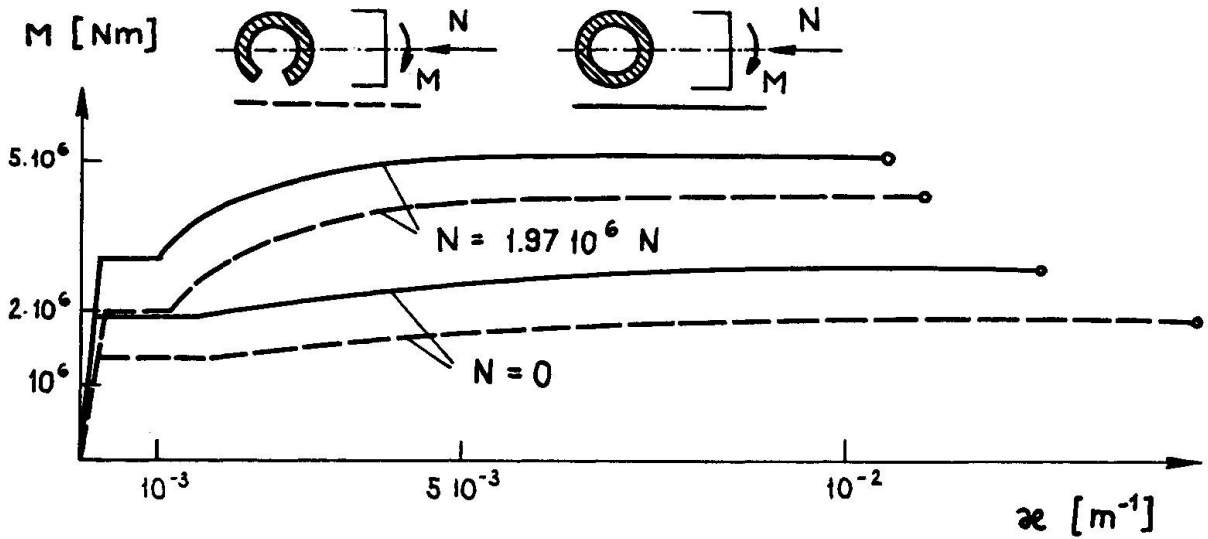
Figure 5: Momentum-curvature-relationship for the reinforced concrete column. The normal force $N = 1.97 \cdot 10^6 \text{ N}$ is the result of water and structure weight.

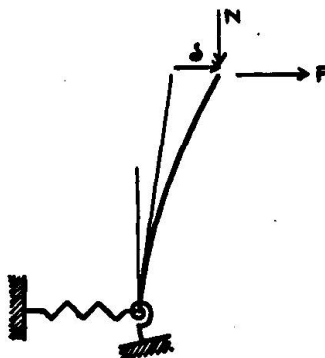
Figure 6: Structural model to calculate the force-deflection-relationship

To get the deflection δ of the column due to the horizontal force F (Figure 6), the curves of Figure 5

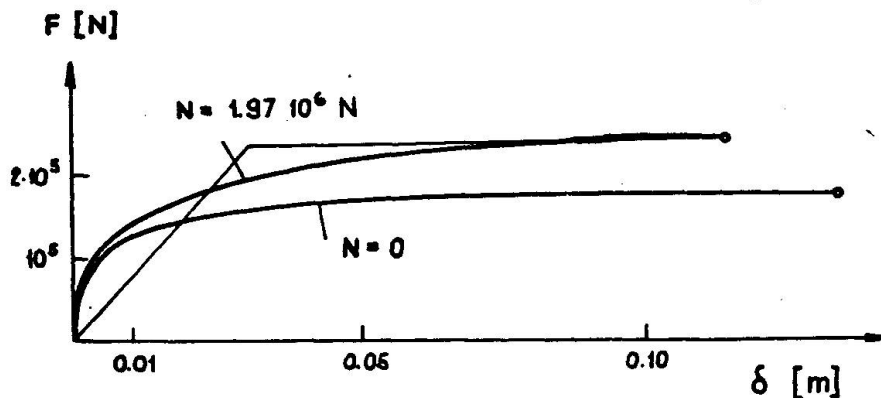
Figure 7: Force-deflection-relationship for the structural system of Gemona watertower

have to be integrated over the length of the column for different forces F . This leads to the nonlinear force-deflection-relationship indicated in Figure 7.

While the $P-\Delta$ -effect, which reduces the ultimate force F by approximately 10%, cannot be neglected, the decrease of stiffness due to the shear force may be disregarded.

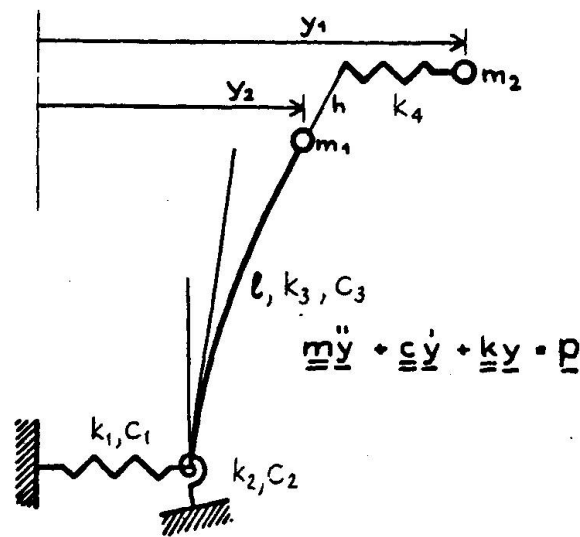
Figure 8: Structural system of Gemona watertower for elastic response analysis; m_1 is the sum of the weight of the structure and Housner's added mass for impulsive pressure; m_2 and k_2 account for the added mass-spring-system resulting from the convective pressure in the composite combiner.

An elastic analysis of the water-structure-system can be performed to study the coupling mechanisms of water and structure. For the purpose of determining and discussing the response of Gemona watertower a two-degree-of-freedom-system (Figure 8) is chosen.

For a cylindrical container with flat bottom, h would be near zero, while in the present case h is not negligible and influences the response considerably. The input parameters for an elastic analysis are (see Figure 8):

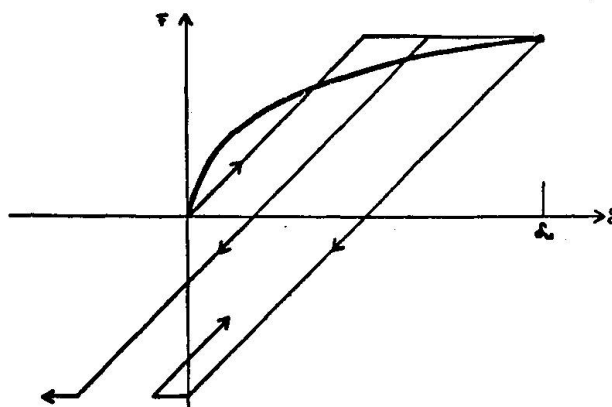
Figure 9: Simplified bilinear hysteretic behaviour of the Gemona watertower column.
