Zeitschrift: IABSE reports of the working commissions = Rapports des commissions de travail AIPC = IVBH Berichte der Arbeitskommissionen

Band: 30 (1978)

FRIULI EARTHQUAKES 1976
STRONG MOTION ACCELEROGRAPH RECORDS

STRUCTURAL BEHAVIOUR OF THE DAMAGED BUILDING DURING THE
FRIULI EARTHQUAKES BETWEEN MAY 6 AND SEPTEMBER 15, 1976

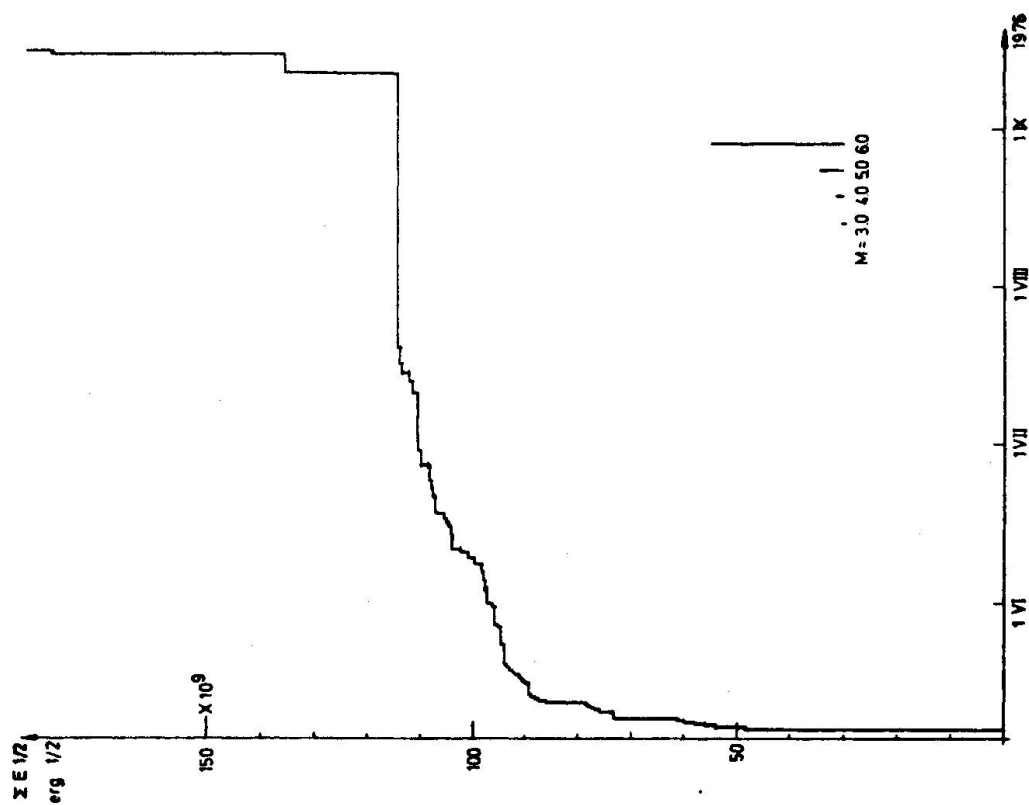
Fig. 4 STRAIN RELEASE CURVE (May 1st to Sept. 15, 1976)
(After I. Cvijanovic)

To the east, in Yugoslavia, typical seismogene zones in continuation with the west-east directed faults of the Friuli Pre-Alps and Julian Pre-Alps are found in the region of Tolmin, whereas southwards this direction changes into north-west-southwest (Dinaride direction). Zones of Ljubljana, Idrija, Ilirska Bistrica-Klana and Rijeka are typical earthquake origin areas with possible magnitudes over 6.5 but however with a small possibility of occurrence. As evident from the time distribution of strong shocks in the region, calm periods exist, however they are lately followed by strong seismic motions (Fig. 3). After the series of 1959 events, no stronger earthquakes were recorded in the period from 1963 to 1975. Finally, the energy release culminated in the May 6, 1976 earthquake and the subsequent earthquakes of the fall 1976 and spring 1977 (Fig. 4).

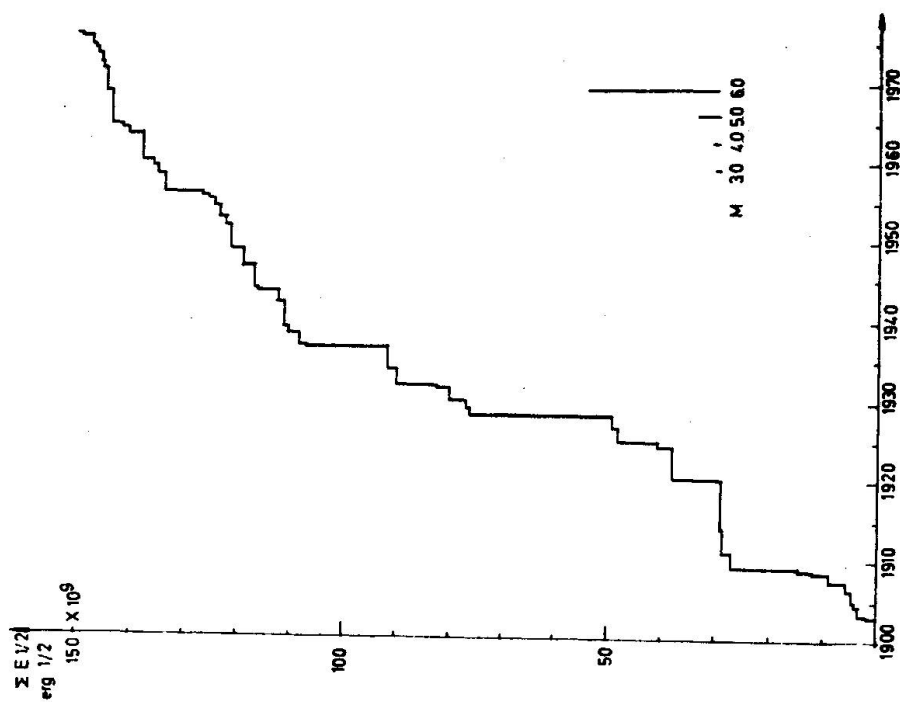
Fig. 3 STRAIN RELEASE CURVE (1900 - 1976)
(After D. Cvijanovic)

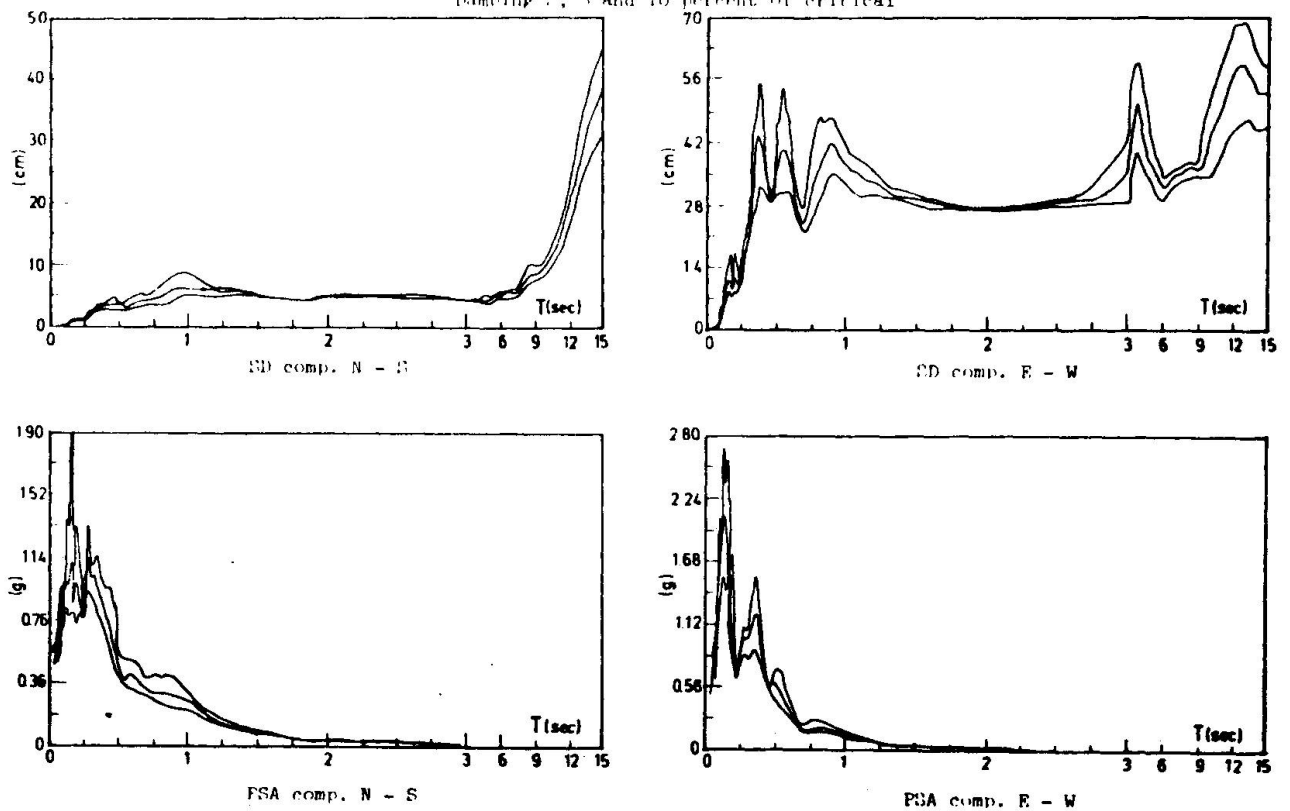
Fig. 10

FRIULI EARTHQUAKE, ITALY, SEPT. 15, 1976, 03h 15m, RECORDED IN BREGINJ - YUGOSLAVIA
 RELATIVE DISPLACEMENT AND PSEUDO ACCELERATION RESPONSE SPECTRA
 Damping 2, 5 and 10 percent of critical

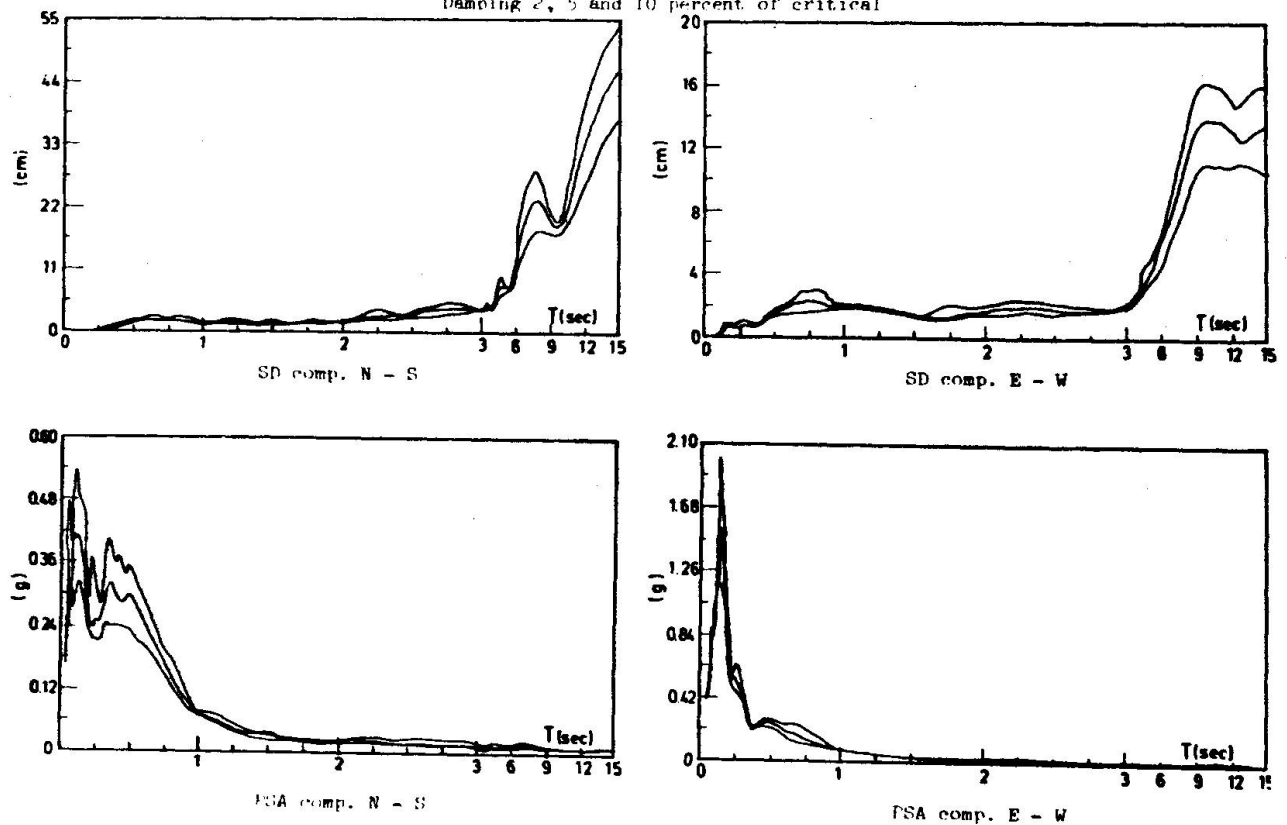
Fig. 11

FRIULI EARTHQUAKE, ITALY, SEPT. 15, 1976, 03h 21m, RECORDED IN BREGINJ - YUGOSLAVIA
 RELATIVE DISPLACEMENT AND PSEUDO ACCELERATION RESPONSE SPECTRA
 Damping 2, 5 and 10 percent of critical

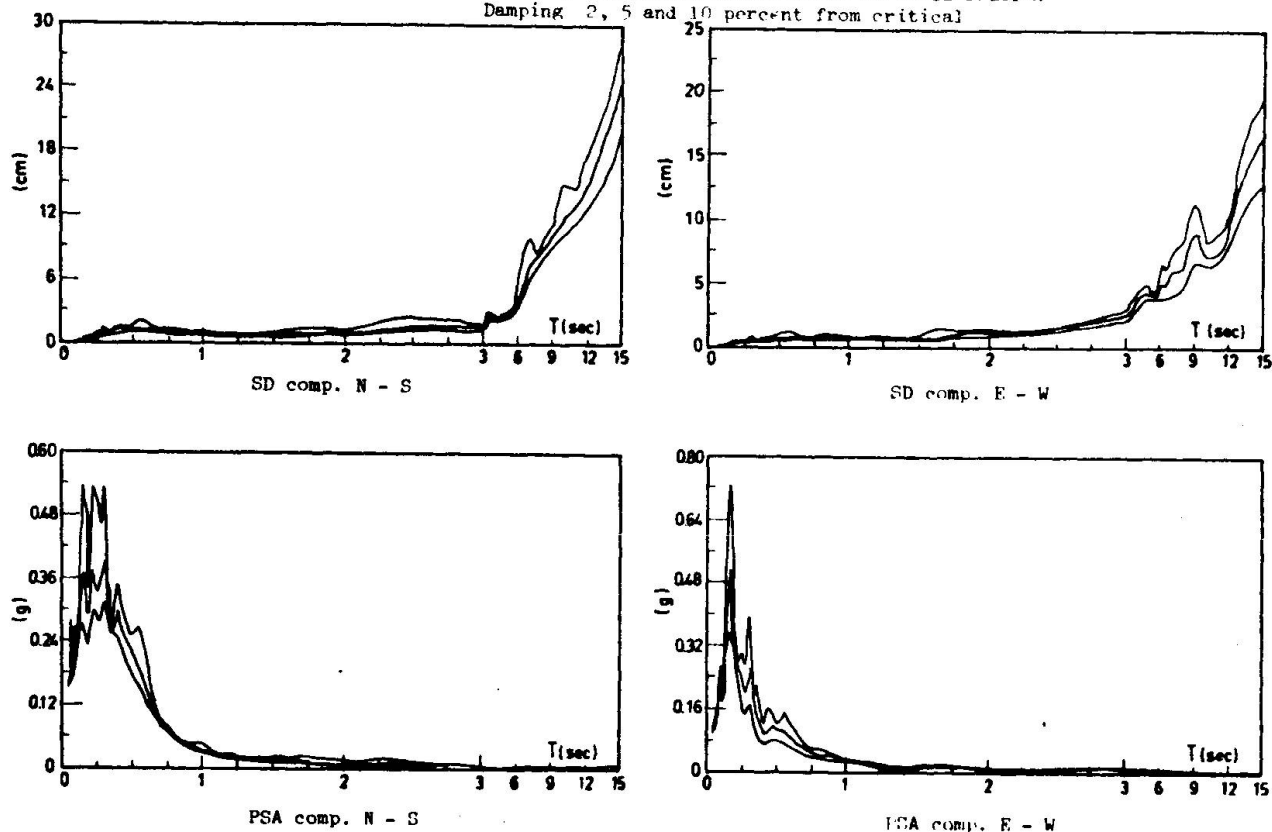
Fig. 12

FRIULI EARTHQUAKE, ITALY, SEPT. 15, 1976, 09h 21m, RECORDED IN KOBARID - YUGOSLAVIA
 RELATIVE DISPLACEMENT AND PSEUDO ACCELERATION RESPONSE SPECTRA
 Damping 2, 5 and 10 percent from critical

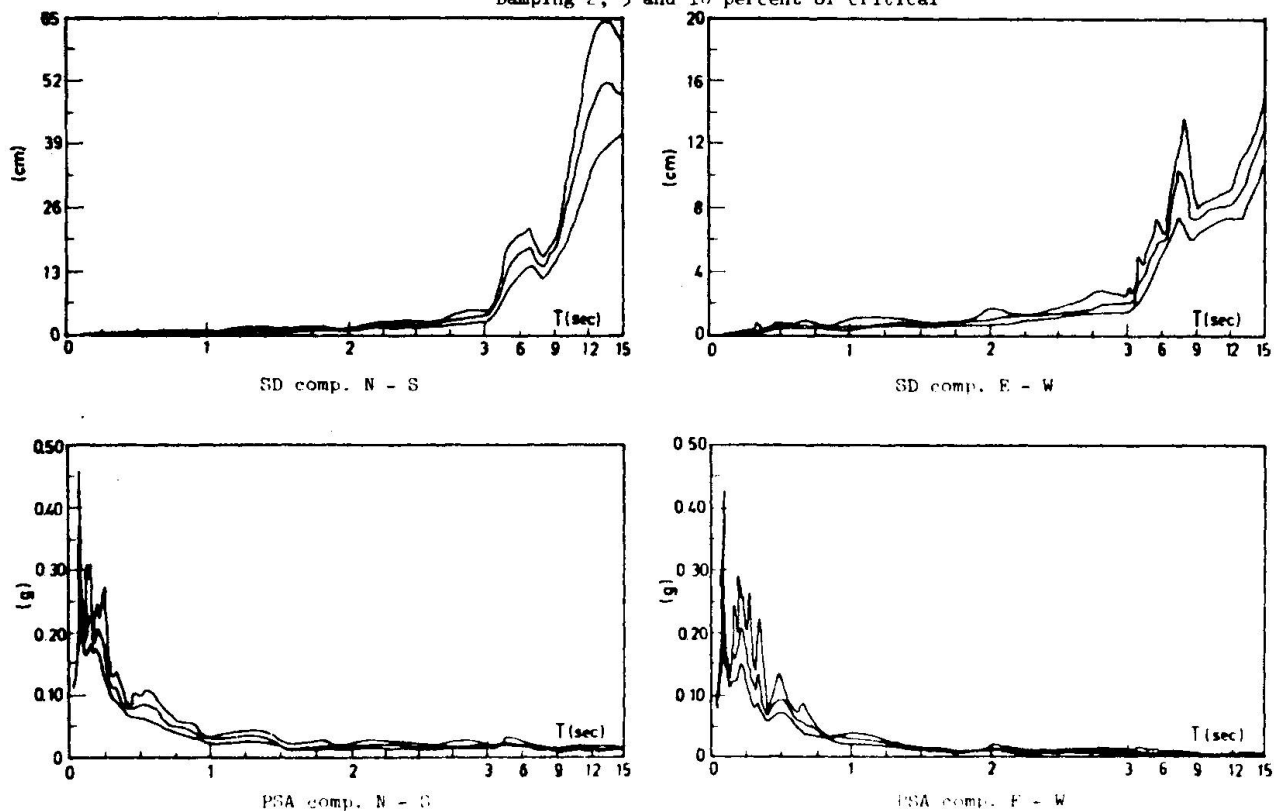
Fig. 13

FRIULI EARTHQUAKE, ITALY, SEPT. 15, 1976, 03 h 15m, RECORDED IN ROBIC - YUGOSLAVIA
 RELATIVE DISPLACEMENT AND PSEUDO ACCELERATION RESPONSE SPECTRA
 Damping 2, 5 and 10 percent of critical

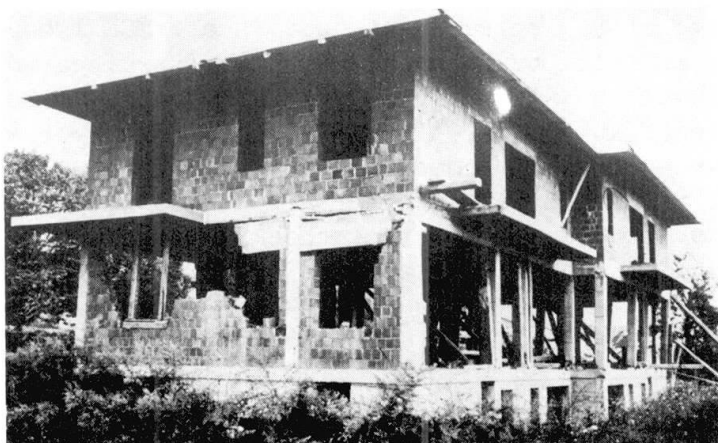
Figure 2: (after September 15th): Uncompleted building in Gemona after renewed earthquake stress. The reinforced concrete columns in the groundfloor were completely destroyed at their fixing points, connection being maintained by the reinforcement only. The massive wooden struts in the groundfloor saved the building from collapse during the second strong earthquake. The already damaged brick wall in the groundfloor was additionally strained due to the strenghtening effect of the wooden struts in the open groundfloor area. The wide brick window jamb was broken out and the reinforced concrete window supports shaken from their rests.

The buildings which were undamaged or which suffered only minor plaster cracks, showed no further damage or, at the most, single wall cracks. Their supporting structure withstood this earthquake load and can be considered sufficiently earthquake-proof against similar earthquakes. The building with severely cracked brick walls suffered in most cases even more masonry damage, due to their weakened condition (Figures 1 and 2).

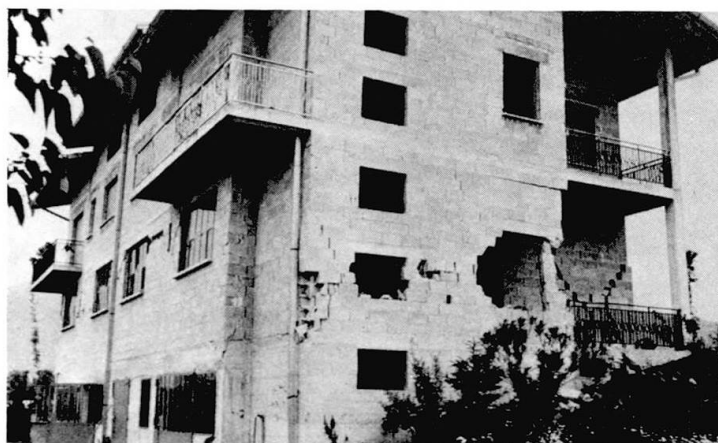
Figure 5: (after May 6th): Residential building with workshop near Artegna with a reinforced concrete cellar and two floors in concrete blocks. The side walls by the entrance incurred gaping X-shaped diagonal cracks due to the high shear stress. These cracks led to partial collapse of the masonry. The highly strained window jambs on the longitudinal façade were badly cracked.

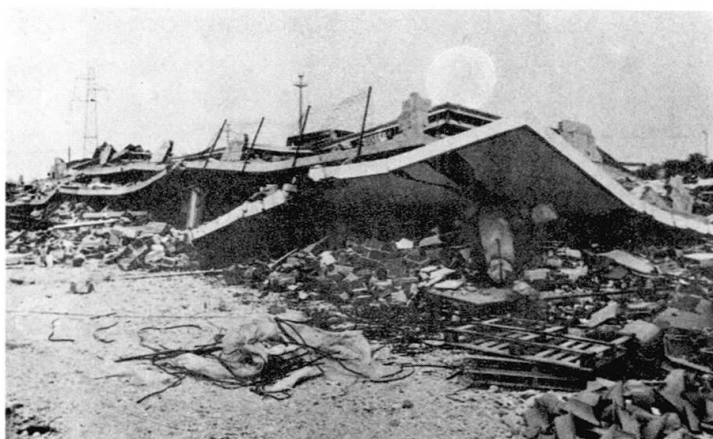
Figure 8: (after September 15th): Wreckage of the residential and business house near Artegna. The groundfloor of the building collapsed during the earthquake of September 11th. Through the impact, the undamaged living storeys also collapsed. The destroyed fixing points of the reinforced concrete columns in the groundfloor as well as the cracked brick walls of the staircase were not enough to carry the renewed strong earthquake stress. The experts had hoped, despite the doubts of the owner, to be able to repair the building.

Those buildings with badly destroyed brick walls or damage to the supporting structure showed a greatly reduced carrying capacity under renewed earthquake load. The buildings experienced further extensive deformation of the damaged parts which often led to local collapse (Figures 5 and 6) or to the collapse of the entire building (Figures 7 and 8).

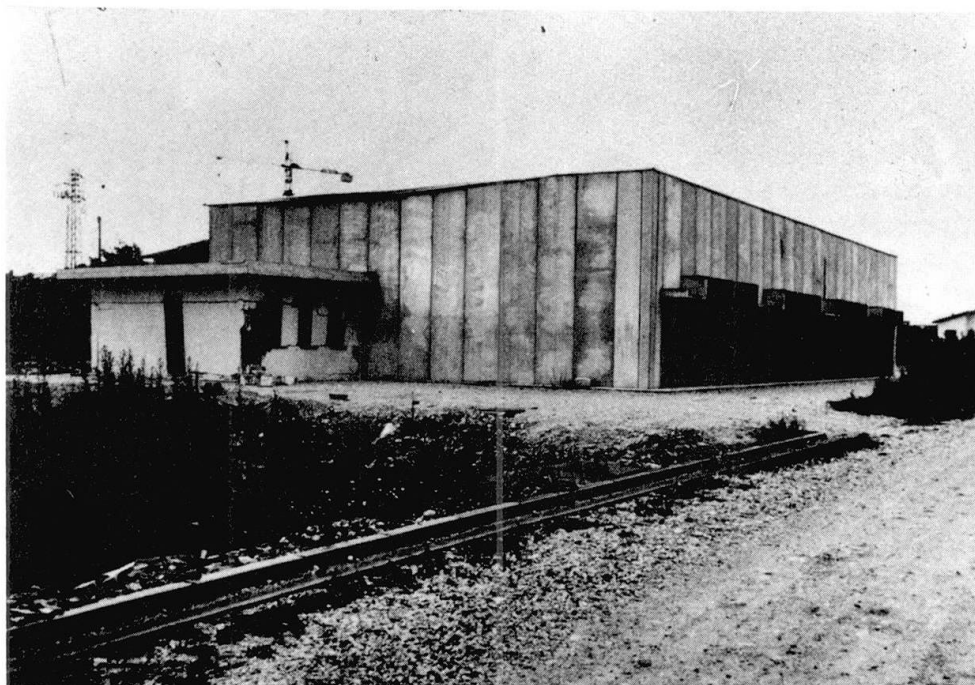
Figure 16: Prefabricated storage shed with brick annex in Gemona. Side wall panels slightly caved in by impact with rigid annex. Upper part of the annex shorn off and pushed over by the impact force due to insufficiently wide joints.

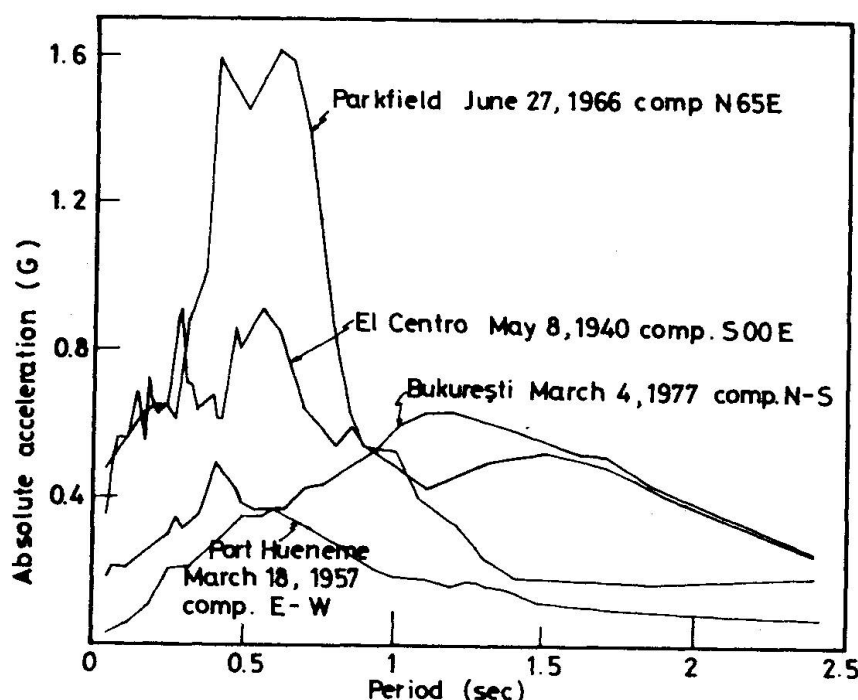
Fig. 2 Absolute acceleration response spectra for damping 5% of critical

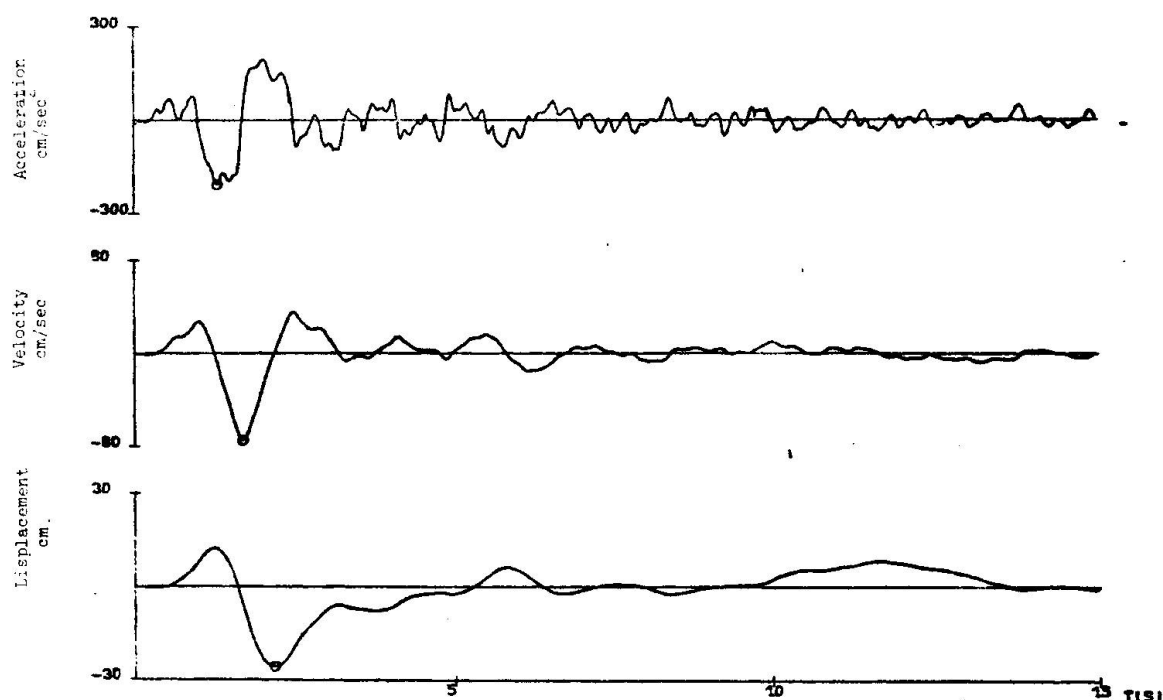
Fig.2 Record of the earthquake of March 4, 1977 - INCERC

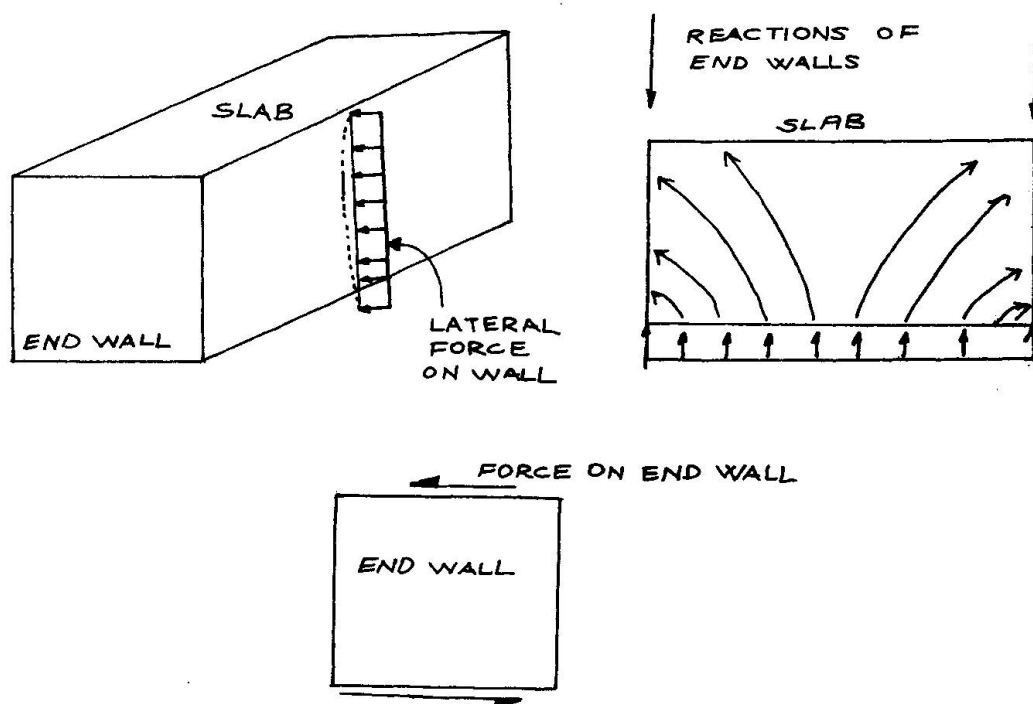
Figure-1 State of Loading on Brick Walls Due to Lateral Forces

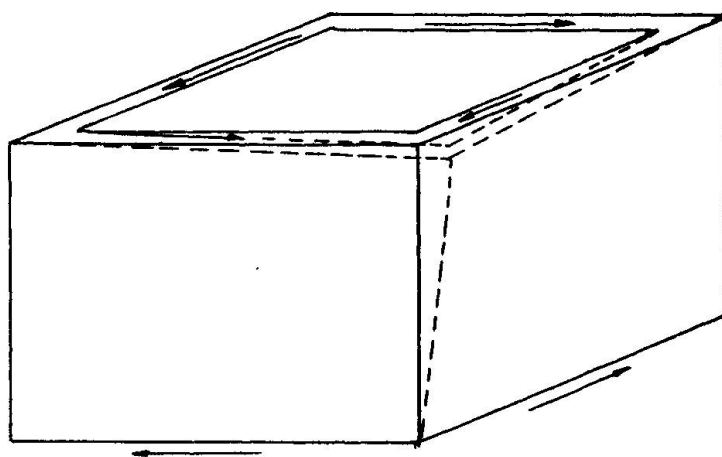
Figure-2 Corner Behaviour of Masonry Buildings.

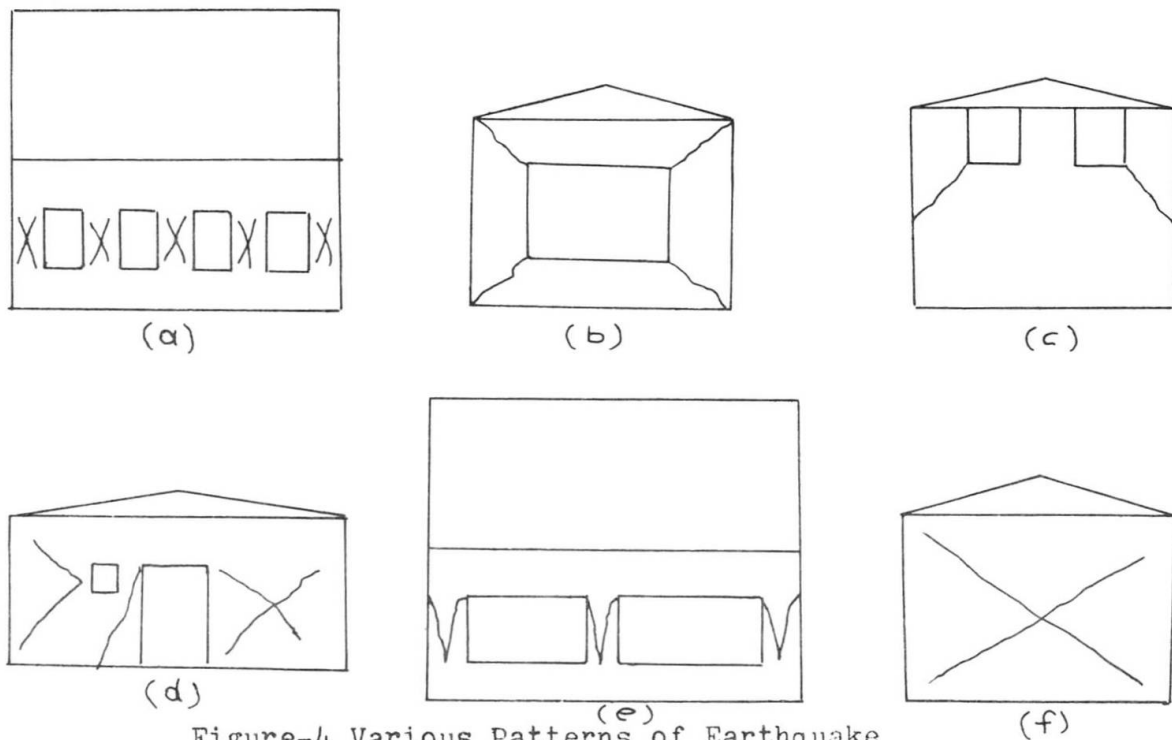
Figure-4 Various Patterns of Earthquake Cracking in Masonry Buildings

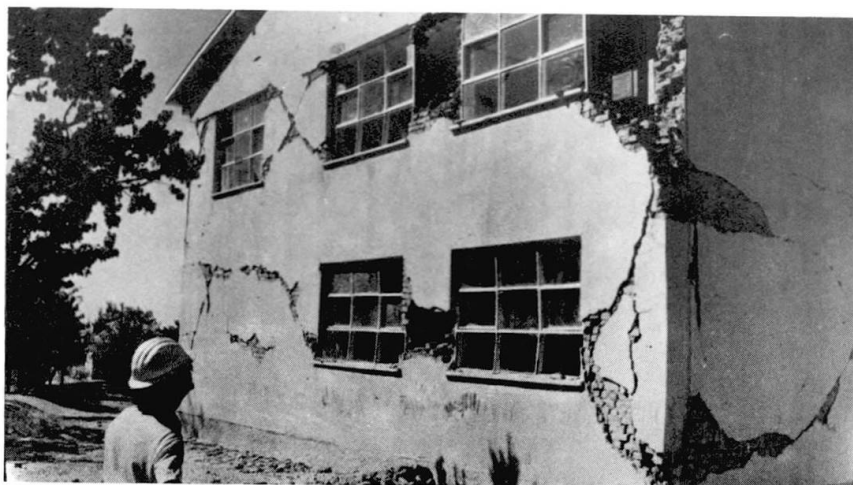
Figure-7 Typical Failure of Brick Masonry

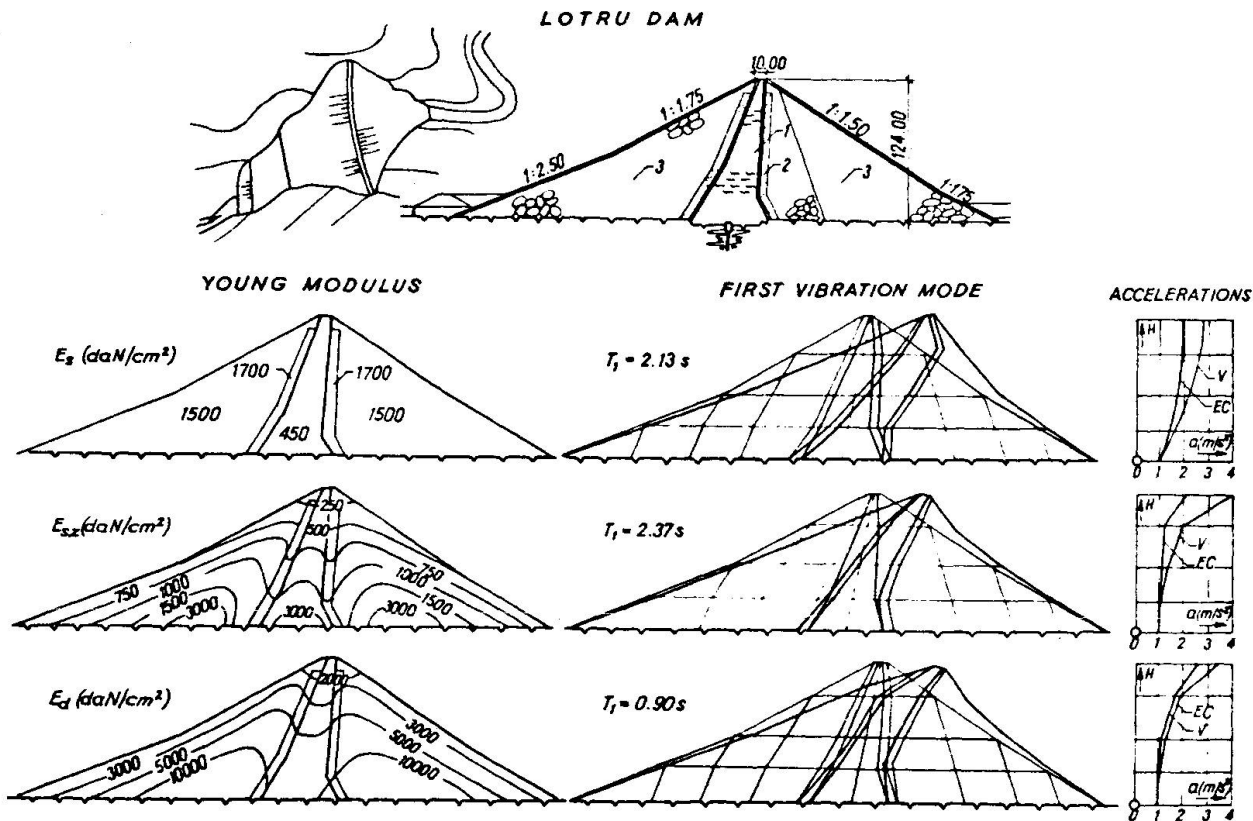
Fig. 3 Earthquake response of the Lotru dam:1-clay core,2-tranzition zone;3-rockfill.

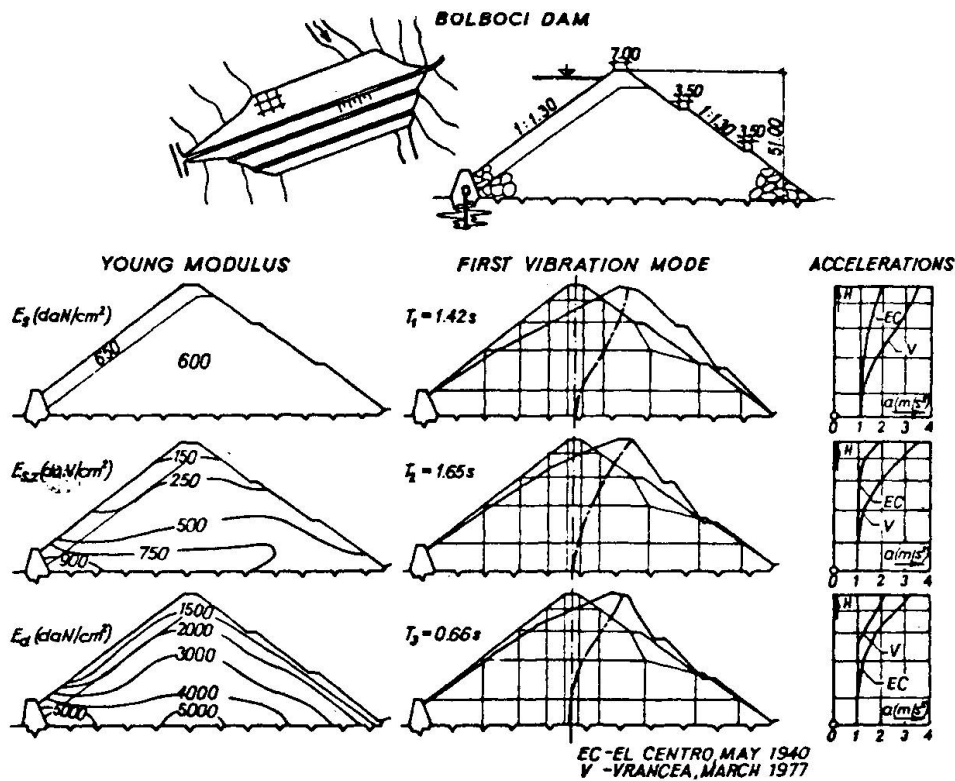
Fig. 4 Earthquake response of the Bolboci dam.

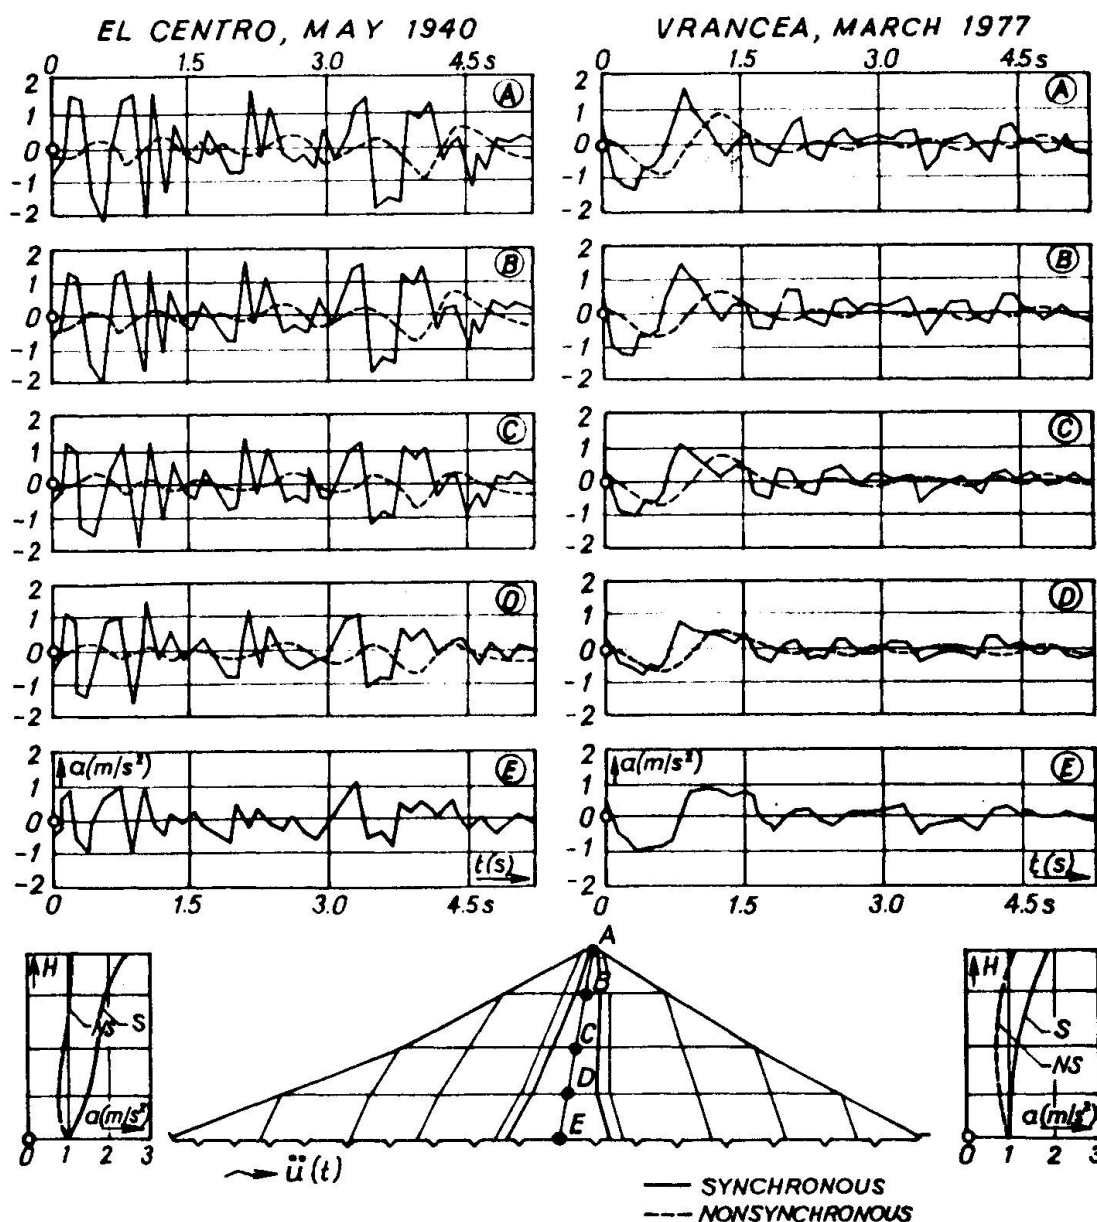
Fig. 6 The influence of the nonsynchronous character of the excitation on the earthquake response of Lotru dam.

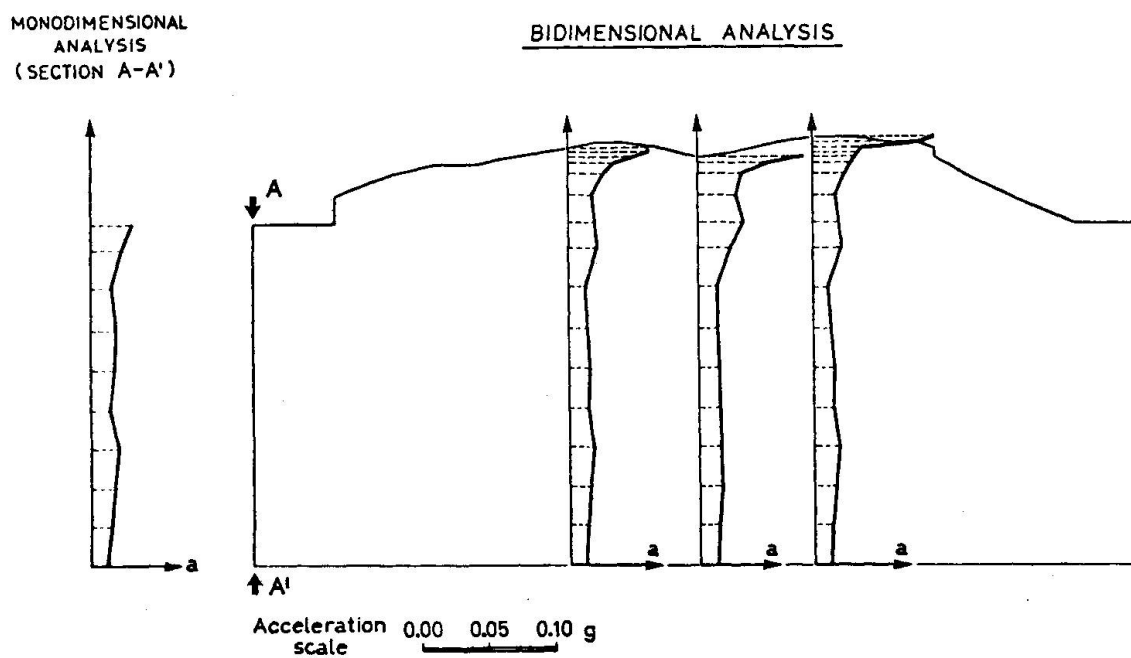
Fig. 2 - Buia hill. Comparison of accelerations obtained with monodimensional and bidimensional analysis

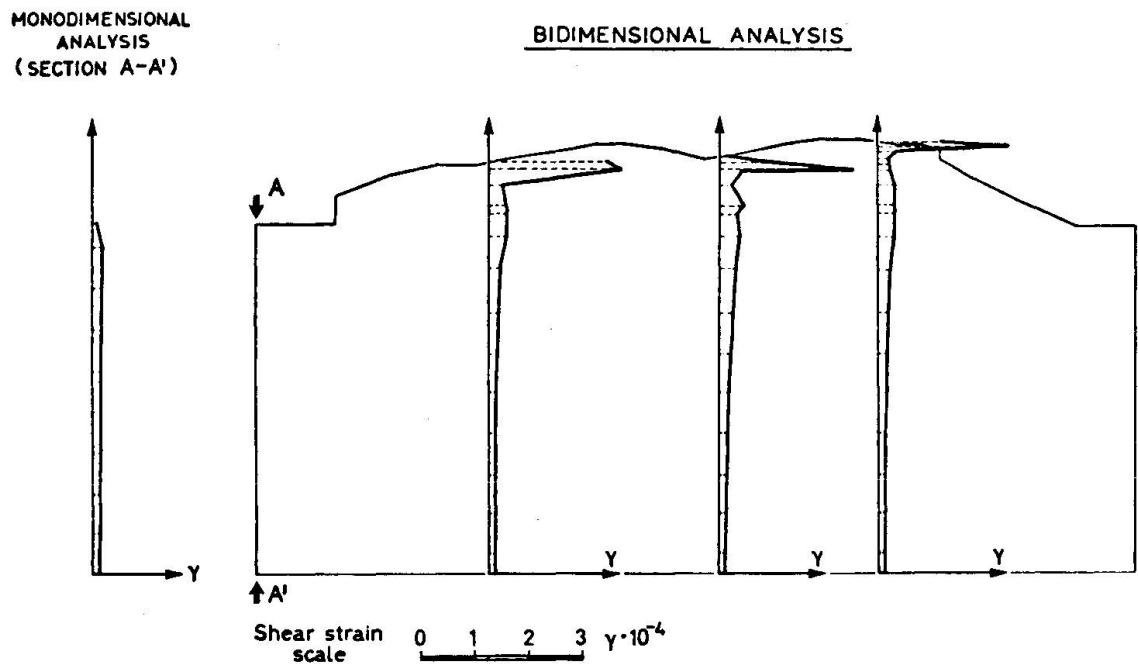
Fig. 3 - Buia hill. Comparison of shear strains obtained with monodimensional and bidimensional analysis

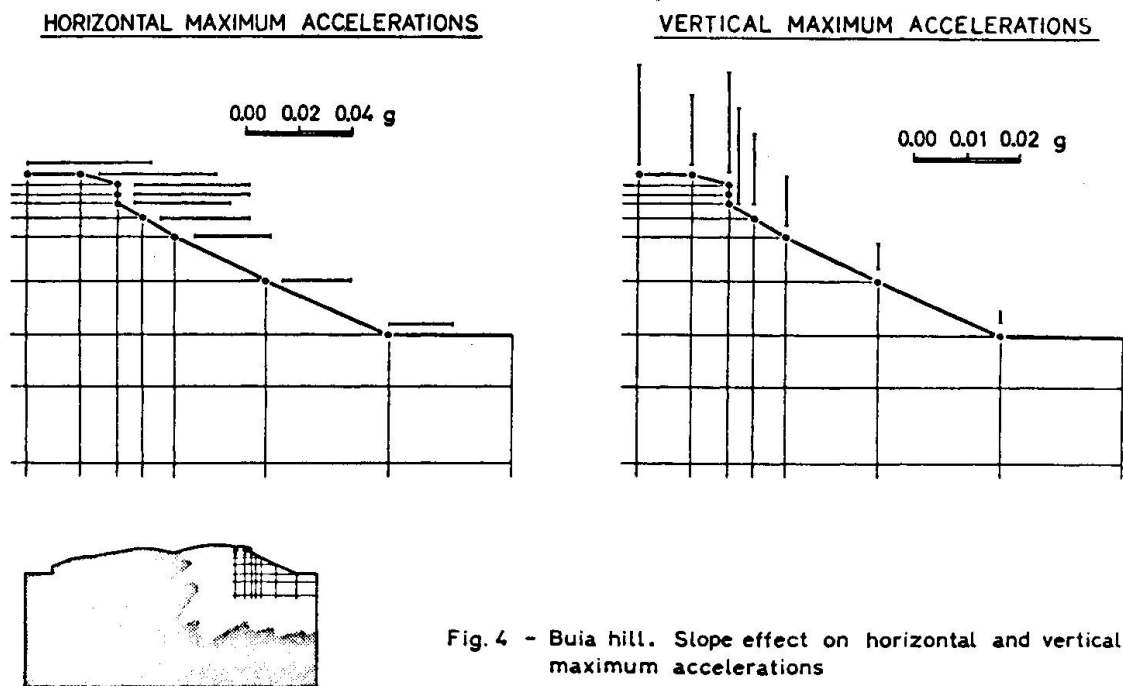
Fig. 4 - Buia hill. Slope effect on horizontal and vertical maximum accelerations

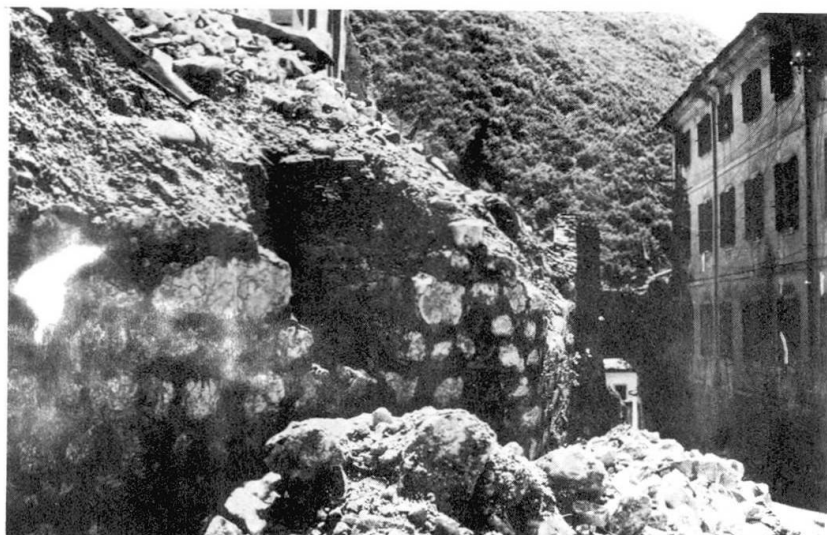
large as in the valley. The slip vectors, however, were large enough to cause the failure of retaining walls. Figure 6 was taken from Gemona. The low strength masonry wall could not resist the slip vector as did the concrete wall sitting next to it.

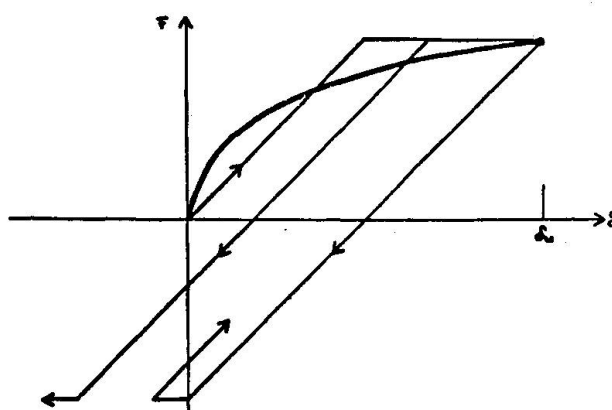
Figure 9: Simplified bilinear hysteretic behaviour of the Gemona watertower column.
