Artikel: Effects of Vrancha earthquake of 4 March 1977 on the territory of Bulgaria

EFFECTS OF VRANCHA EARTHQUAKE OF 4 MARCH 1977 ON THE TERRITORY
OF BULGARIA

S.Sachanski - Dr.Eng.Head Dept.Seismic Mechanics,Bulgarian Academy of Sciences,Sofia,Bulgaria.

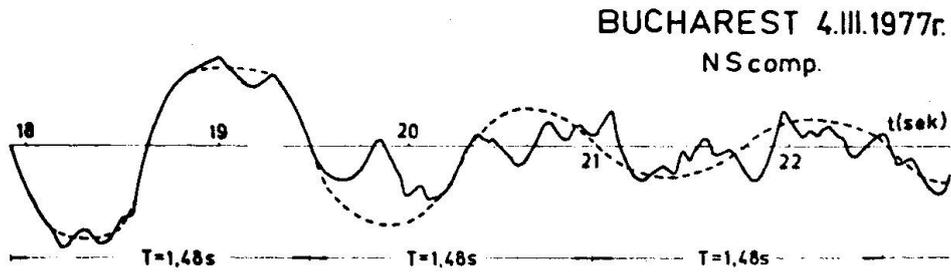
fig. 1

On the accelerograms recorded in Bucharest (INCERC), at distance 170 km from epicenter, can be seen typical sinusoidal character of the motion after 18 sec for both NS and EW components (fig.1). The accelerograms in Nish (453 km from epicenter) (fig.2) contain similar long period motion combined with short period waves specified by the geological conditions.

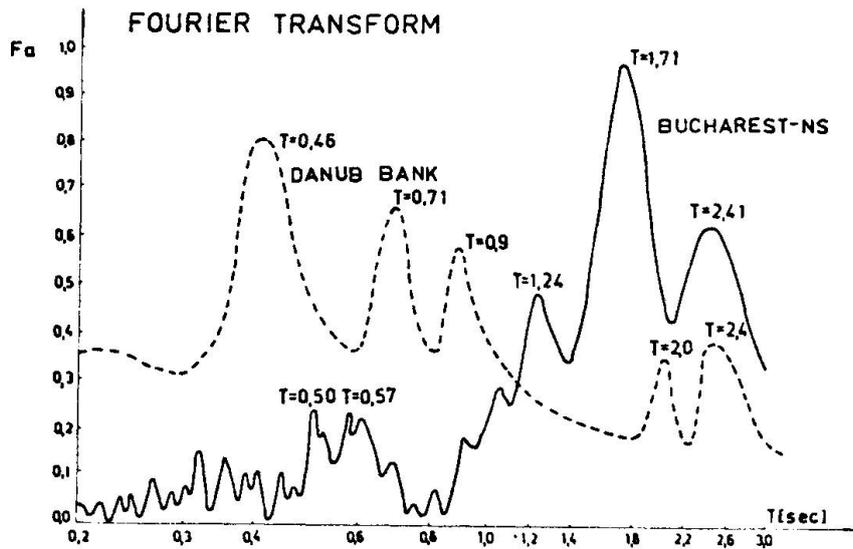
fig. 3

The Fourier transform spectra from Vrancha earthquake for Bucharest [1] and Nish [2] records and experimentally determined period [3] at right bank of Danube river (300 km from epicenter) are given on (fig.3). It is evident that specific deep geological conditions with short natural predominant periods for surface layers generate additional short motions (fig.2). Well known filtration of the short period waves with distance is not observed in this case. There are some regions on the territory of Bulgaria which generate short period motions and others one-long periods. This fact was confirmed by the behaviour of the structures with different natural periods located at different ground conditions.

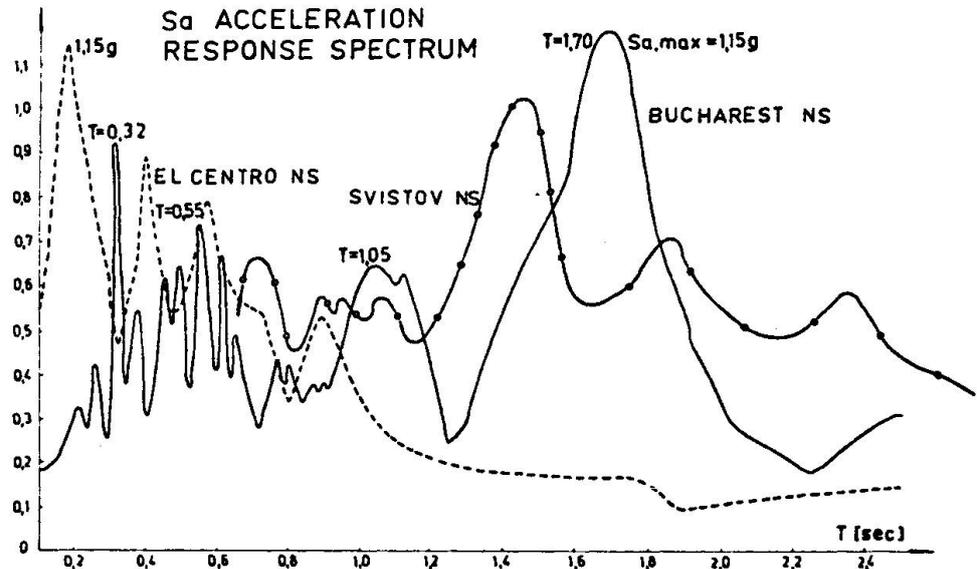
fig. 4

The response spectra for Bucharest record NS component, El Centro 1940 NS component and Svistov NS probable component at 0% critical damping are given on (fig.4). It is evident that Vrancha earthquake effect significantly the flexible structures with natural periods $T > 1$ sec. On this bases can be explained the large numbers of the damages in flexible structures. In some specific regions small buildings of one-two storeys had been heavily damaged

The most suprising effect of this earthquake was the total colaps of three reinforce concrete buildings without shear walls in first floor. This colapse can be explained by specific response spectra with maximum at $T > 1$ sec (fig. 4), sinusoidal exitation in both directions, large horizontal displacements and additional influence of P- Δ effect on the bending moments into the columns.

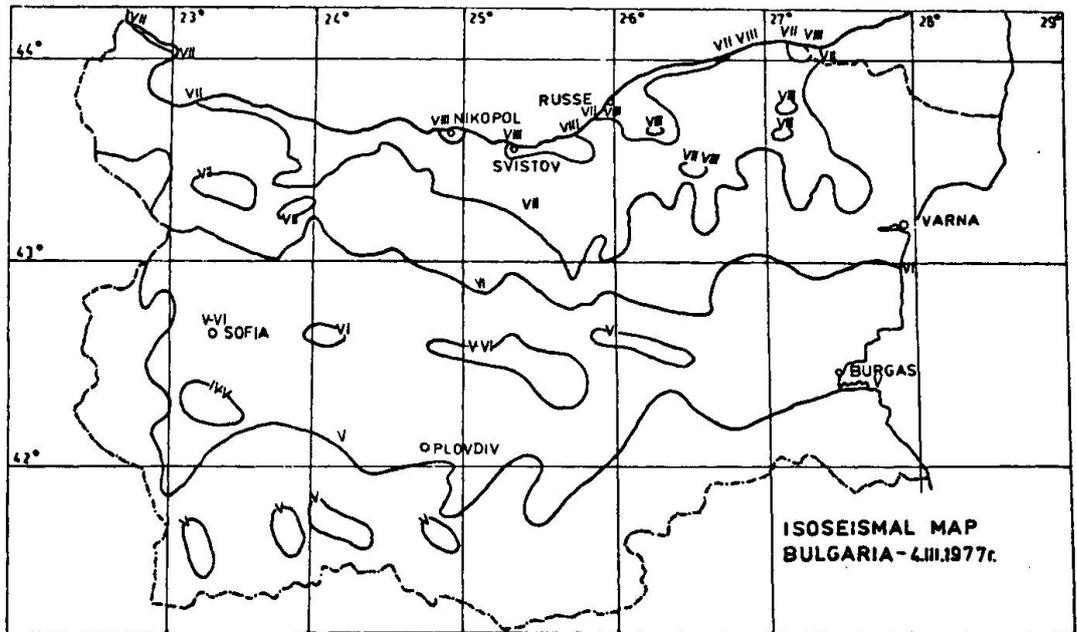
fig. 5

The isoseismal map of Vrancha earthquake on the territory of Bulgaria (fig.5) is influenced significantly by the geological conditions- specially on alluvial deposits at the rivers valley. The

most affected area—right bank of Danube is characterised by alluvial deposits and loessoidal surface layers of thickness 5 to 30 m.

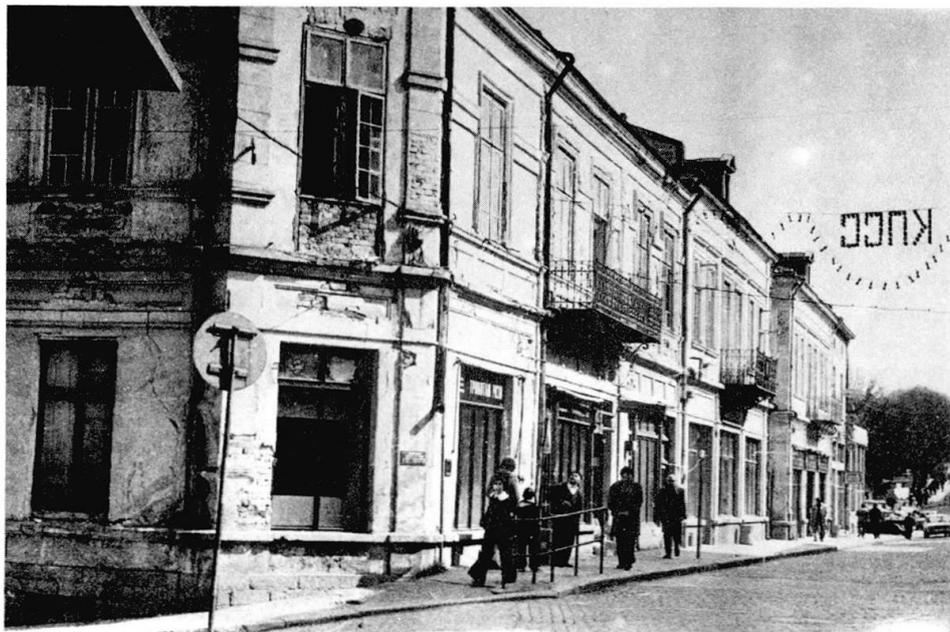
fig. 6

In the most effected area—Svistov (point 1 on fig. 5) one storey brick masonry buildings did not get any cracks. Two storey very old buildings (fig. 6) with wooden floors did not suffered significantly. Some of them got small cracks (fig. 7) Some old buildings from last century (fig. 8) not designed for earthquakes but well built with steel connections between walls were damaged mainly in connections between timber roofs and masonry. In some other areas (point 2 on fig. 5) one and two storeys masonry buildings were heavy damaged. Those buildings had been built with low strength bricks and mortars (mud or lim-sand), timber floors and roofs non connected well with walls (fig. 9).

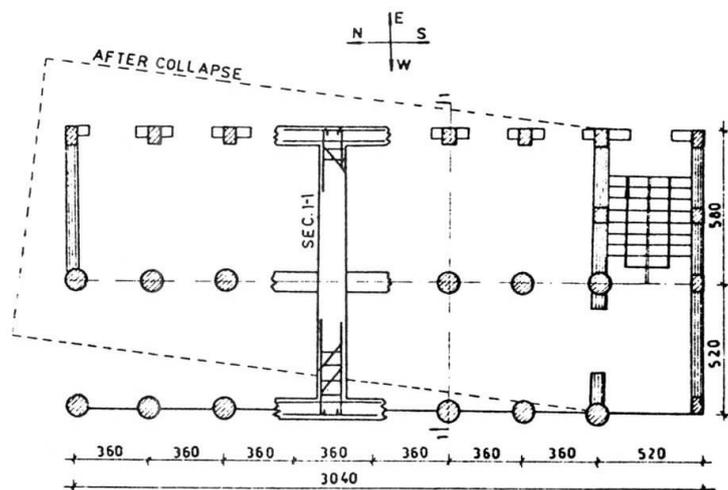
fig. 10

The fifth storey office building (fig. 10) is typical building with flexible first storey. The existing of shear walls at the stairs only develop additional rotational effects and reserve partly only first two storeys at the stairs (fig. 11). The cylindrical columns of the building are well designed (fig. 12) but connections between girders and columns did not forme space resisting frame for horizontal exitation. The small length of down girders steel bars into columns (fig. 10 b) was not capable to bear suficient bending moments from the earthquake. Similar construction had the sixt storeys public residential building wich was colapsed on the same way (fig. 13).

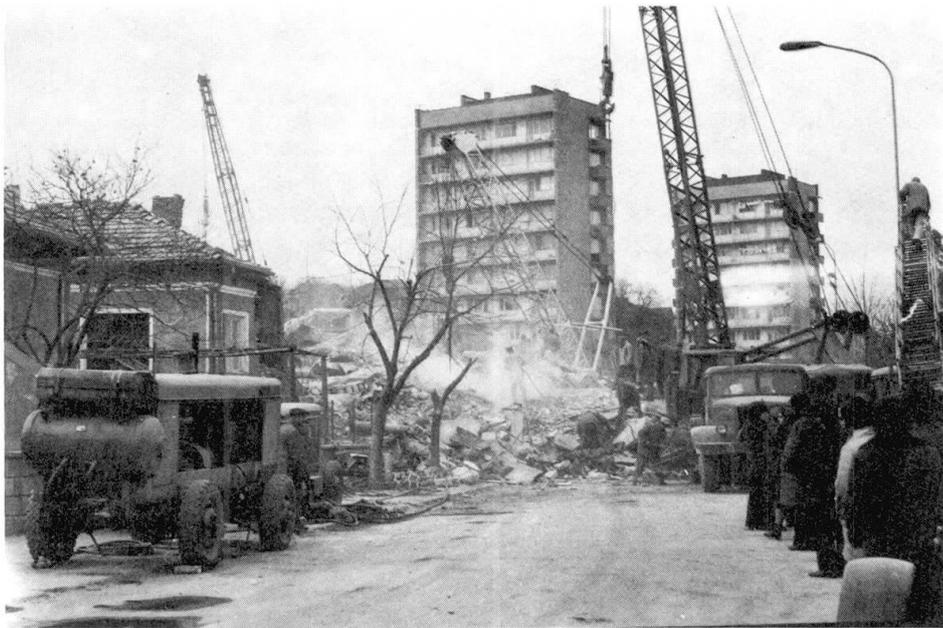
fig. 14

The nine storeys apartment building with shops (without shear walls) into first storey was colapsed as previous two buildings (fig. 14). Another two nine storeys buildings with the same construction but with masonry shear walls in first storey have resisted very well to the earthquake (fig. 15).

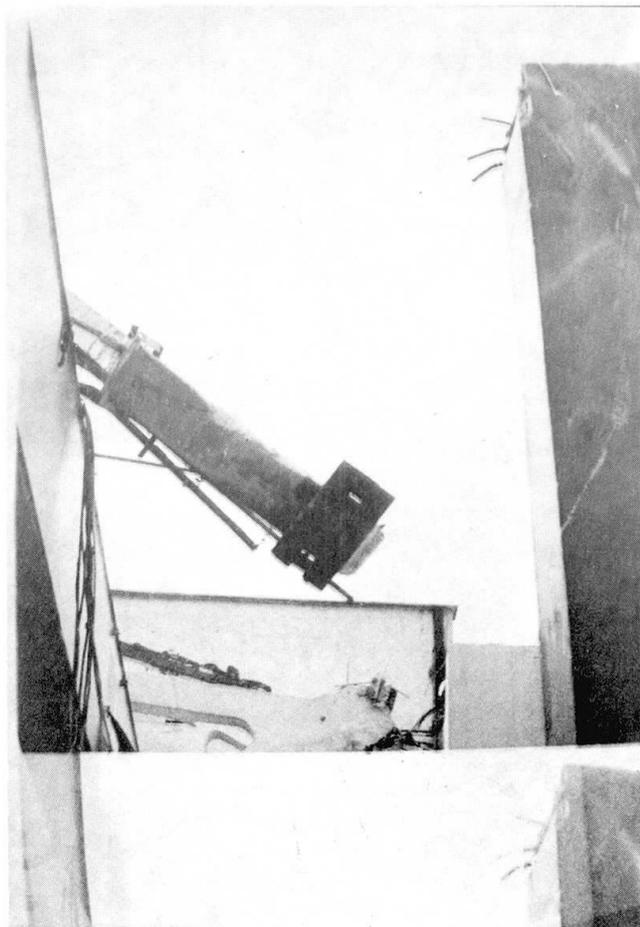
fig. 16

The damages in many industrial buildings were mainly from bed connections between roof trusses and columns (fig.16) between roof ,wall panels and columns.

Large panel and precast constructions non designed have resisted very well to this earthquake. Special attantion have to paid to the quality of realization on place of the joints between separate elements.
