**Artikel:** Effects of Vrancha earthquake of 4 March 1977 on the territory of Bulgaria

# EFFECTS OF VRANCHA EARTHQUAKE OF 4 MARCH 1977 ON THE TERRITORY OF BULGARIA

S. Sachanski - Dr. Eng. Head Dept. Seismic Mechanics, Bulgarian Academy of Sciences, Sofia, Bulgaria.

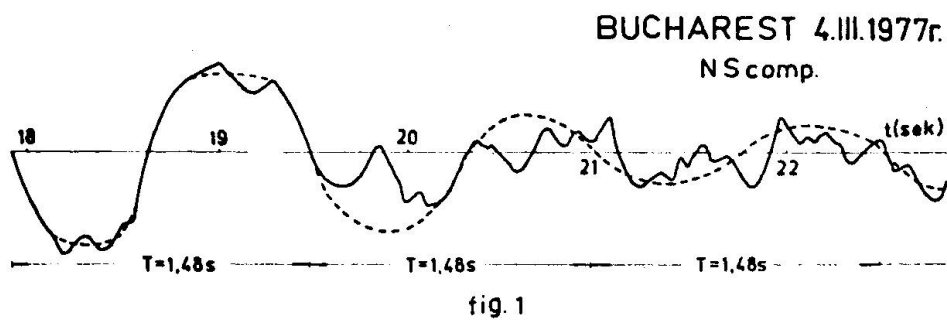
On the accelerogram recorded in Bucharest ( INCERC), at distance 170 km from epicenter, can be seen typical sinusoidal character of the motion after 18 sec for both NS and EW components (fig.1). The accelerogram in Nish (453 km from epicenter) (fig.2) contain similar long period motion combined with short period waves specified by the geological conditions.

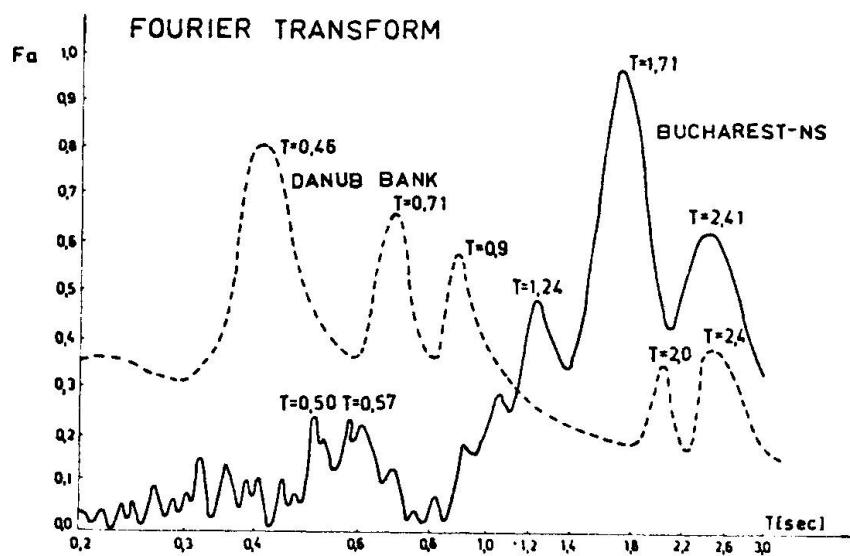
The Fourier transform spectra from Vrancea earthquake for Bucharest [1] and Nish [2] records and experimentally determined period [3] at right bank of Danube river ( 300 km from epicenter) are given on (fig.3). It is evident that specific deep geological conditions with short natural predominant periods for surface layers generate additional short motions (fig.2). Well known filtration of the short period waves with distance is not observed in this case. There are some regions on the territory of Bulgaria which generate short period motions and others one-long periods. This fact was confirmed by the behaviour of the structures with different natural periods located at different ground conditions.

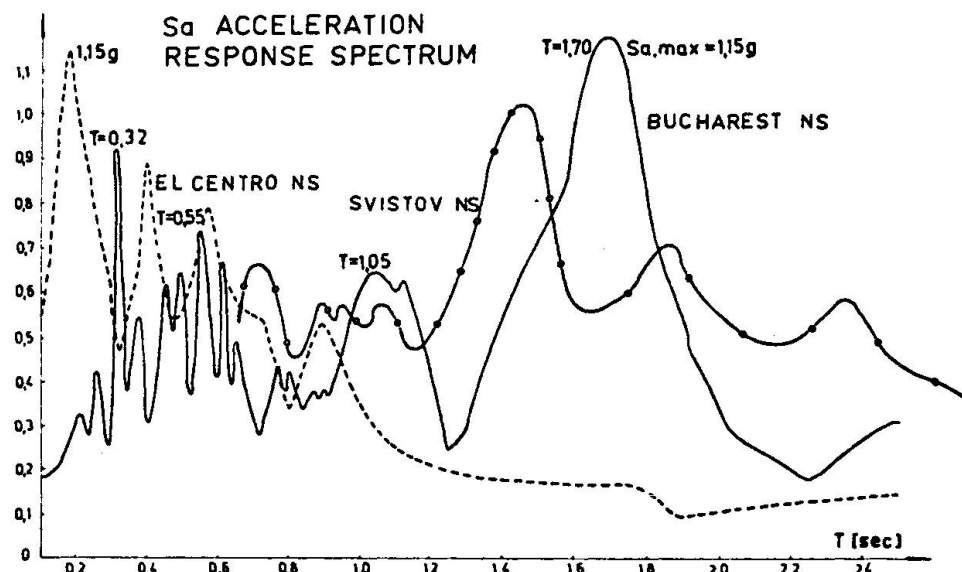
fig. 4

The response spectra for Bucharest record NS component, El Centro 1940 NS component and Svistov NS probable component at 0% critical damping are given on (fig.4). It is evident that Vrancea earthquake effect significantly the flexible structures with natural periods  $T > 1$  sec. On this bases can be explained the large numbers of the damages in flexible structures. In some specific regions small buildings of one-two storeys had been heavily damaged

The most suprising effect of this earthquake was the total collapse of three reinforce concrete buildings without shear walls in first floor. This collapse can be explained by specific response spectra with maximum at  $T > 1$  sec (fig. 4), sinusoidal excitation in both directions, large horizontal displacements and additional influence of P- $\Delta$  effect on the bending moments into the columns.

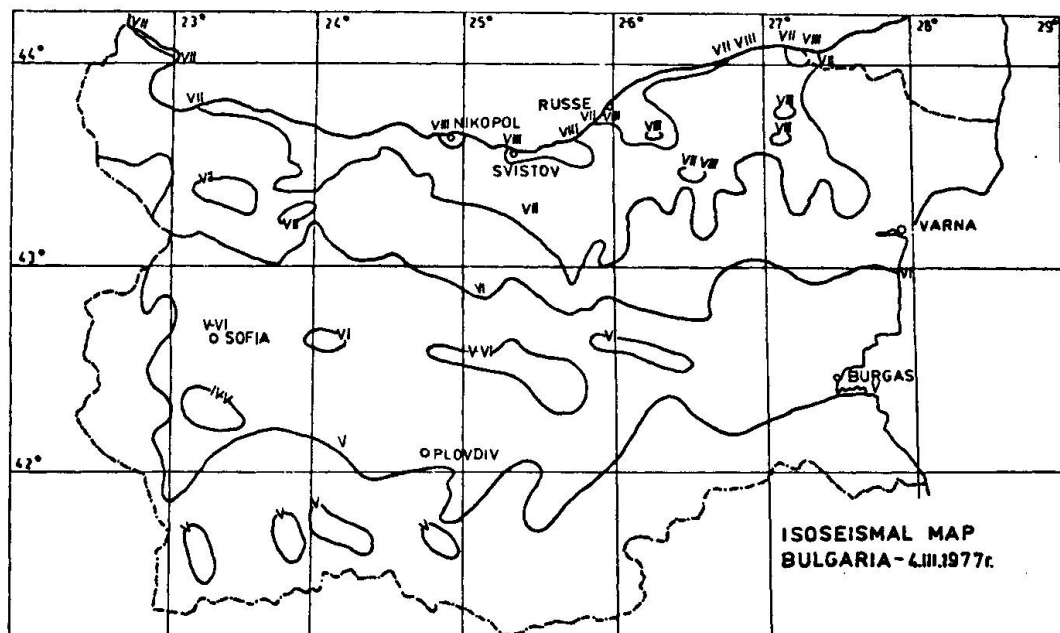
The isoseismal map of Vrancea earthquake on the territory of Bulgaria ( fig.5 ) is influenced significantly by the geological conditions-specially on alluvial deposits at the rivers valley. The

most affected area—right bank of Danube is characterised by alluvial deposits and loessoidal surface layers of thickness 5 to 30 m.

In the most effected area—Svistov ( point 1 on fig. 5 ) one storey brick masonry buildings did not get any cracks. Two storey very old buildings (fig. 6 ) with wooden floors did not suffered significantly. Some of them got small cracks (fig. 7) Some old buildings from last century ( fig. 8) not designed for earthquakes but well built with steel connections between walls were damaged mainly in connections between timber roofs and masonry. In some other areas ( point 2 on fig. 5) one and two storeys masonry buildings were heavy damaged. Those buildings had been built with low strength bricks and mortars ( mud or lim-sand ), timber floors and roofs non connected well with walls (fig. 9 ).

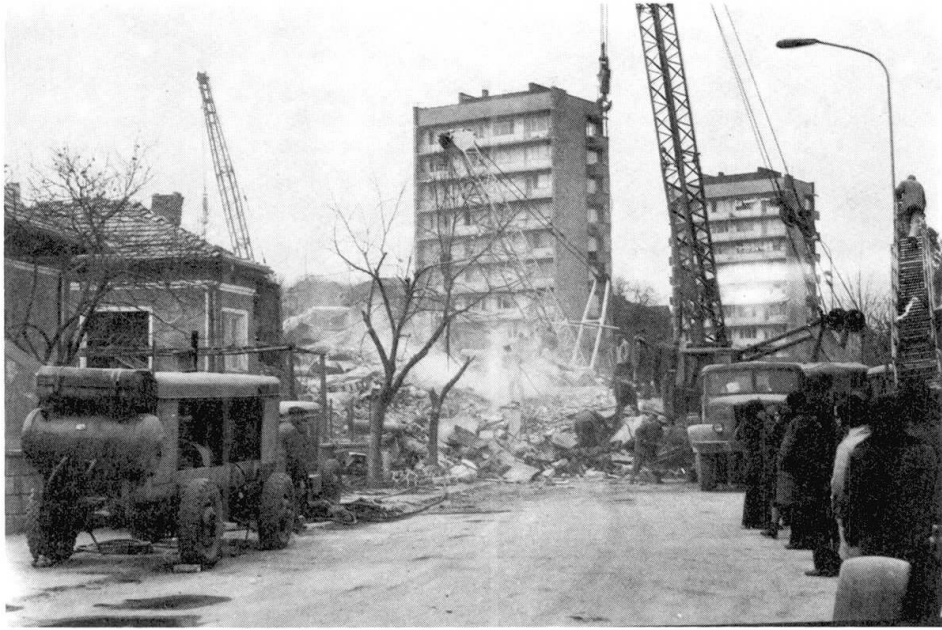
fig. 14

The nine storeys apartment building with shops ( without shear walls) into first storey was collapsed as previous two buildings ( fig. 14). Another two nine storeys buildings with the same construction but with masonry shear walls in first storey have resisted very well to the earthquake ( fig. 15).

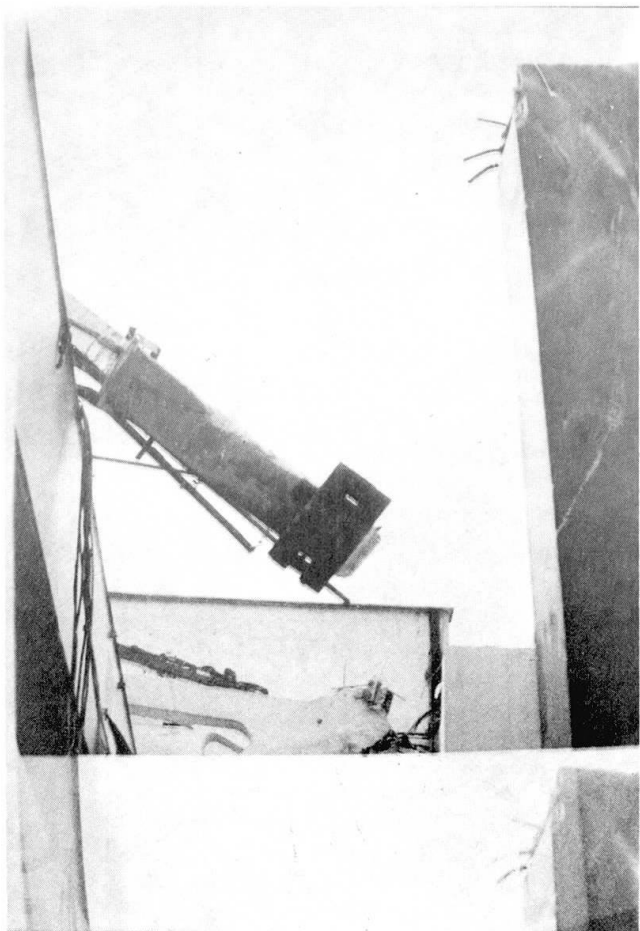
fig. 16

The damages in many industrial buildings were mainly from bad connections between roof trusses and columns ( fig.16 ) between roof , wall panels and columns.

Large panel and precast constructions non designed have resisted very well to this earthquake. Special attention have to be paid to the quality of realization on place of the joints between separate elements.
