Artikel: A first geotechnical assessment of recent Patti earthquake (Sicily)

A FIRST GEOTECHNICAL ASSESSMENT OF THE RECENT PATTI EARTHQUAKE
(SICILY)

Michele Maugeri, Professor of Soil Mechanics Faculty of Engineering, University of Catania.

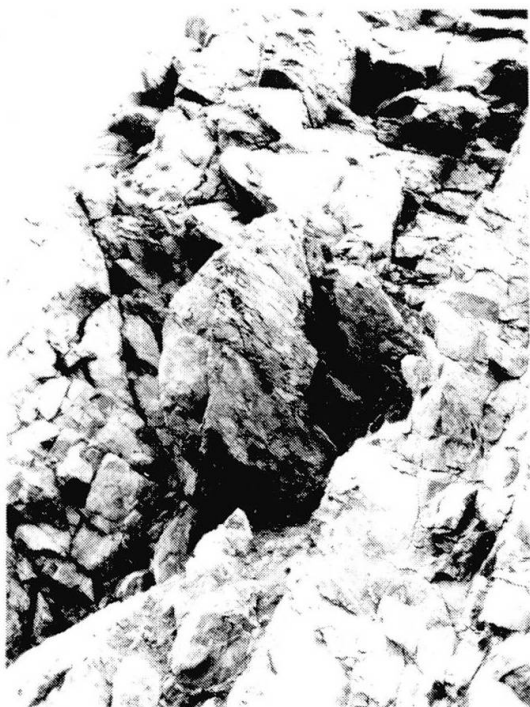
A landslide, consisting in a rock mass failure, was observed at Capo Calavà, whose location is on the left of the Patti gulf. The slope was high and formed of very jointed and altered rock, which has been consolidated in the past by spritz beton and anchorages.

Because of the earthquakes the rock failure was accelerated and a series of blocks, from 10 to 60 cm in diameter fell down into the road. As is clear from fig. 10 the entire cliff is at present in a dangerous limit equilibrium.

Fig. 10: Rock fall at Capo Calavà.
