**Zeitschrift:** IABSE reports of the working commissions = Rapports des commissions de travail AIPC = IVBH Berichte der Arbeitskommissionen  
**Band:** 30 (1978)  
**Artikel:** A first geotechnical assessment of recent Patti earthquake (Sicily)  
**Autor:** Maugeri, Michele  
**DOI:** <https://doi.org/10.5169/seals-24193>

A FIRST GEOTECHNICAL ASSESSMENT OF THE RECENT PATTI EARTHQUAKE  
(SICILY)

Michele Maugeri, Professor of Soil Mechanics Faculty of Engineering, University of Catania.

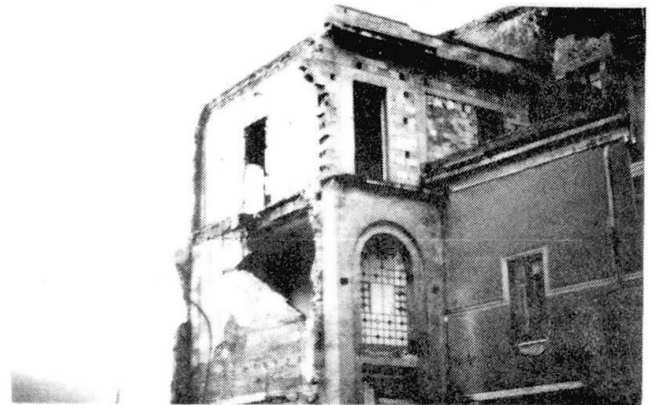
The worst damaged houses in Patti were those founded on sandstone, built of masonry and rarely cemented, in the old centre of the town.

On that site the sandstone formation assumes a hill configuration, which could produce an amplification on maximum ground acceleration (Maugeri, 1976), which can explain, together with the poor construction quality, the severe destruction of some houses.

In fig. 6 the damage suffered by one wing of Patti Cathedral is visible and in fig. 7, the damage at the corner of the main nave is evident.

Fig. 6: Patti Cathedral: the left wing.

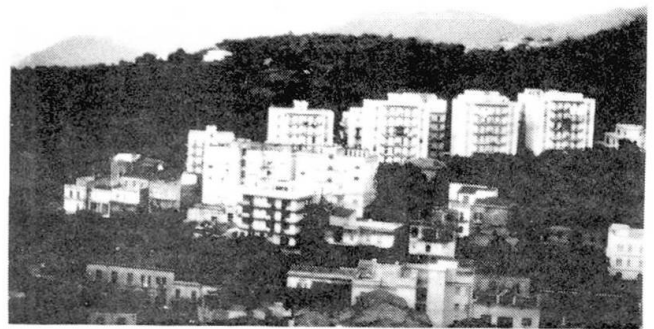
The new concrete buildings in Patti, shown in fig. 8, are built on fissured clay and were apparently damaged on the buffer walls only, mainly at the lower levels.

Fig. 8: Concrete buildings at Patti virtually undamaged.
