Artikel: Fatigue of HSFG bolted joints: effects of design parameters
Autor: Cullimore, M.S.G.
DOI: <https://doi.org/10.5169/seals-28974>

Fatigue of HSFG Bolted Joints – Effects of Design Parameters

M.S.G. CULLIMORE

University of Bristol
Bristol, England

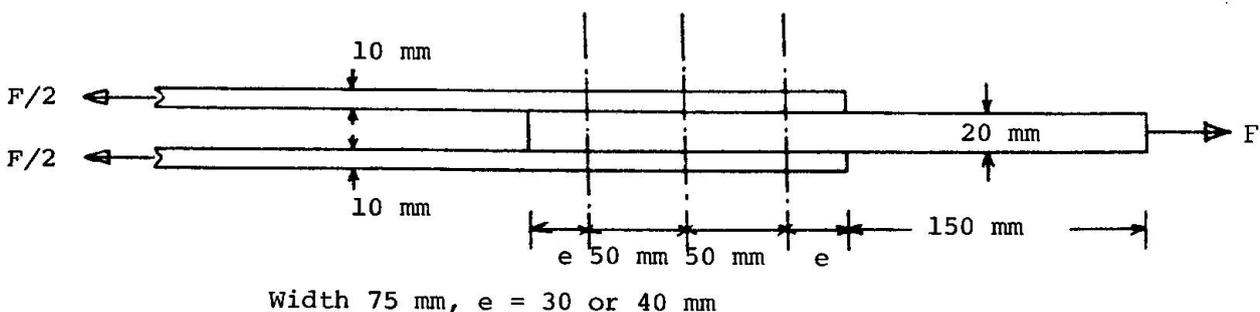
Fig. 1. Standard Fatigue Test Piece

The test piece for the basic test, shown in Fig. 1, was made of BS.4360 Grade 50 steel with three M20 bolts, tightened to 190 kN, the tension specified in BS.4395 Pt. 2. The bolts were a special load indicating type which enabled the bolt tension to be monitored continuously throughout the test. The contact surfaces of the joints were grit-blasted with chilled iron grit G34.

3 x 20 M HSFG Bolts

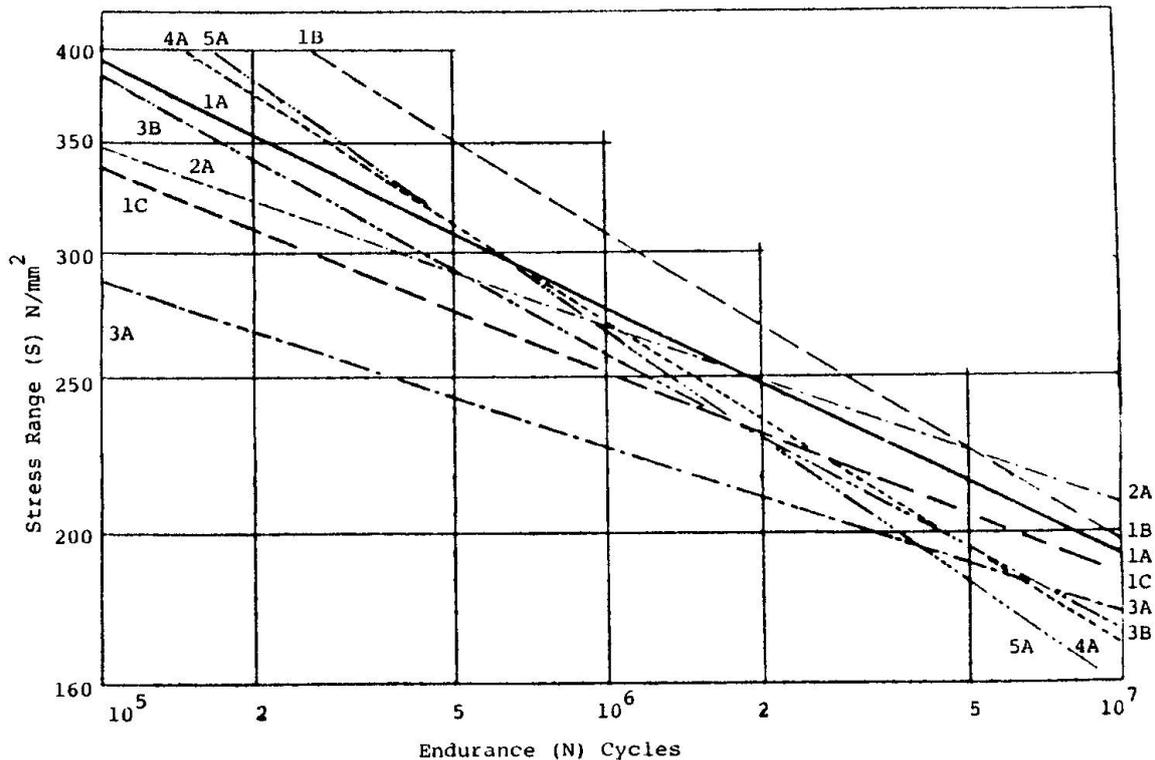
Fig. 2 Fatigue Tests Results S-N Mean Lines

These results are summarised graphically in Fig. 2. The values of the coefficients m and K in the equation :-

2.3.1 Mean stress - A reduction in mean stress gives a marked improvement in the life for a given stress range, especially at the higher stress range.

2.3.2 Surface finish - The mill scale surface joints had a very much lower life at the higher stress ranges than the shot blasted ones. The effect, however, appears to be reversed at stress ranges below about 220 N/mm^2 . The effect of the zinc epoxy primer was to reduce the fatigue life for all the stress ranges used.

2.3.3 Plate strength - The higher strength Grade 55 steel gave a consistently inferior fatigue performance to the Grade 50 steel. The fatigue strength of the lower strength Grade 43 steel joints was poorer than either. In the latter case, the maximum stresses in the area of the first bolt were approaching the yield strength of the material.

2.3.4 Bolt tension - For lives above one million cycles joints with the higher bolt tension had a better fatigue strength than those with the lower tension.

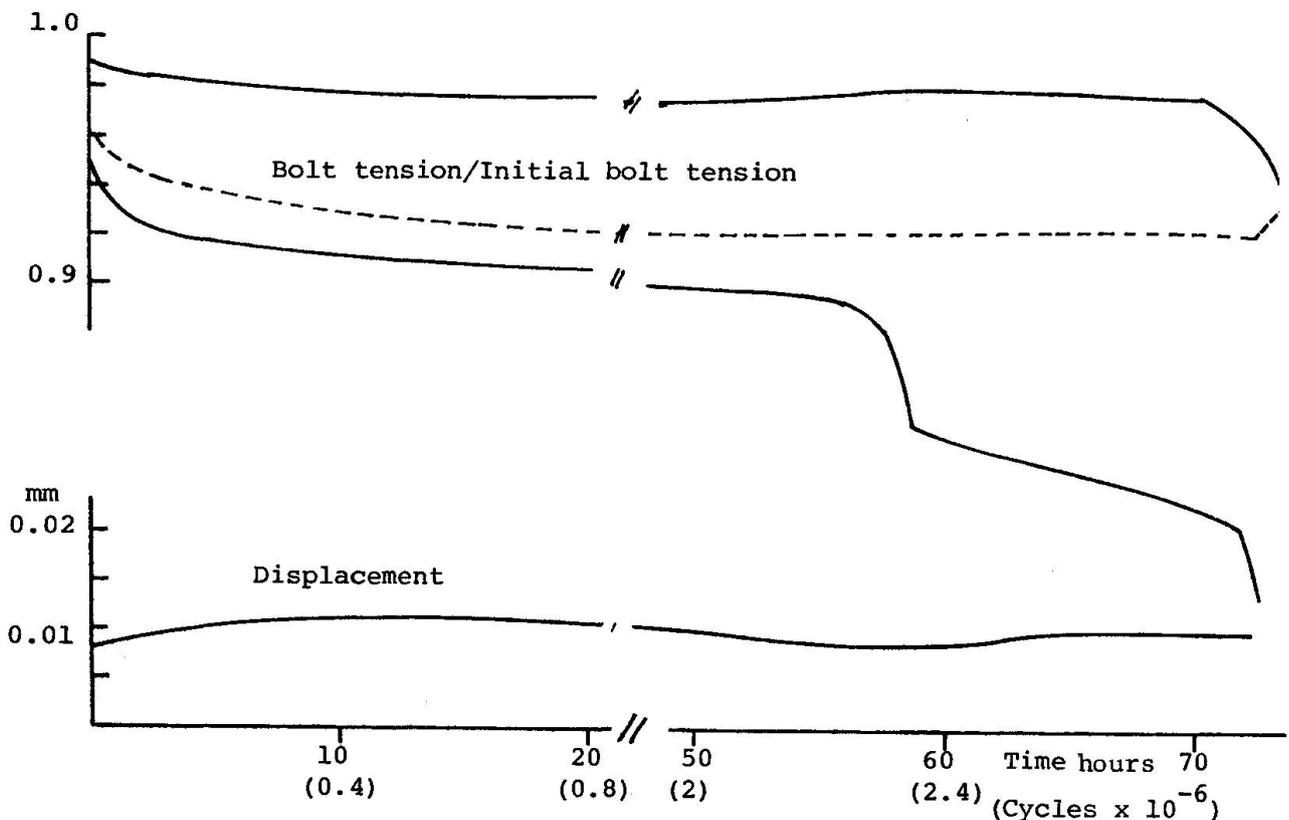
Fig. 3 Fatigue Test - Joint Stability

The results of measurements of bolt tension and displacement monitored continuously throughout a typical test are shown in Fig. 3. The load displacement loop was not closed on the first cycle, giving a small irrecoverable displacement. This got smaller with each succeeding load cycle until complete stabilisation (loops of constant size) was obtained after about 50,000 to 70,000 cycles. The bolt tensions show the expected relaxation with time [5]. Failure in this case was by cracking of the cover plate and washer, which probably accounts for the loss of bolt tension in the bolt there (lower of three curves) after about 58 hours. After the initial increase, the displacements show very little change.
