Fatigue of HSFG Bolted Joints – Effects of Design Parameters

M.S.G. CULLIMORE

University of Bristol

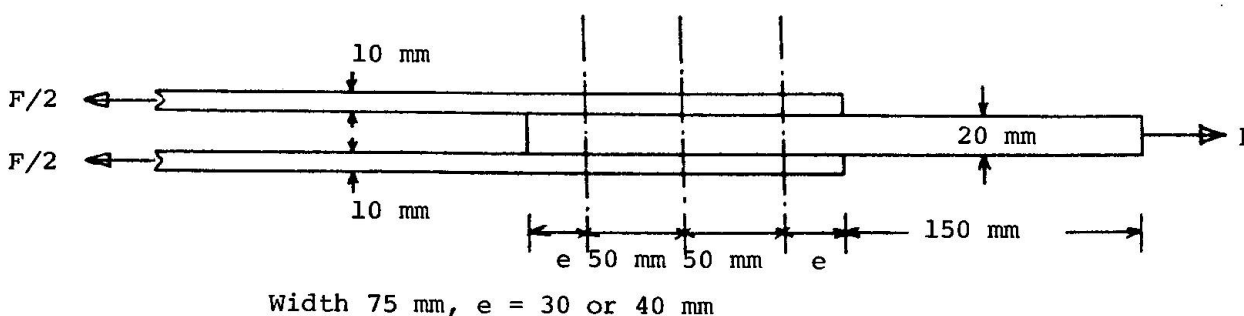
Fig. 1. Standard Fatigue Test Piece

The test piece for the basic test, shown in Fig. 1, was made of BS.4360 Grade 50 steel with three M20 bolts, tightened to 190 kN, the tension specified in BS.4395 Pt. 2. The bolts were a special load indicating type which enabled the bolt tension to be monitored continuously throughout the test. The contact surfaces of the joints were grit-blasted with chilled iron grit G34.

3 x 20 M HSFG Bolts

during assembly of the joint, setting up and throughout the test. Displacements between the centre and cover plates, on both sides, were also measured. After grit-blasting the plates were exposed to the air for 24 hours before assembly to allow a mild degree of corrosion. Testing was commenced 24 hours after assembly to allow the initial bolt relaxation to take place. Details of the variants for the various series of tests are given in Table 1.

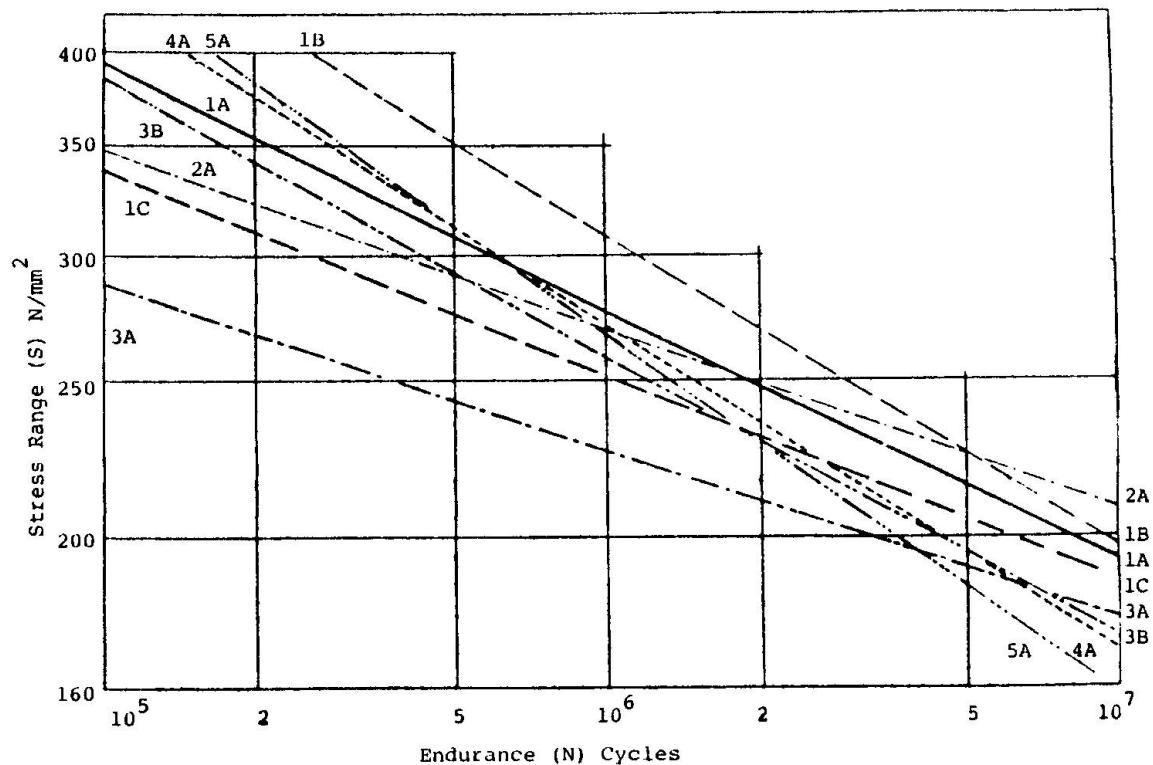
Fig. 2 Fatigue Tests Results S-N Mean Lines

These results are summarised graphically in Fig. 2. The values of the coefficients m and K in the equation :-

$$\log N = K - m \log S$$

2.3.1 Mean stress - A reduction in mean stress gives a marked improvement in the life for a given stress range, especially at the higher stress range.

2.3.2 Surface finish - The mill scale surface joints had a very much lower life at the higher stress ranges than the shot blasted ones. The effect, however, appears to be reversed at stress ranges below about 220 N/mm^2 . The effect of the zinc epoxy primer was to reduce the fatigue life for all the stress ranges used.

2.3.3 Plate strength - The higher strength Grade 55 steel gave a consistently inferior fatigue performance to the Grade 50 steel. The fatigue strength of the lower strength Grade 43 steel joints was poorer than either. In the latter case, the maximum stresses in the area of the first bolt were approaching the yield strength of the material.

2.3.4 Bolt tension - For lives above one million cycles joints with the higher bolt tension had a better fatigue strength than those with the lower tension.

2.3.5 Edge distance - Increasing the edge distance did not produce the expected improvement in performance. The consistency of these results was, however, poorer than for the standard test so that it could be that the increase from 30-40 mm is insufficient to cause a significant change.

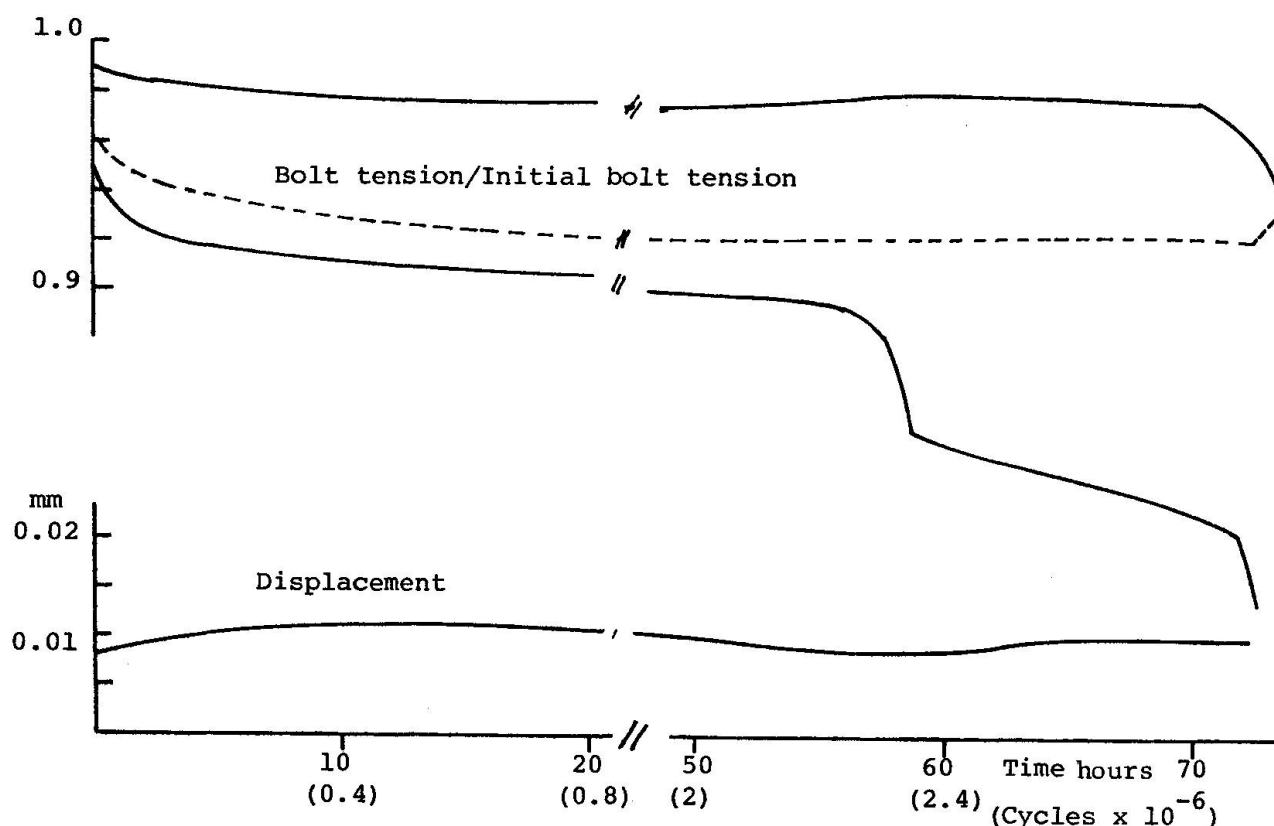
Fig. 3 Fatigue Test - Joint Stability

The results of measurements of bolt tension and displacement monitored continuously throughout a typical test are shown in Fig. 3. The load displacement loop was not closed on the first cycle, giving a small irrecoverable displacement. This got smaller with each succeeding load cycle until complete stabilisation (loops of constant size) was obtained after about 50,000 to 70,000 cycles. The bolt tensions show the expected relaxation with time [5]. Failure in this case was by cracking of the cover plate and washer, which probably accounts for the loss of bolt tension in the bolt there (lower of three curves) after about 58 hours. After the initial increase, the displacements show very little change.

4.1 No evidence of fatigue failure having been accompanied by slipping was noted, except in the case of the highest loads used in the Grade 43 steel tests (and in the 1-bolt tests), where the upper load was a high proportion of the slip load and the stresses at the first bolt were approaching yield.
