Artikel: Fatigue of HSFG bolted joints: effects of design parameters
Autor: Cullimore, M.S.G.
DOI: <https://doi.org/10.5169/seals-28974>

Fatigue of HSFG Bolted Joints – Effects of Design Parameters

M.S.G. CULLIMORE

University of Bristol
Bristol, England

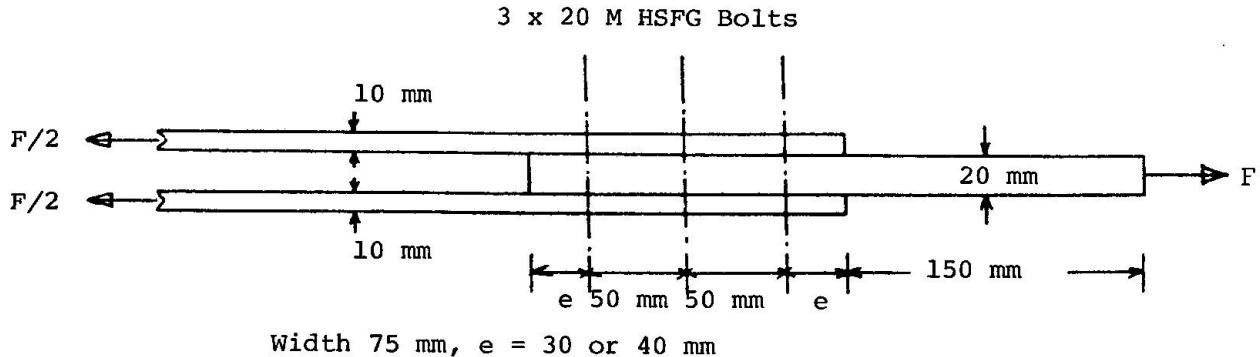
Fig. 1. Standard Fatigue Test Piece

The test piece for the basic test, shown in Fig. 1, was made of BS.4360 Grade 50 steel with three M20 bolts, tightened to 190 kN, the tension specified in BS.4395 Pt. 2. The bolts were a special load indicating type which enabled the bolt tension to be monitored continuously throughout the test. The contact surfaces of the joints were grit-blasted with chilled iron grit G34.

A suitable 1-bolt specimen could not be made from 20 mm plate as, even with the minimum width, the maximum stress (at the slip load) was too low to cause fatigue failure. It was necessary to use another combination of plate thicknesses which would allow an adequate stress range and give approximately the same stress situation in the contact pressure area. An adequate stress range was obtained by reducing the centre plate to 10 mm x 50 mm. The radius of the contact pressure area (R) between the cover and centre plates and the ratio (Pa/Pb) of the maximum pressure there to the pressure on the bolt head annulus were calculated [4] for the standard (75 mm wide) 3-bolt test piece as 22.4 mm and 0.90 respectively. The desired conditions would be obtained almost exactly by using 11 mm thick cover plates with the 10 mm thick centre plate. However, as 11 mm is not a standard thickness, 10 mm cover plates were used, giving R = 21.9 mm and Pa/Pb = 0.95, which were considered to be close enough to the values for the standard test piece for practical purposes. The remaining details were the same as those of the standard test piece.

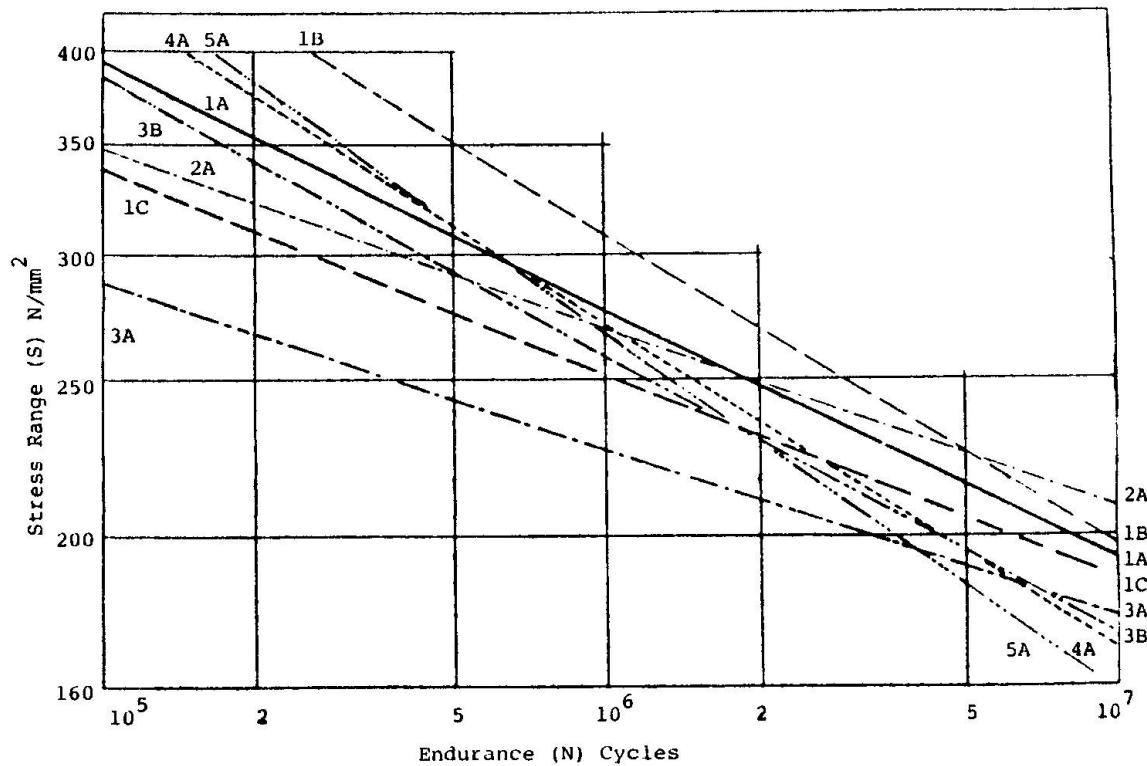
Fig. 2 Fatigue Tests Results S-N Mean Lines

These results are summarised graphically in Fig. 2. The values of the coefficients m and K in the equation :-

$$\log N = K - m \log S$$

2.3.1 Mean stress - A reduction in mean stress gives a marked improvement in the life for a given stress range, especially at the higher stress range.

2.3.2 Surface finish - The mill scale surface joints had a very much lower life at the higher stress ranges than the shot blasted ones. The effect, however, appears to be reversed at stress ranges below about 220 N/mm^2 . The effect of the zinc epoxy primer was to reduce the fatigue life for all the stress ranges used.

2.3.3 Plate strength - The higher strength Grade 55 steel gave a consistently inferior fatigue performance to the Grade 50 steel. The fatigue strength of the lower strength Grade 43 steel joints was poorer than either. In the latter case, the maximum stresses in the area of the first bolt were approaching the yield strength of the material.

2.3.4 Bolt tension - For lives above one million cycles joints with the higher bolt tension had a better fatigue strength than those with the lower tension.

2.3.5 Edge distance - Increasing the edge distance did not produce the expected improvement in performance. The consistency of these results was, however, poorer than for the standard test so that it could be that the increase from 30-40 mm is insufficient to cause a significant change.

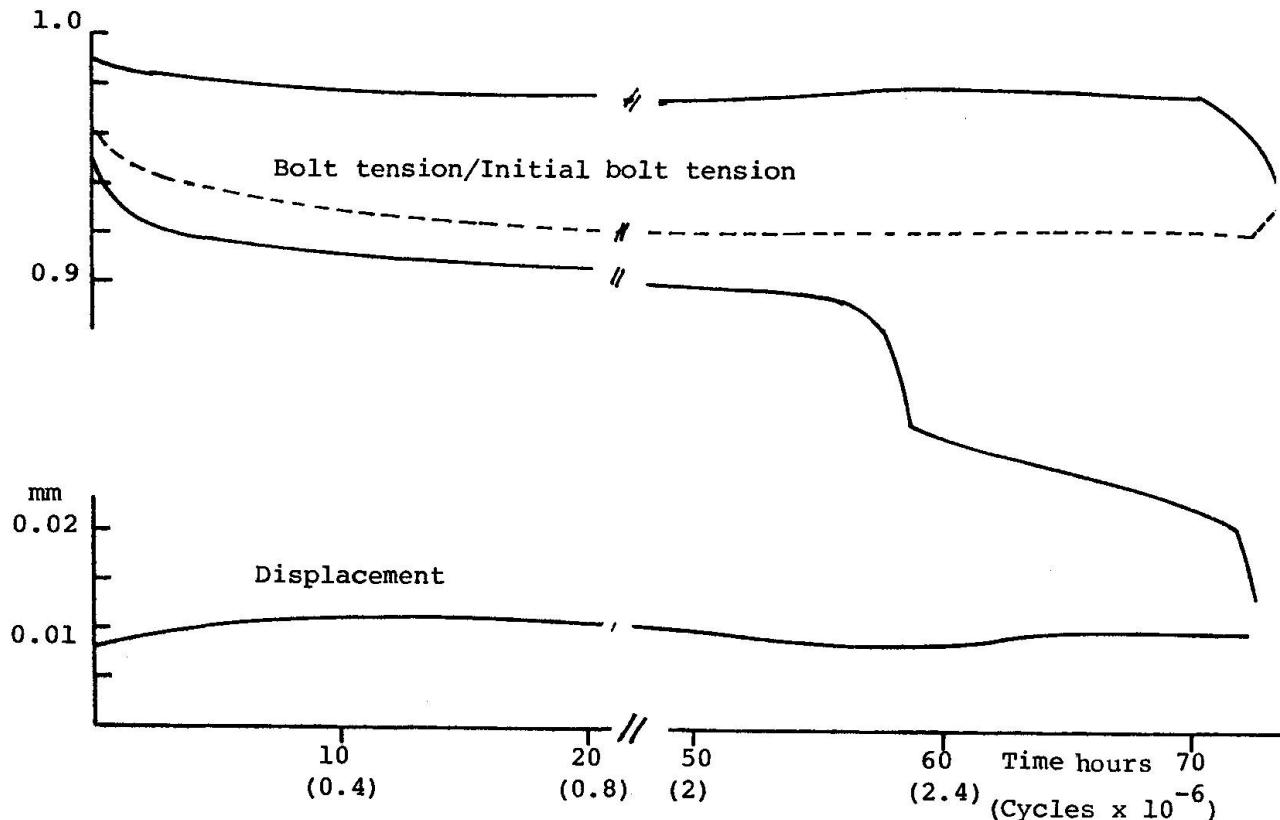
Fig. 3 Fatigue Test - Joint Stability

The results of measurements of bolt tension and displacement monitored continuously throughout a typical test are shown in Fig. 3. The load displacement loop was not closed on the first cycle, giving a small irrecoverable displacement. This got smaller with each succeeding load cycle until complete stabilisation (loops of constant size) was obtained after about 50,000 to 70,000 cycles. The bolt tensions show the expected relaxation with time [51]. Failure in this case was by cracking of the cover plate and washer, which probably accounts for the loss of bolt tension in the bolt there (lower of three curves) after about 58 hours. After the initial increase, the displacements show very little change.

There was no evidence of joints suffering progressive slip as the number of load cycles became large. The initiation of cracks in the cover plate caused by indentations will be reduced by using washers under both bolt head and nut.
