**Artikel:** Fatigue of nodal joints and box-section members in a bridge truss

**Autor:** Tajima, Jiro / Miki, Chitashi / Asama, Tatsuo

## **Fatigue of Nodal Joints and Box-Section Members in a Bridge Truss**

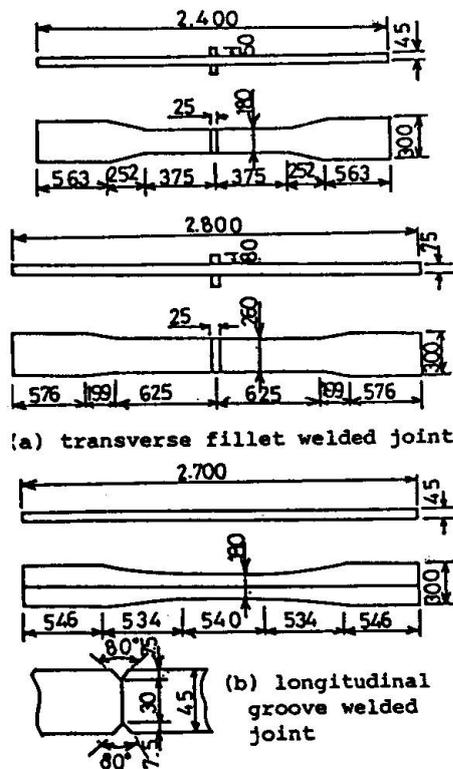
Fig. 1 Joint Specimen

The mechanical properties of the steels used for joint specimens are shown in Table 1. Fig. 1 shows the configurations and dimensions of the specimens. The non-loadcarrying cruciform fillet welded joint (a) simulates the stress condition at the joint of a diaphragm attached to a chord member of a truss. Welding was done manually using an electrode exclusively for fillet welds

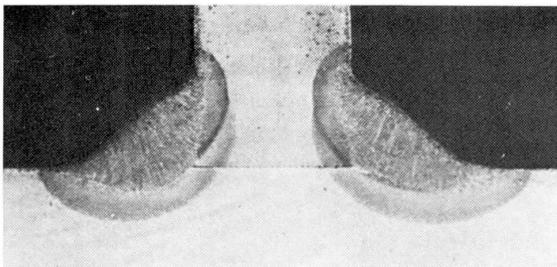
Fig. 2 Shapes of Fillet Welds

said to produce a regular bead shape as shown in Fig. 2. Leg length of fillet welds for 45mm thickness specimens and 75mm thickness specimens are 10mm (two paths) and 13mm (three paths) respectively. Partially penetrated longitudinal groove weld joint simulate for corner welds of truss members with box section. Welding was done using the submerged arc process.

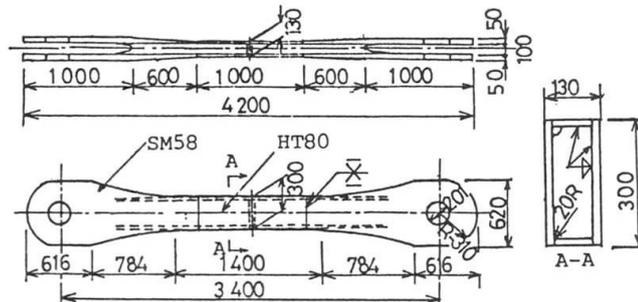
Fig. 3 Box Section Specimen

The mechanical properties of the steels used for specimens of box section are shown in Table 1. Fig. 3 shows the configurations and dimensions of the specimens. Type BA has a diaphragm used SM41 steel at the center of the specimen, and other types have no diaphragm. Welding of the diaphragm was done manually using the same electrode used for joint specimens mentioned above. Corner Welding of these specimens were conducted with automatic welding. Kinds of welding are shown in Table 2. Three types, BB, BD, BF, were with partially penetrated groove welds and one type, BF, was with fillet welds.

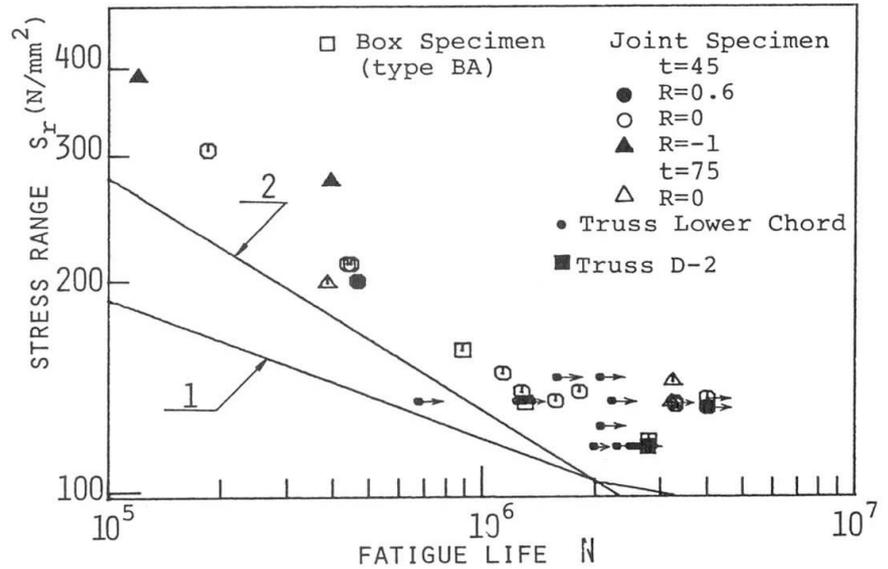
Fig. 6 Results of Fatigue Tests on Transverse Fillet Welds

Fig. 6 shows the results of fatigue tests on cruciform joint specimens, box-section specimens with diaphragm and panel point structures concerning about transverse fillet welds. Twelve cruciform joint specimens of  $t = 45\text{mm}$  and three cruciform joint specimens of  $t = 75\text{mm}$

were tested. With joint specimens of  $t = 45\text{mm}$ , fatigue tests were performed with stress ratios ( $R$ ) at 0.6, 0 and -1. The influences of differences of mean stress on fatigue strength are not very prominent. Differences in fatigue strengths depending on differences in plate thickness of base metals were also small. Fatigue cracks were initiated at the toe of first path fillet welds in most specimens, but in some specimens cracks were initiated at the toe of second path welds.

Three specimens of box-section with diaphragm (Type BA) were tested. In Fig. 6 the results of these tests are plotted. Fig. 8 shows fracture surface of BA-1 specimen. With these three specimens, beach mark tests were performed. Fatigue cracks initiated at the corner of fillet welds of diaphragms at the early period in the life.

In Fig. 6, results of tests on panel point structures are also plotted. In these tests only one fatigue crack was occurred at the toe of fillet welds of diaphragms arranged in the chord members of D type specimen. Line 1 in Fig. 6 shows the former design allowable stress [3] for this type of joint under pulsating stress for the Honshu-Shikoku bridges. All of the test results satisfy the requirement of this criterion. However, the slope of line 1 is too gentle in comparison with the test results. Line 2 in Fig. 6 shows the current design allowable stress for this type of joint. This curve is revised based on the fatigue test results and the analysis of fatigue life by fracture mechanics concept.

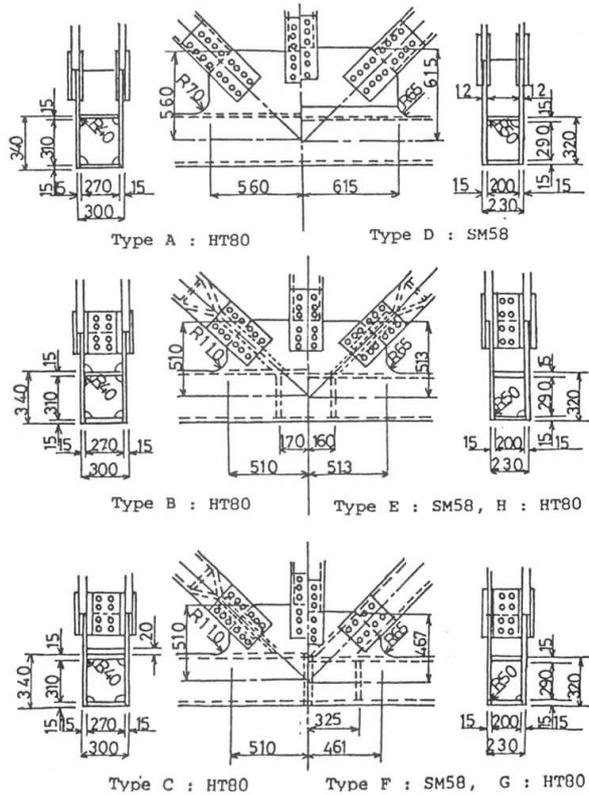
Fig. 5 Truss Panel Point Structures

The mechanical Properties of the steels used for truss panel point structures are shown in Table 1. Fatigue tests were performed using the loading apparatus shown in Fig. 4. The hatched portion in the figure represents a specimen. Fig. 5 gives details of the vicinities of panel points of eight varieties of test specimens. The major points of difference between the each types lie in the methods of connecting the diagonal members, the numbers of diaphragms and fillet radii of gusset plates. Corner welds of chord members were made by manual welding for the specimens A, B and C and by the submerged-arc welding for D, E, F, and G. Kinds of Corner welds are single bevel groove welds, and bevel angle is 45°, depth is 7.5mm for type A, B and C, 8mm for type D-G.

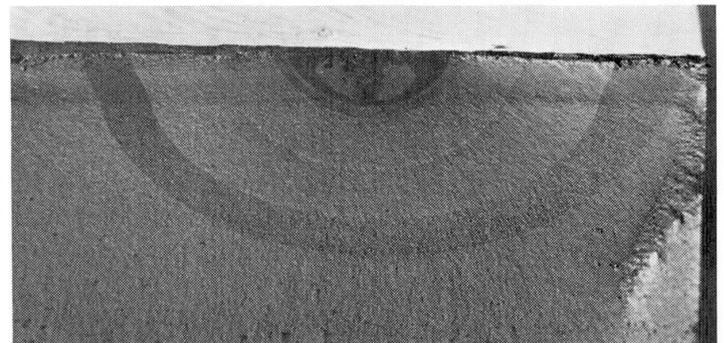
Fig. 7 Fracture Surface of Cruciform Joints

With one joint specimen of  $t = 45\text{mm}$ , two stage multi-stress amplitude test was performed to form the beach marks on the fracture surface (Beach mark test). Fig. 7 shows the result of beach mark test. In this figure, five beach marks can be counted, and numbers of loading block for this specimen are also five. So it was found that the fatigue crack had initiated at the first stress block (prior to  $0.18 N_f$  with  $N_f$  being failure life) from the concave part at the toe of fillet weld.

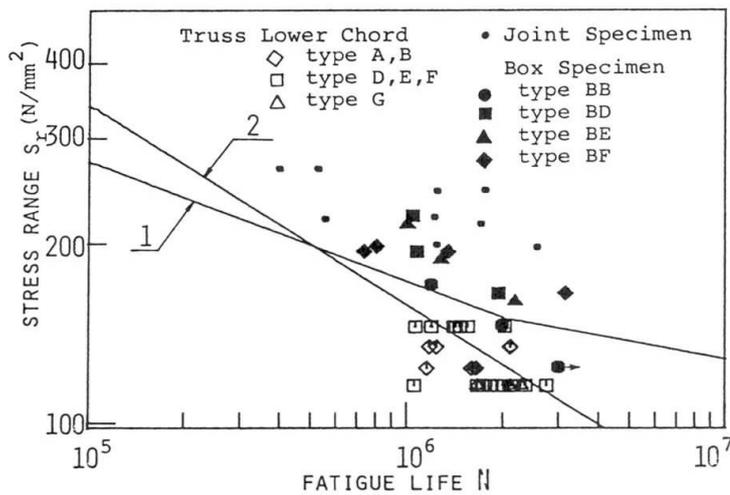
Fig. 9 Results of Fatigue Tests on Longitudinal Welds

Fig. 9 indicates the results of fatigue tests on longitudinal weld joints, box section specimens and panel point structures concerning about longitudinal welds. With longitudinal weld joints, initiation points of fatigue cracks in six out of the entire nine test specimens were blowholes or pores existing at roots of welds, the size being 0.6 to 1.2mm in diameter. Other initiation points were a small pit at bead surface, grinder scratch at surface of base metal and defect at part of base metal repaired by welding. Residual tensile stresses of approximately 340 N/mm<sup>2</sup> and 250 N/mm<sup>2</sup> were measured at joints of an unloaded specimen and an after fatigue test specimen, respectively.

In Fig. 9, line 1 shows the former design allowable stress and line 2 shows the current design allowable stress for this type of joints under pulsating stress. Most of experimental values of panel point structure specimens are below the former design allowable stress. Furthermore, about half of experimental values of panel point structure specimens are below the current design allowable stress. The current design allowable stress is established based on the fatigue test results of box section specimens and the analysis using fracture mechanics concept. From that analysis, weld defects as blowholes exceeding 1.5mm in diameter of inscribed circle must be avoided to remain therein.

With box section specimens, each three test specimens of type BB, BD and BE, and four of type BF were tested. Results of fatigue tests on these specimens are shown in Fig. 9. The locations of fatigue crack initiation in each type of specimens are as follows.

All specimens except C-1 and C-2, fatigue tests were terminated by growth of fatigue cracks initiated at corner welds of bottom chord members. The relation between nominal stress range and number of cycles of stressing the fatigue crack was discovered at a bottom chord is shown in Fig. 9. In the type A and B specimens fatigue cracks at corner welds were initiated from irregularities at the roots of welds due to nonfusion or lack of penetration. The number of fatigue cracks initiated in the four specimens of type A and B was 13, with surface length from 9mm to 310mm. In the type D, E, F, and G specimens most of fatigue cracks were initiated from blowholes existing at the roots of welds. Fig. 13 shows one example of fracture surface of corner welds. In E-2 and G-1 each one crack occurred at the corner of butt joint of lower chord member, where some small pits existed near the surfaces of plates. The number of fatigue cracks initiated in the eight specimens of type D, E, F and G was 30, with

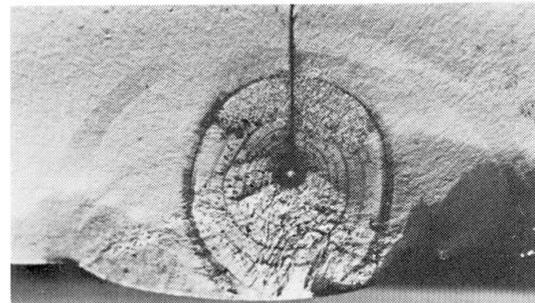
Fig. 10 Fracture Surface of Longitudinal Weld Joint

Beach mark tests were performed with three joints specimens. Fig. 10 shows the fracture surface with beach marks. Fatigue crack had been initiated from the wall of a blowhole at the root of weld. In this fracture surface, thirty beach marks can be counted and numbers of loading block are thirty four so the fatigue crack of this specimen had started growing before 0.12 N<sub>f</sub> cycles of loading.

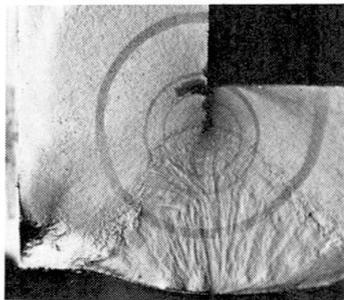
Fig. 11 Fracture Surface of BB-1 Specimen

- BB type : blowhole (2.5 x 1.8, 4.1 x 3.4mm) at the root of welds.
- BD type : bead surface, blowhole (3.9 x 3.6mm) at the root of welds and imperfection of weld metal.
- BE type : weld root (no blowhole) and blowhole (1.1 x 0.5, 1.4 x 0.7mm) at the root of welds.
- BF type : slag inclusions at the end of butt joint (2 specimens) and slag inclusions at the toe of fillet weld and root.

Fig. 11 and 12 shows the fracture surface of BB-1 and BE-2 specimens.
