## **THEME 6**

**Case Studies of Steel Structures**

## **Fatigue Design of the Honshu-Shikoku Bridges in Japan**

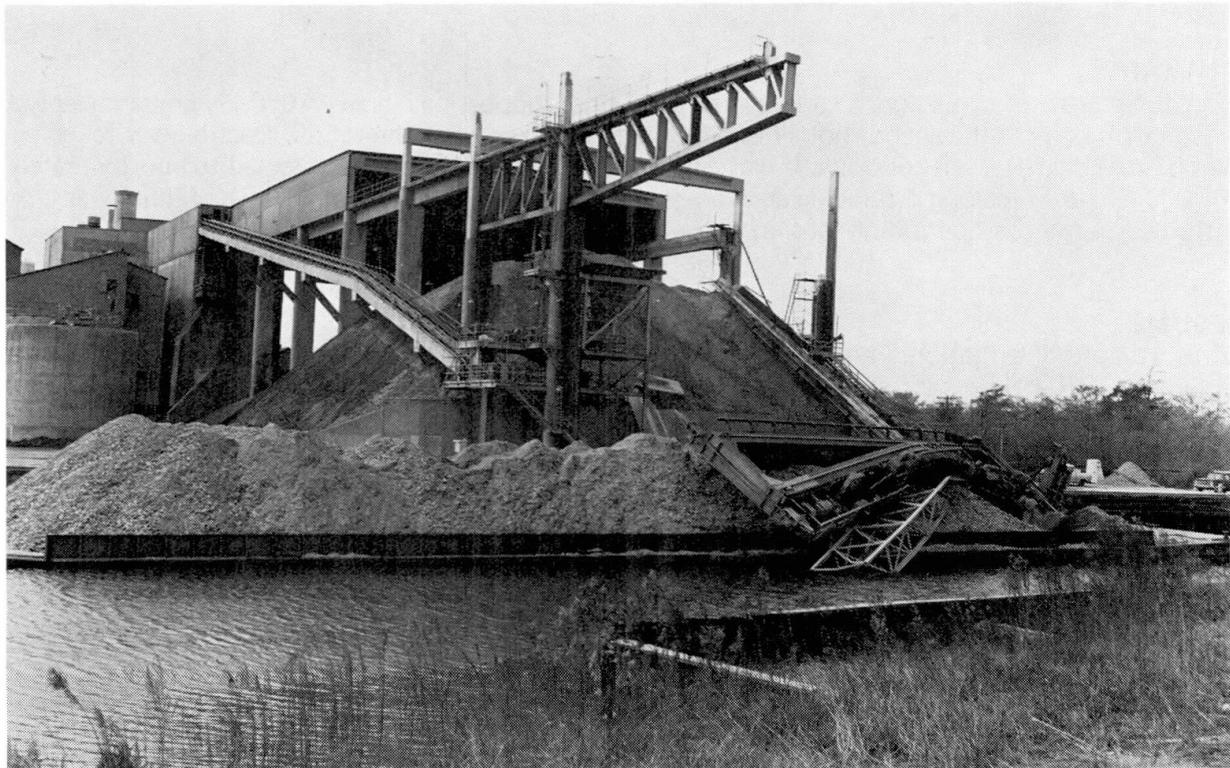
Fig. 1 View of Collapsed Truss and Crane
